# Gear Failure Analysis Involving Grinding Burn

G. Blake, M. Margetts and W. Silverthorne

## Management Summary

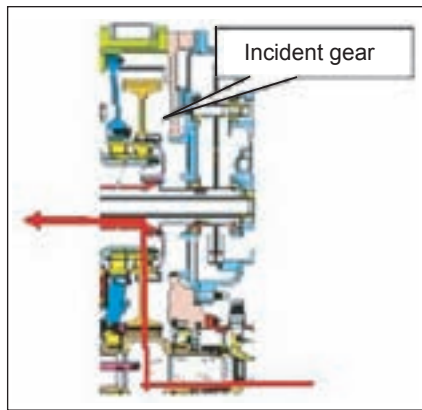
The subject gearbox had accumulated 1,650 hours of use at the time of inspection. A partial illustration of the gear train and the gear is shown in Figure 1. The gear and mating pinion are carburized, ground and shot peened AMS6265. The engine torque path is also shown in Figure 1.

Figure 1—Partial illustration of gear train showing torque path.

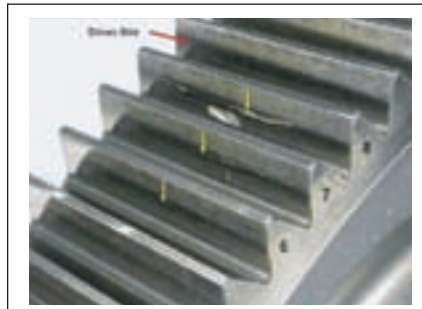
Cracks were found in the first-stage spur gear as shown in Figure 3. Tooth number eight, shown in Figure 3, was found to have a divot close in size to the metallic sliver found on the chip detector. The cracks were located in three adjacent teeth on the driven side. The cracks stretched across the central 75% of the face width within the active tooth profile. The cracks were arc shaped, higher on the active tooth profile at the ends than in the center.

The visual cracks and distress of the gear were confined to the three teeth shown in Figure 3. The remainder

Figure 3—Three adjacent teeth cracked observable without MPI or magnification.

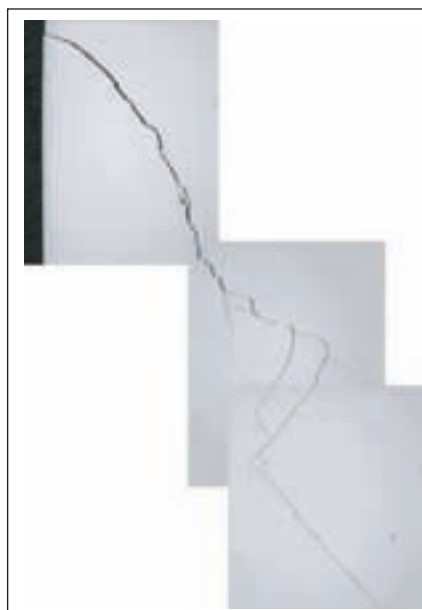
A photographic montage through the crack on tooth 6 (see Figure 3) is presented in Figure 5. The crack was approximately 0.103" long and 0.061" in depth. Several smaller cracks were observed branching from the main crack. The crack intersected the surface at approximately 0.23" from the tooth tip.

Figure 5 shows the crack trajectory to be inward from the tooth surface. Analysis will be presented in the later portion of this paper to bound the crack propagation path.

Figure 5—Photo montage of crack from tooth surface.

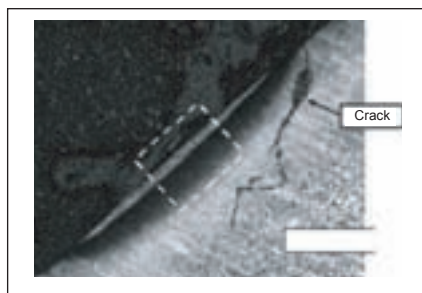
The cross section was etched as shown in Figure 6 and grinding abuse was observed on both sides of the tooth. Detailed views of the grinding abuse are shown in Figures 7 and 8. The grinding abuse produced a rehardened layer on the surface measuring up to 0.007" deep. The crack followed the heat-affected zone, as illustrated in the upper image in Figure 7.

Figure 7—Detailed views of the grinding abuse and crack on the driven side. Etchant 5% Nital.

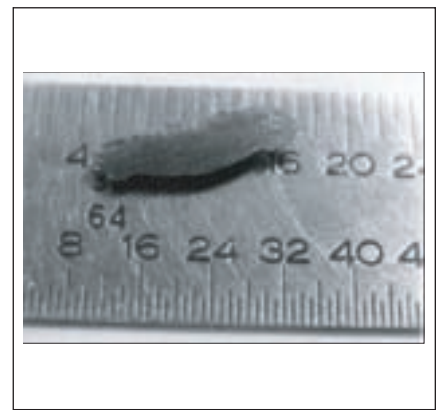
The gearbox has a chip detector in the scavenge oil passage. The technicians removed the chip detector and found a large sliver of material clinging

to the end. The size of the sliver is shown in Figure 2.

Typically, wearing or pitting components will generate very fine particles that, when mixed with oil, create a paste. The paste is what most technicians expect to find when investigating a chip light indication. The size of the debris found on the plug was cause for removal of the gearbox.

Figure 2—Debris found on chip detector.

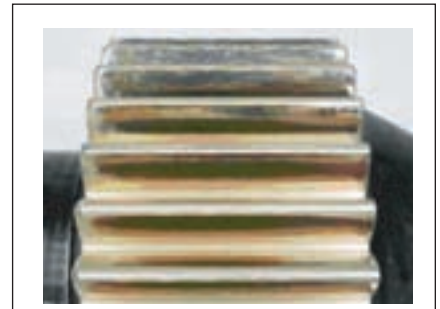
A detailed inspection was performed on all other parts of the gearbox. No other components showed any signs of degradation or indications of high load experience. The mating pinion gear showed no signs of surface distress or maldistributed load as shown in Figure 4.

Figure 4—Mating pinion showing no surface distress or evidence of maldistributed load.

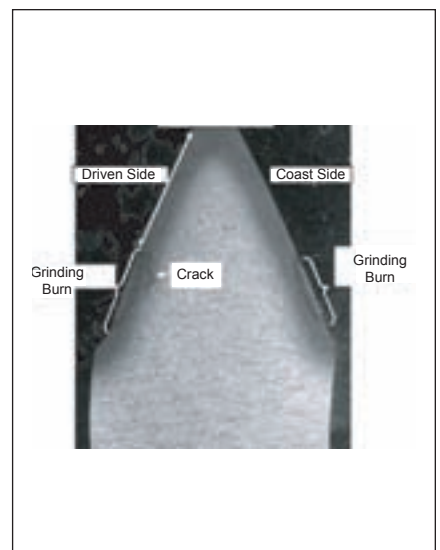
Figure 6—Etch cross section showing tempered and rehardened (burned) zone in dedendum area of the driven and coast side of the gear tooth.

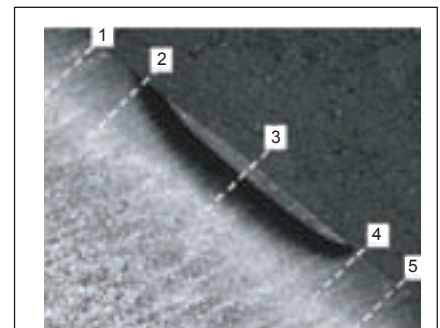
Similar grinding abuse was observed on the coast side of the tooth, as shown in Figure 8. The dotted lines in Figure 8 show the approximate location of the five hardness surveys.

Figure 8—Coast side showing rehardened and tempered zone and locations of hardness traverses.

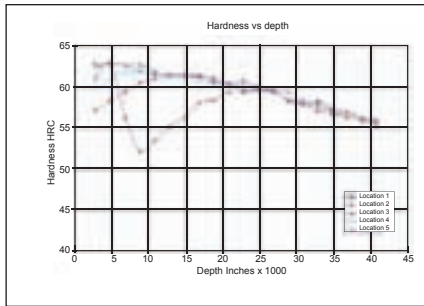
Figure 9—Hardness vs. depth at locations with and outside of the rehardened zone.

tempered areas (dark colored zone), as shown in Figure 9.

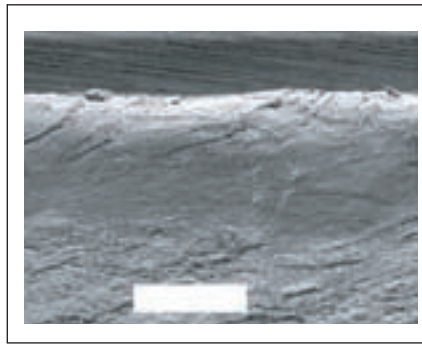
Figure 10—SEM photo showing fatigue direction from mid face towards end face.

The No. 6 gear tooth section was laboratory-fractured to expose the crack surface. The crack could not be completely opened due to its shallow depth and orientation. A SEM (scanning electron microscope) photograph of the fracture is shown in Figure 10. The crack morphology was indicative of fatigue progression from mid face towards end face, as illustrated in Figure 10. The arrows indicate the direction of local fatigue crack progression.

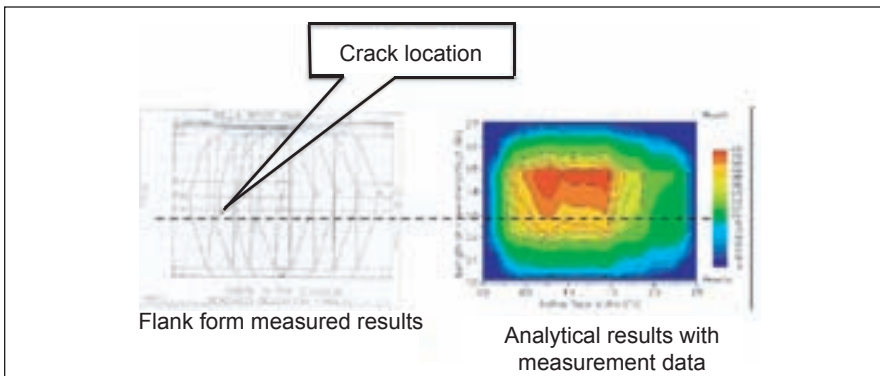
Figure 11—Approximate crack location vs. contact stress distribution.

The flank form inspection of the incident gear located the approximate radial position of the crack. The profile traces were made at the mid face of each tooth. The profile chart shown in Figure 11 shows four adjacent teeth, three of which contain the cracked teeth. The approximate location of the crack is shown as a rapid change (bump) in the lower 25% of the profile chart.

The contact stress distribution of the gear relative to the approximate crack location is shown in Figure 11. The crack location is near the start of single-tooth contact of the gear but not in the area of highest contact stress. However, the crack seems to follow the contour of the surface stress in the axial direction.

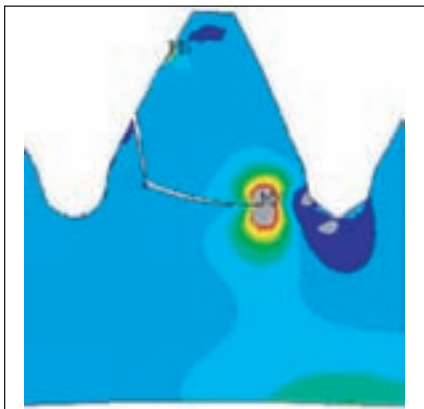
Figure 13—Crack trajectory solution starting from initial crack using maximum continuous torque and speed - first principal stress contours shown.

The crack as measured in Figure 5 was added to the model. Linear elastic fracture mechanics (LEFM) was then used to predict the crack trajectory from this initial point. The solution is shown in Figure 13. The crack tip was modeled as a quarter-point rosette, as shown in Figure 14. The solution shown represents maximum continuous speed and maximum continuous torque applied at the highest point of single tooth contact.

The depth of the initial crack depth is slightly below the case-core transition point. The model assumed no residual stress in this area of the gear.

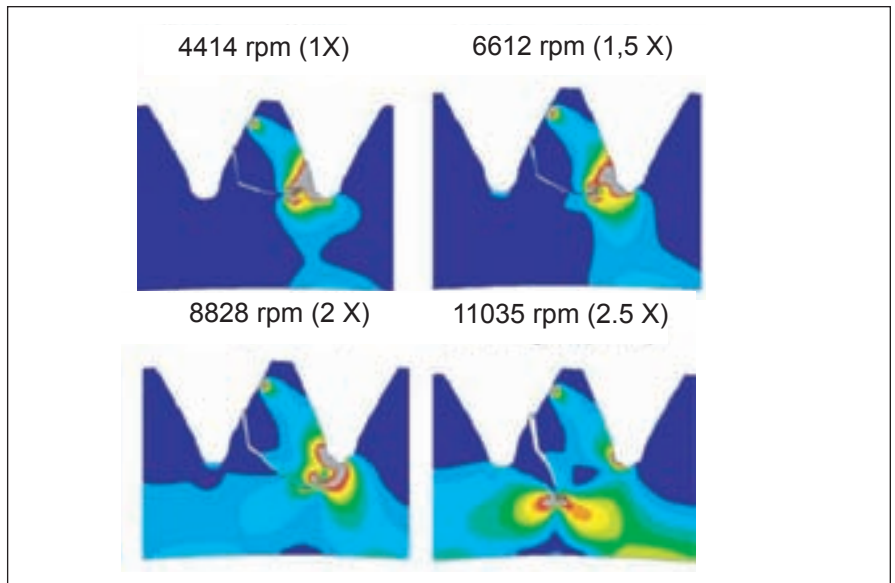
The model was then used to predict the effects of speed on crack trajectory. Reference 2 highlights the effects of rotational speed on crack trajectory. At maximum continuous speed, the crack trajectory was across the tooth. The trajectory changed toward the blank center as speed increased, given the same applied torque (Figure 15).

Figure 15—Crack trajectory vs. rotational speed.
