# Repair of Large, Surface-Degraded Industrial Gears — a New Approach

Horacio Albertini, Carlo Gorla and Francesco Rosa

This paper presents a new approach to repair industrial gears by showing a case study where pressure angle modification is also considered, differently from the past repairing procedures that dealt only with the modification of the profile shift coefficient.

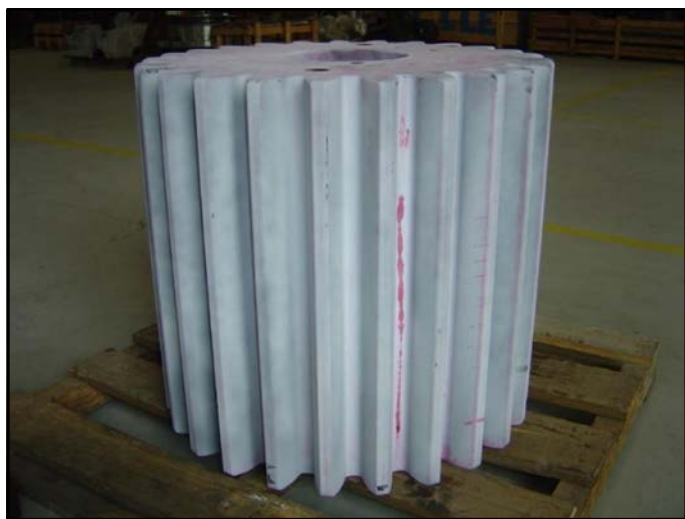
The proposed approach applies only to gears affected by mild damages. For example, gears that present cracking, fracture, bending fatigue, and severe plastic deformation cannot usually be repaired because of their heavily impaired geometry and mechanical properties. Gears affected by these types of failures can be easily identified and discarded by a simple visual inspection or other quick inspection methods, like a dye penetrant test (Fig. 1).

Figure 1 Crack revealed by dye penetrant test.

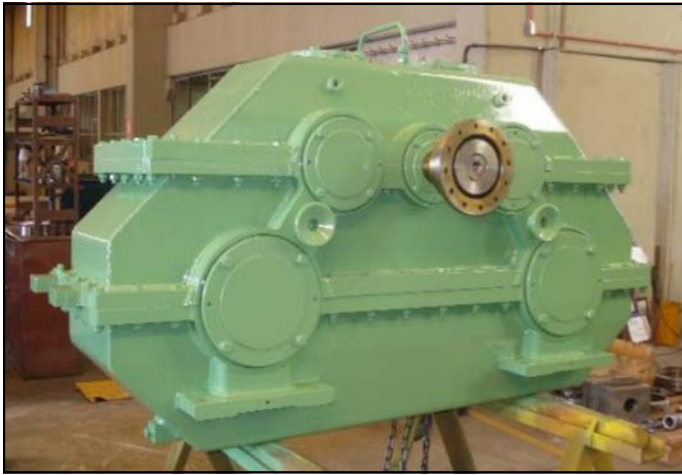
Figure 5 Refurbished gearbox.

Figure 5 shows the case study gearbox. The user is a steelmaker, and this gearbox drives the wheel that moves the crane of either a 300/50 tons × 22 m hot metal charging crane or a 300/50 tons × 23.5 m teeming crane. This unit was first built in 1979, and some repairs have been carried out so far. The reason why the gearbox was removed from the crane is not known.

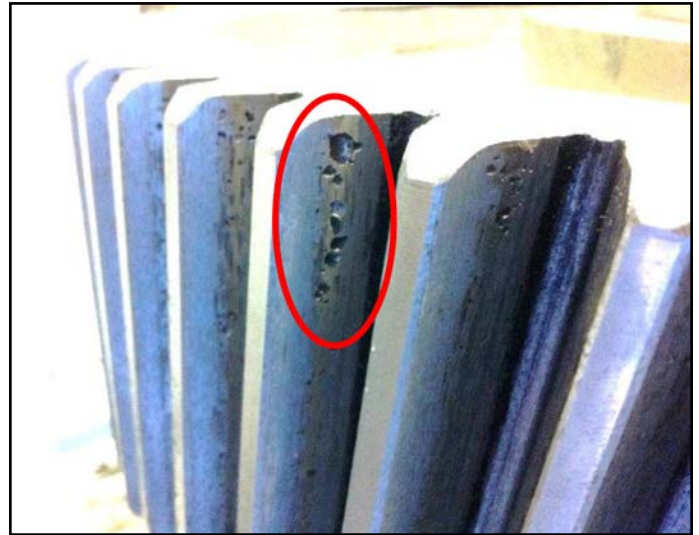
It is worth noting that the safety against pitting is below the safety factor, which is supposed to be  $S_{Hmin} \geq 1.0$ . The pinion and the gear have safety factors equal to 0.77 and 0.80, respectively. This is evidence that the teeth may have their flanks damaged by pitting. Indeed, the inspection confirms the presence of pitting (Fig. 7).

Figure 7 Pitting detail.

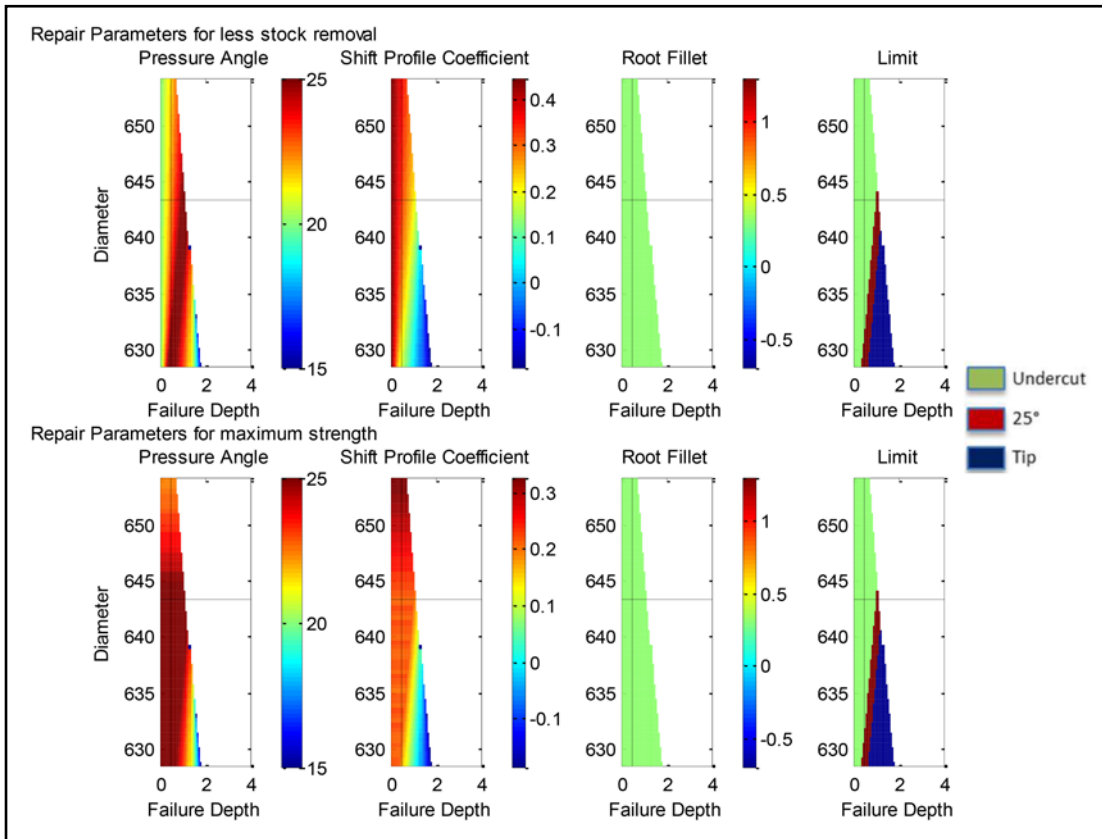
The script developed is used, and the first information of the repair procedure is obtained. As Figure 8 shows, the repaired damage can be about 1.00 mm deep on the tooth tip and can linearly increase up to a depth of about 2.00 mm at the tooth root. The pressure angle can be increased up to 25° depending on the location and the depth of the damage. Deep damages located in an area near to the tooth root can be repaired using pressure angles from 15° to 20° (in blue). The modification of the profile shift coefficient is a consequence of the pressure angle calculated, and it can be seen that it varies from the original  $x_2 = 0.4464$  to about  $x_2 = -0.2$ . The root radius fillet coefficient can be kept 0.3 mm as the original profile. The gear tip diameter can be reduced to a diameter below  $d_{a2} < 645$  mm (the black horizontal line) if the minimum profile shift coefficient is used. In the second row, the graph shows the values for maximum strength, which means that the modified profile is the borderline from the colored area (maximum possible depth).

Figure 8 Modification of damaged gear.

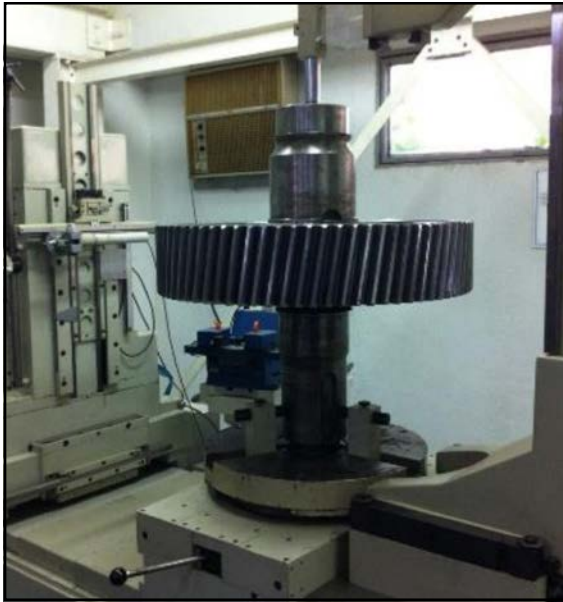
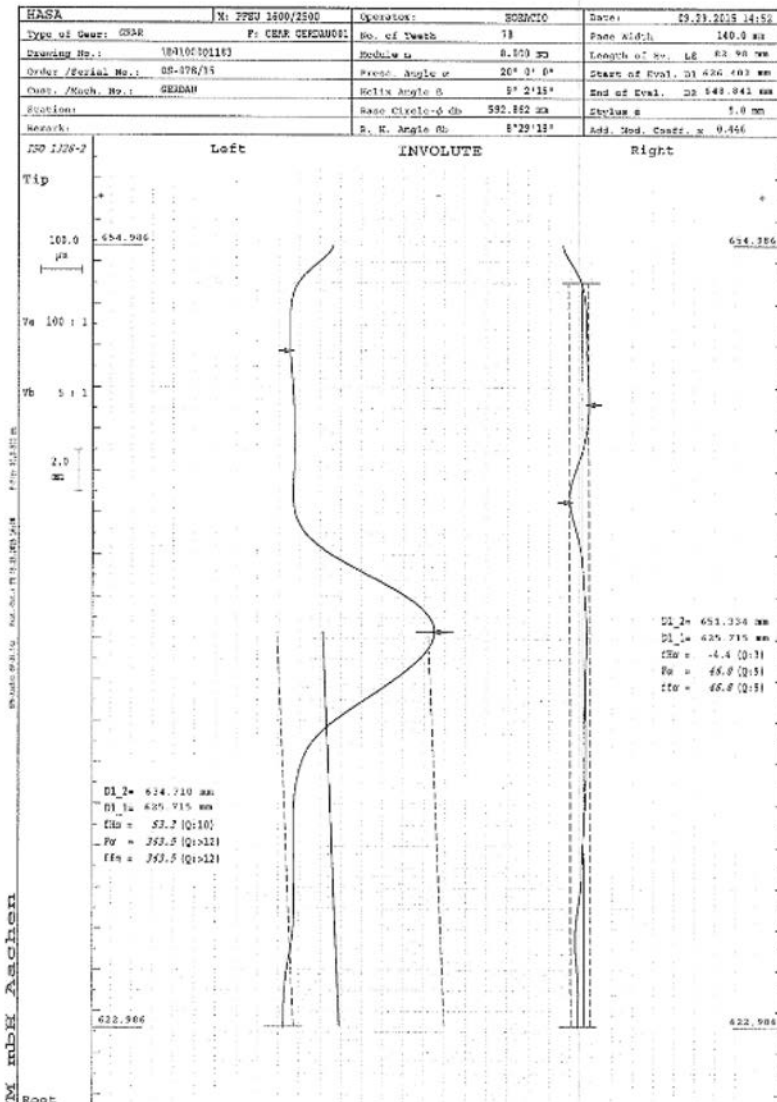
The gear profile has also been inspected (Fig. 9a) (Ref. 22). The tooth of the gear profile surface that has the deepest pits is marked (Fig. 7); the profile chart is shown in Figure 9b. The depth and diameter location of the deepest pit are, respectively,  $F_a$  and  $D1\_2$  of the left profile.

As can be seen, the pit is about 0.4 mm deep (the value in the chart is in microns) and it is located at diameter 634.710 mm. Despite the damage on the left flank, the right involute profile is in tolerance (DIN quality 9). The light blue arrow in Figure 10 shows the diameter of the deepest pit.

Figure 9 Damaged gear placed in gear-testing machine; a)—result of inspection; b)—pitting is about 0.4mm deep and located in diameter of 634.710mm.

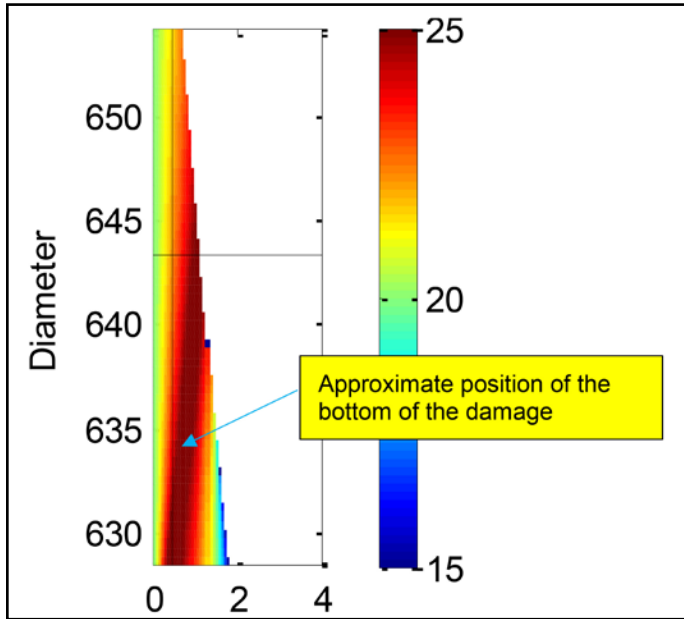
Figure 10 Position of bottom of damage inspected.

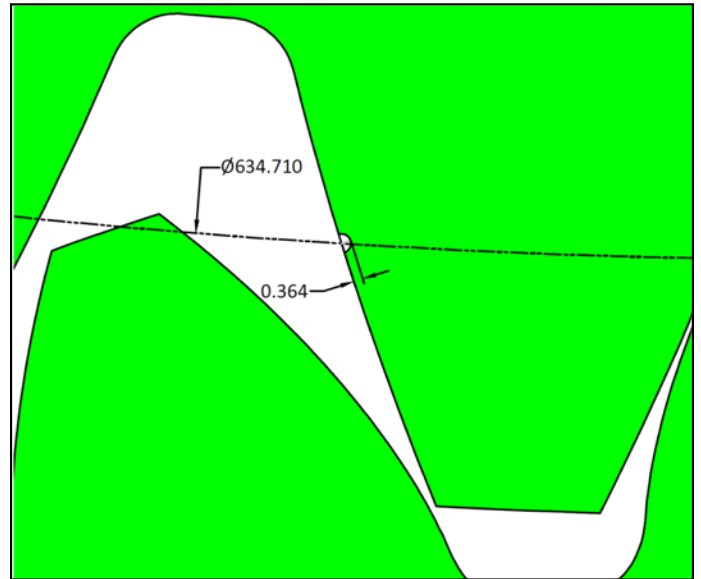
Figure 11 Detail of depth and position of pitting.

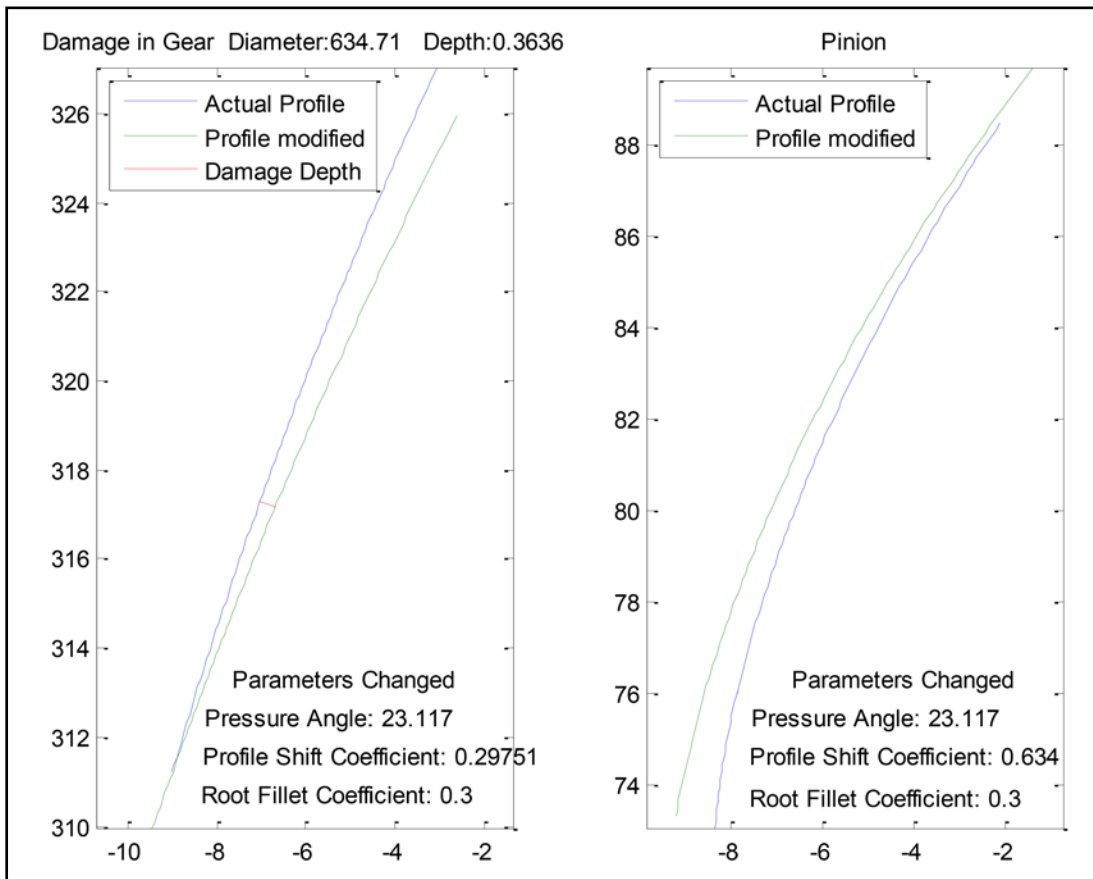
Figure 12 Modification chart.

The hypothesis for repair is to change the pressure angle to the maximum and the profile shift coefficient to the minimum in order to remove the damage and minimize the stock removal, avoiding tip pointing and undercut of the active profile of the repaired gear.

gives the nominal values of the parameters necessary to remove the damage considering the premises above. Normal pressure angle  $\alpha_n$ , the profile shift coefficient  $x_2$  and  $x_1$ , and the root fillet coefficient  $\rho$  are shown (Fig. 12).

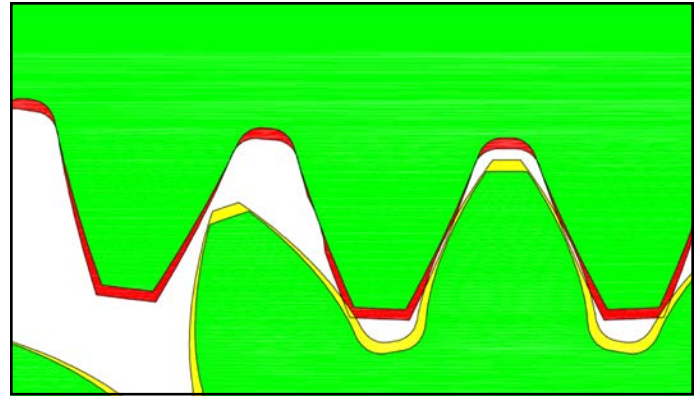
Figure 13 Comparative chart of actual and modified pair — red area is stock removal and yellow area is amount increased.
