# Space Station's Solar Power Compromised by Balky SARJ Unit

## UNDUE VIBRATIONS, POWER SPIKES AND GRIT GIVE NASA PAUSE

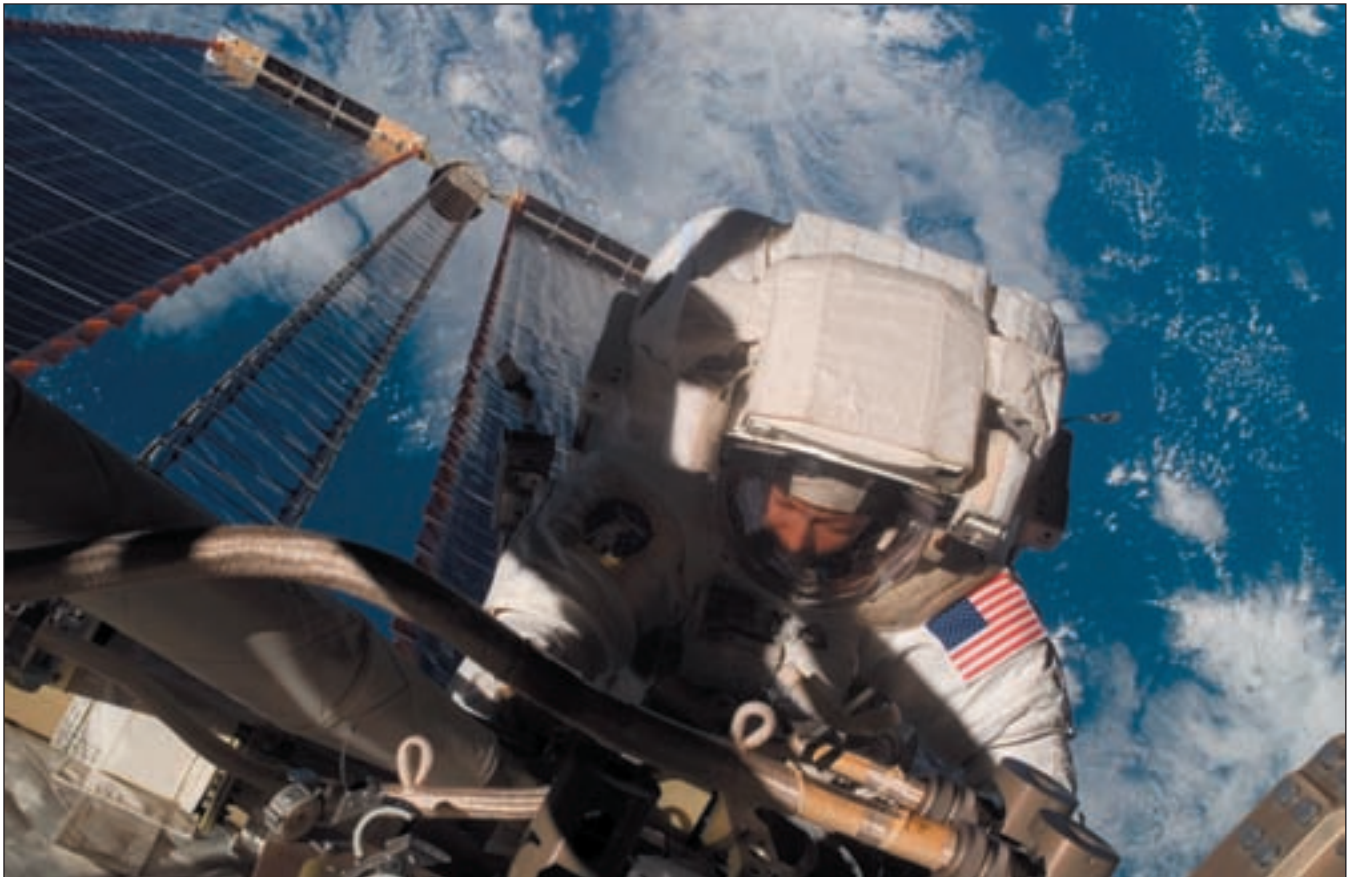
Shuttle Discovery flight engineer Daniel Tani during a more than 6-hour spacewalk dedicated in part to an inspection of the International Space Station's malfunctioning Solar Alpha Rotary Joint (SARJ). Tani returned to the station with metal "shavings," samples of an as yet unknown origin gleaned from beneath the joint's multi-layered insulation covers.

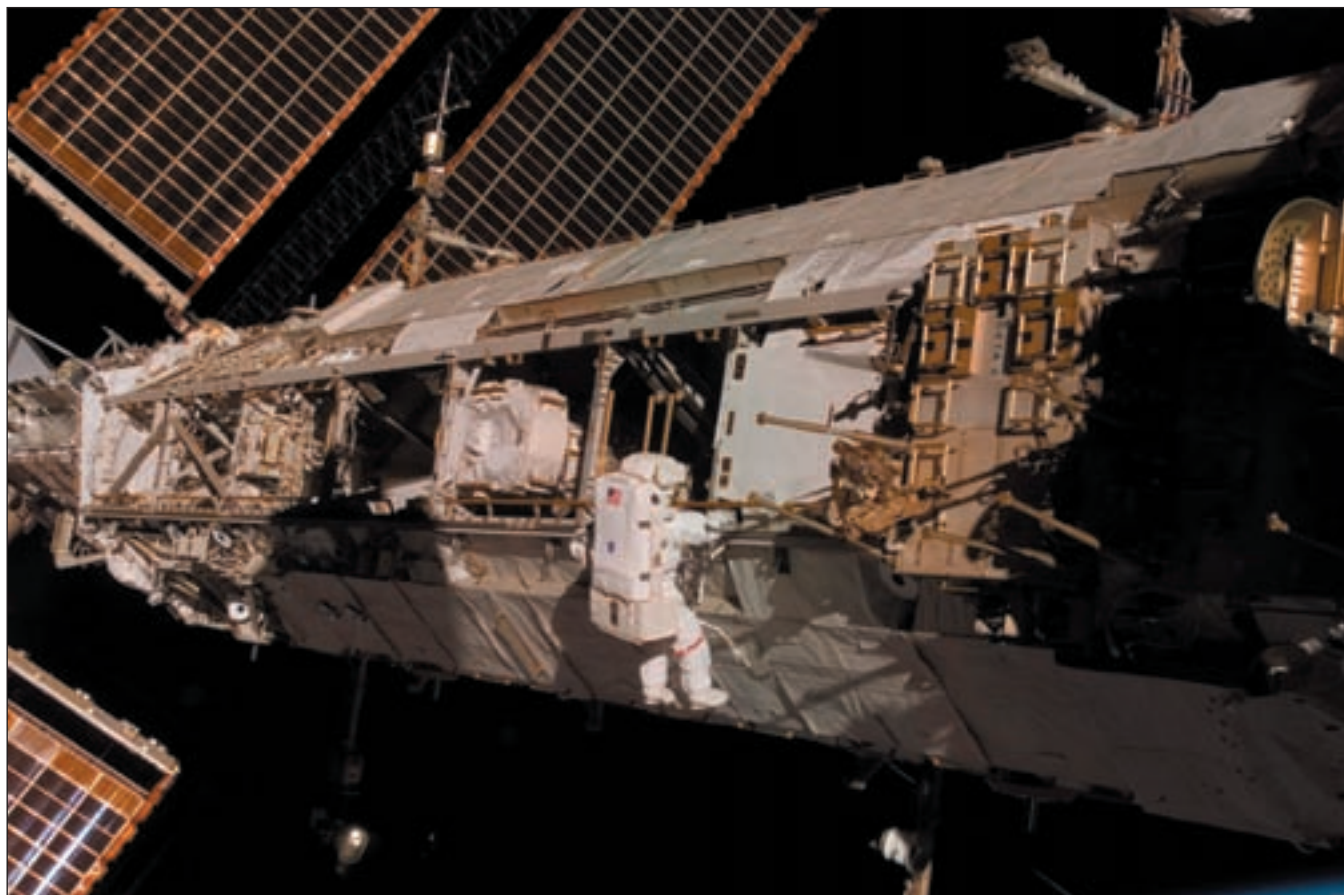
Expedition 16 shuttle Discovery commander Peggy A. Whitson (above) was also involved in the spacewalk investigation of the ISS solar array's (top and next page) faulty SARJ unit. She is seen here examining the damaged starboard component.
