The Anatomy of a Micropitting-Induced Tooth Fracture Failure—Its Causation, Initiation, Progression and Prevention

Raymond J. Drago, Roy J. Cunningham and Steve Cymbala

Management Summary

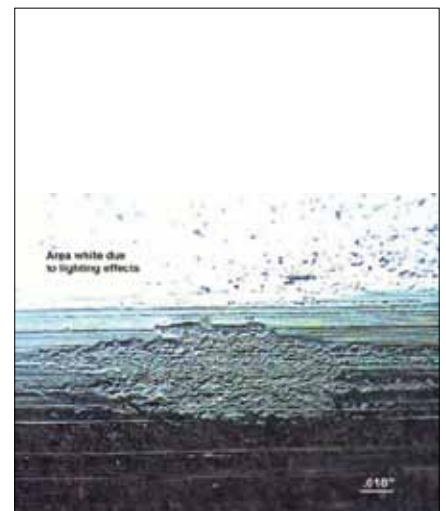
Figure 1—Typical micropitted region.

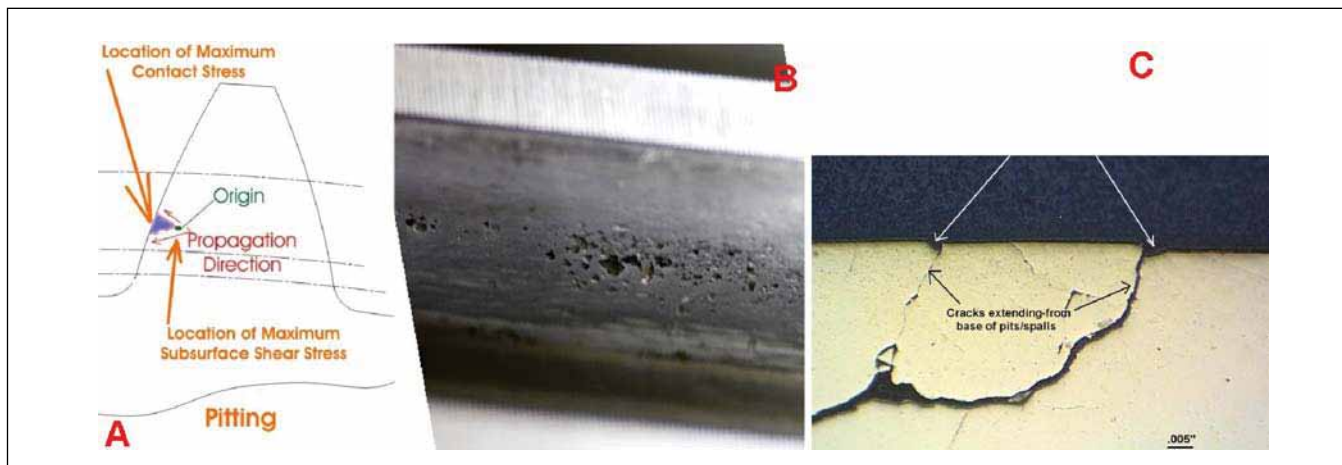
bility of gears has been defined by macroscopic pitting, or macropitting, in which a crack initiates at a subsurface location where the shear stress exceeds the shear allowable (Fig. 2A). When such a crack propagates to the tooth surface, a small piece or, more often, several small pieces of material (Fig. 2C) are liberated, leaving an inverted, cove-shaped defect (Fig. 2B).

Figure 2—Classic macropitting fatigue.

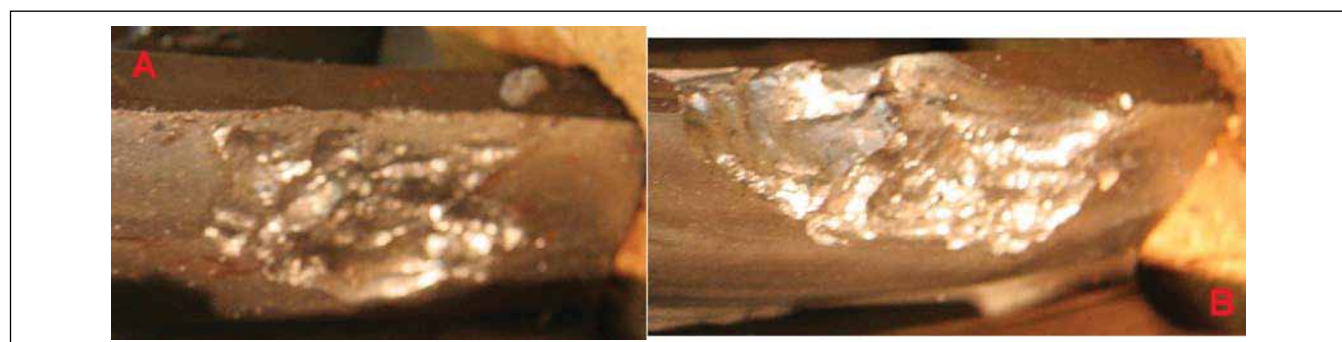
As this process is repeated, more and more pits appear and eventually the tooth surface is heavily damaged (Fig. 3). Eventually, and if the loads are high enough, the pitting-damaged region of the tooth acts as a significant stress concentration, and bending fatigue failure of the tooth may occur through the pitted region (Fig. 3B).

Figure 3—Heavy pitting often leads to local tooth fracture.

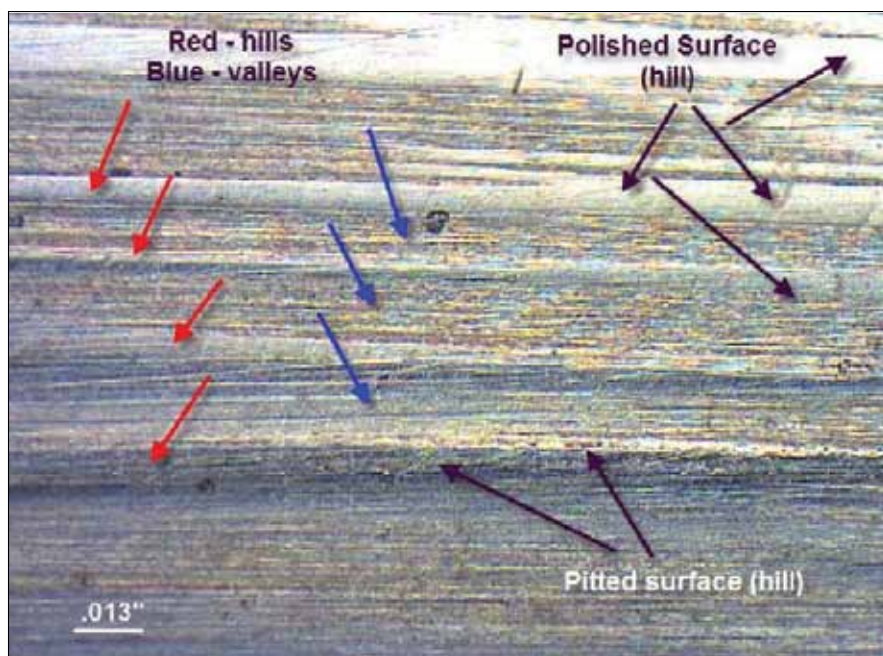
The cause of micropitting remains elusive. Initially, it was thought that the cleanliness of the steel might be playing a significant role, but micropitting exists even where very clean steels are used. It appears at local surface irregularities, including tooling witness lines (Fig. 4) and general-surface roughness peaks. It has been demonstrated that micropitting capacity can be improved through the use of improved finishing techniques, especially “super finishing” processes that reduce the surface finish down well below 10 RMS. The use of

Figure 4—Micropitting aligned with finishing tool witness lines.

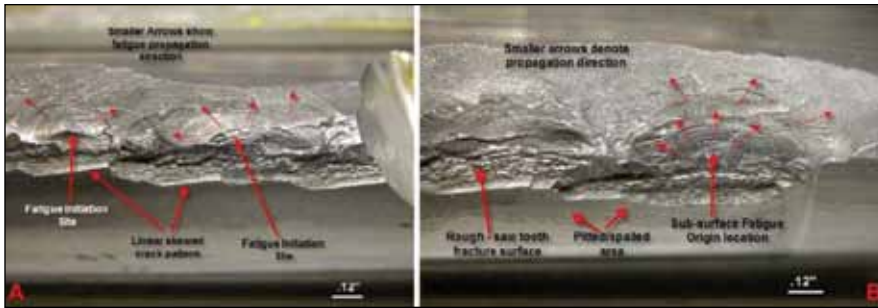
Figure 7—Helical gear tooth after partial tooth fractures.

tooth fractures shown in Figure 7.

Certainly, the very minor damage shown in Figure 6 would not, at first review, seem serious enough to cause the very extensive, service-ending damage shown in Figure 7. After reviewing a number of gears from similar systems at various stages of progression, the authors were able to develop a history that clearly shows minor, initial damage leading to a catastrophic result.

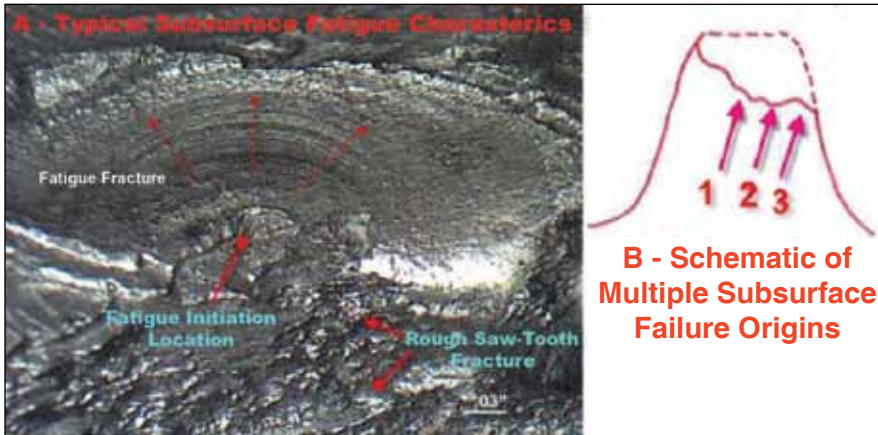
Figure 8—Magnified view of subsurface fatigue characteristics.

Figure 8 shows two views of the same general region of micropitting on a helical gear tooth. The regions shown are magnified views of one of the micropitted regions denoted by the red arrows in Figure 6. This gear, which initially appeared quite similar to the one shown in Figure 6, eventually experienced many service-ending tooth fracture failures such as those shown in Figure 7. In order to examine the mechanism by which the seemingly mild micropitting distress progressed to a complete tooth fracture, we will examine this failure in detail. (*Authors' note: The figures used to illustrate this discussion were taken from several related, individual failure investigations conducted by the authors; thus, each figure does not necessarily show the same gear. Each figure was selected from the large number of images accumulated during the course of these investigations so as to best illustrate the point under discussion.*)

A visual examination of each tooth fracture surface displayed several zones of bending fatigue initiation and propagation. Fatigue was indicated by the many semi-circular beach marks, which are plainly visible. Bending fatigue initiated subsurface from the pitting/spalling and propagated up and over the tip from the drive side to the coast side of the tooth, resulting in removal of portions of the tooth tip. Fatigue characteristics are revealed in Figure 8—an enlarged view of the fatigue and rough surface topography shown in Figure 7.

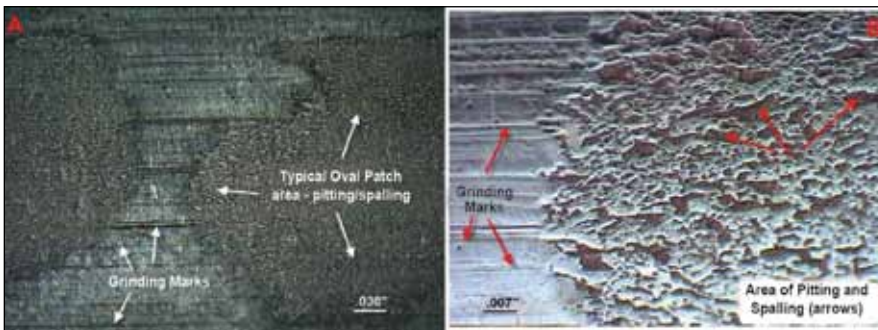
Figure 9—Typical micropitted tooth surface appearance.

lar-shaped spalls that are not readily apparent through visual examination (Fig. 9A), but are visible with some additional magnification (Fig. 9B).

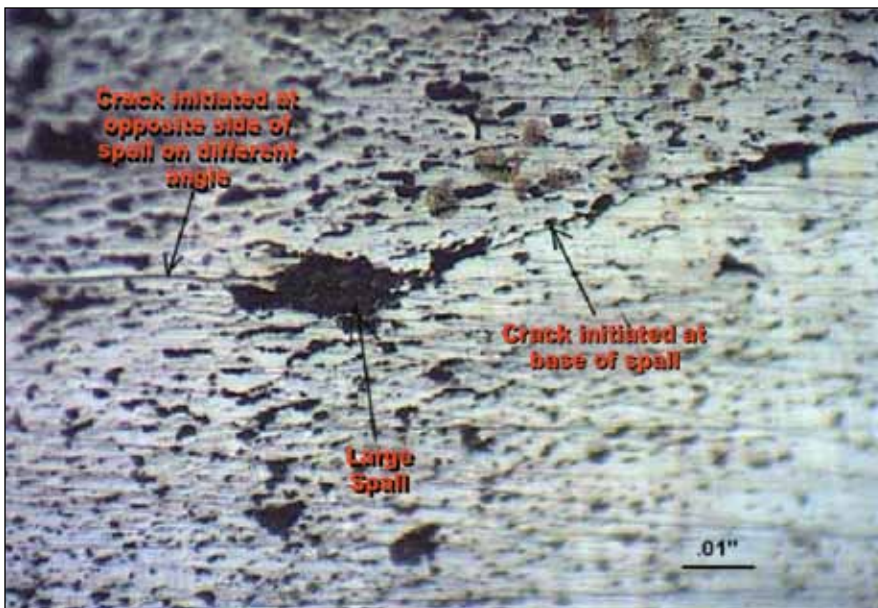
Figure 10—Cracks emanating from small spalls in micropitted region.

As the spalls continue to initiate and grow, they propagate by a crack mechanism shown in Figure 10. While these cracks are small, over time they progress and result in larger spalls occurring on the tooth surface. Continued propagation of these cracks into the body of the tooth (Fig. 11) led to the tooth fracture failures necessitating the gear's removal from service.

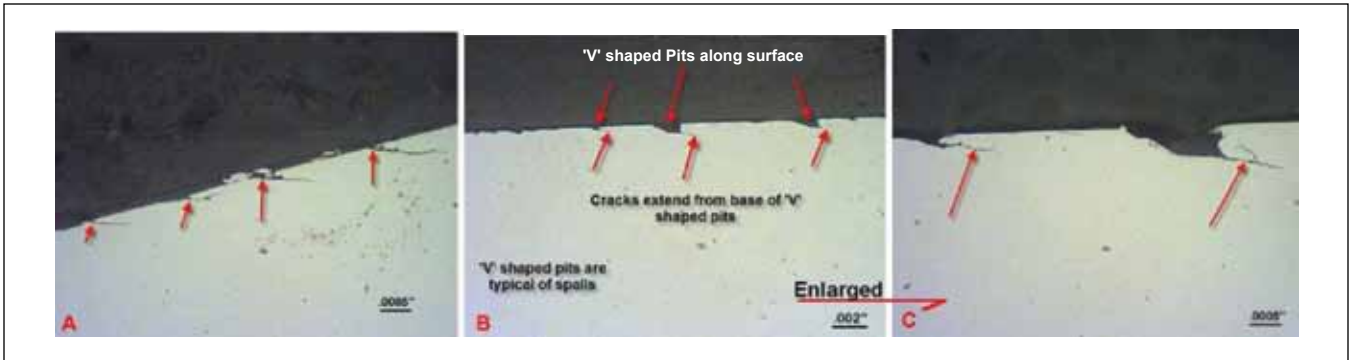
Figure 11—Small cracks propagating from spalls shown in Figure 9.

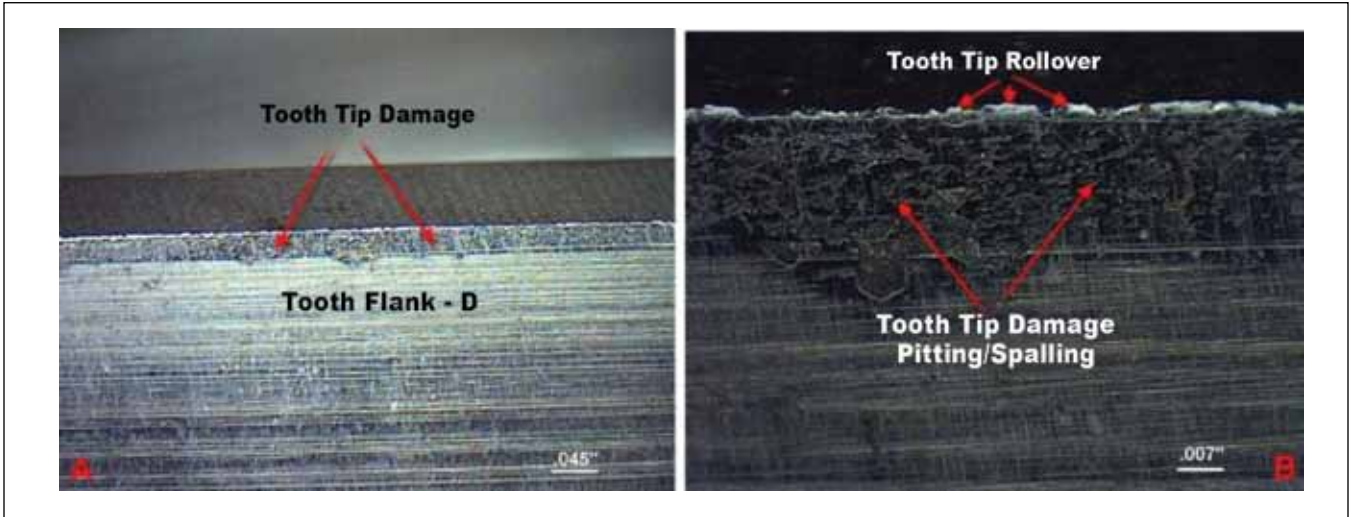
Figure 12—Micropitting at the tip of a gear tooth due to inadequate profile modification.

Micropitting also very often occurs when the amount of involute modification provided at the tips and flanks of a mating pair of gear teeth is inadequate to compensate for the deflections that occur under load. In this case, a very fine line of micropitting occurs on the tips of the teeth on one member and on the flanks of the mating member, very close to the lowest point of contact on the tooth. The appearance of this type of micropitting, shown on the tip of one tooth in Figure 12, is slightly

different from that typically observed on the tooth flanks in general, but the basic failure mechanism is quite similar.

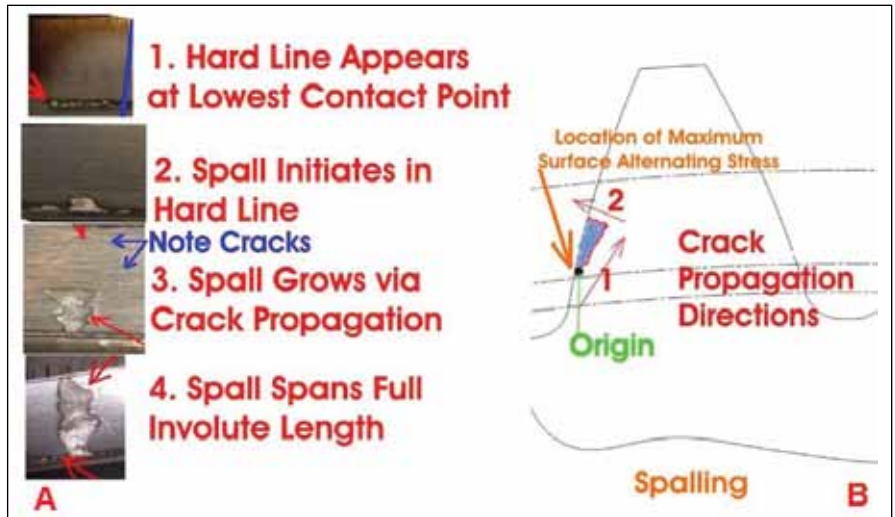
Figure 13—Initiation of a spall in a line of micropitting (the “hard line”).

the bending stresses are quite high—poses a particular danger of tooth fracture. The mechanism by which this occurs is shown in Figure 13.

The spalls progress from the hard line (Fig. 13A) via cracks that initiate at or near the surface in the micropitted region, then extending into the gear tooth body, until a piece breaks away

from the tooth surface. This crack mechanism is shown schematically (Fig. 13B) and in sequence (Fig. 13A.)

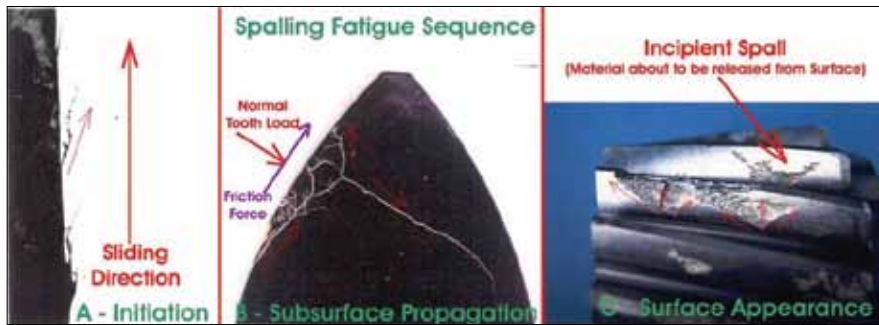
Figure 14—Micropitting-induced spall progression leading to a tooth bending fatigue fracture failure.

The real danger in this mechanism is the fact that it occurs in an area of high bending stress. It is thus very likely that one of the spall cracks will progress through the tooth body, causing a tooth bending fatigue failure (Fig. 14).

The initial spall cracks (Fig. 14A) are rather small, and initiate at or near the surface. As these cracks progress, they result in rather large spalls—becoming apparent on the gear tooth surface (Fig. 14C)—since the cracks are initiating at the surface and progressing into the body of the tooth in a relatively short time. One or more of the cracks will progress through the tooth body (Fig. 14B).

The large spalls shown in Figure 14C all initiate very low on the tooth profile in a region well below the region of single tooth contact (in the transverse plane) where the tooth loads should be very close to zero. The high loading in this region at the tips of the teeth is due to inadequate tooth profile modification, thus rendering the load at engagement and disengagement to be very high. Because of the large spalls, such micropitting-induced failure modes are much more serious than those in which micropitting gradually destroys the tooth profile. This is due to the relatively quick progression of cracking into the tooth body and the larger partial—and often total—tooth fractures that ensue.

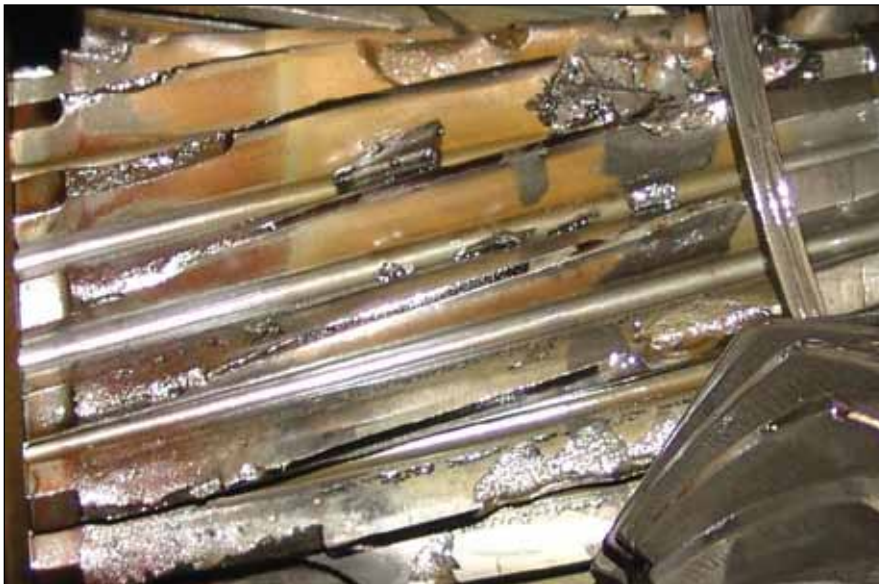
Figure 15—Partial tooth fractures resulting from spall crack progression.

When a crack progresses through the tooth body, partial tooth fractures (Fig. 15) will result. But unlike the fractures that occur due to extensive pitting damage, spall-induced fractures are likely to quickly occur after even a small amount of spalling has occurred.
