Repair of High-Value/ High-Demand Spiral Bevel Gears by Superfinishing

Eric C. Ames

Following is a report on the R&D findings regarding remediation of high-value, high-demand spiral bevel gears for the UH-60 helicopter tail rotor drivetrain. As spiral bevel gears for the UH-60 helicopter are in generally High-Demand due to the needs of new aircraft production and the overhaul and repair of aircraft returning from service, acquisition of new spiral bevel gears in support of R&D activities is very challenging. To compensate, an assessment was done of a then-emerging superfinishing method—i.e., the micromachining process (MPP)—as a potential repair technique for spiral bevel gears, as well as a way to enhance their performance and durability. The results are described in this paper.

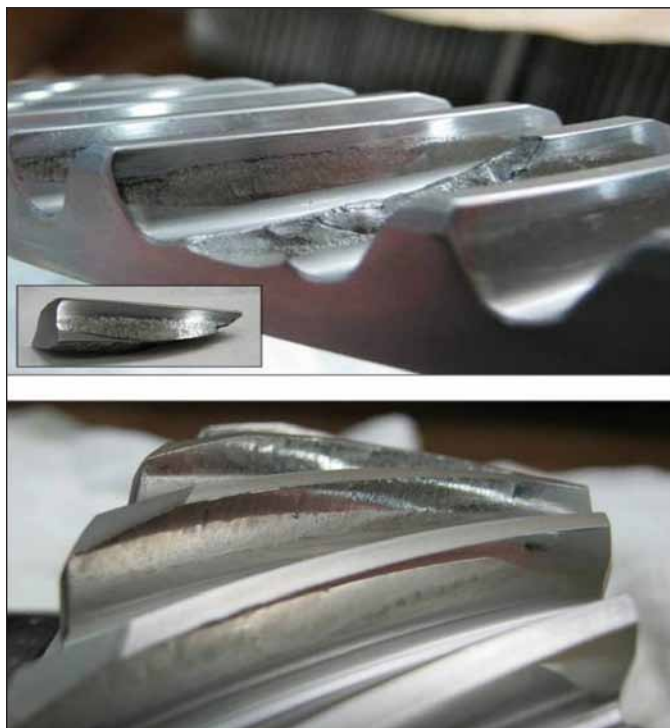
The first block of testing was conducted back in March 2010 and utilized a mixture of new-production gears and some with very low service usage. Testing revealed that the tail take-off bevel gear mesh had limited tolerance to sustained operation at these high-overload conditions. Near the end of the test, a tooth fracture of the tail take-off (TTO) bevel gear was observed. This fracture likely resulted from a line of micropits that formed on the root of the gear due to high contact pressures from the tip of the mating pinion. Figure 3 shows the post-test condition of both the TTO gear and its mating gear. Teeth of the TTO bevel gear were all heavily scuffed, and heavy wear, polishing and scuffing were observed on the TTO pinion teeth.

Figure 3 TTO bevel gear and pinion post: Block I overload testing.

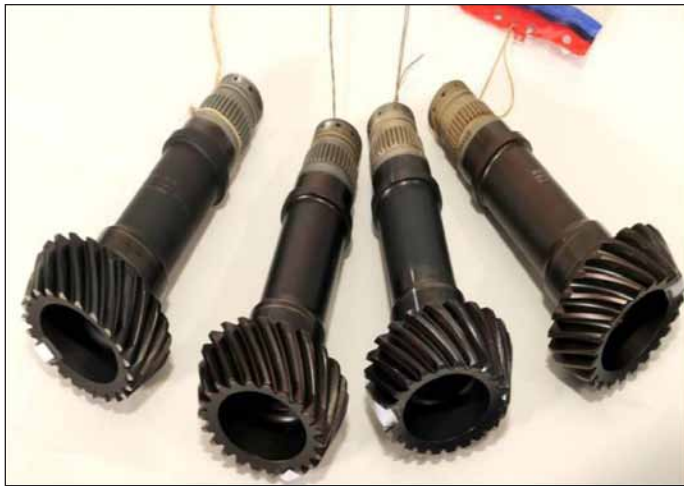
Figure 4 Candidate-TTO pinions as received from SAFR.

testing and ranking of the candidates in terms of suitability for repair and re-assembly into the test gearbox. OSS is an FAA-certified overhaul-and-repair facility specializing in dynamic components for Sikorsky Aircraft. Each of the pinions was subject to a magnetic particle inspection and found to be free of cracks. OSS ranked the damage of each of the pinions and recommended that two pinions (SN C518-00159 and SN A518-00011) were best suited for repair, with SN C518-00159 being the least damaged.

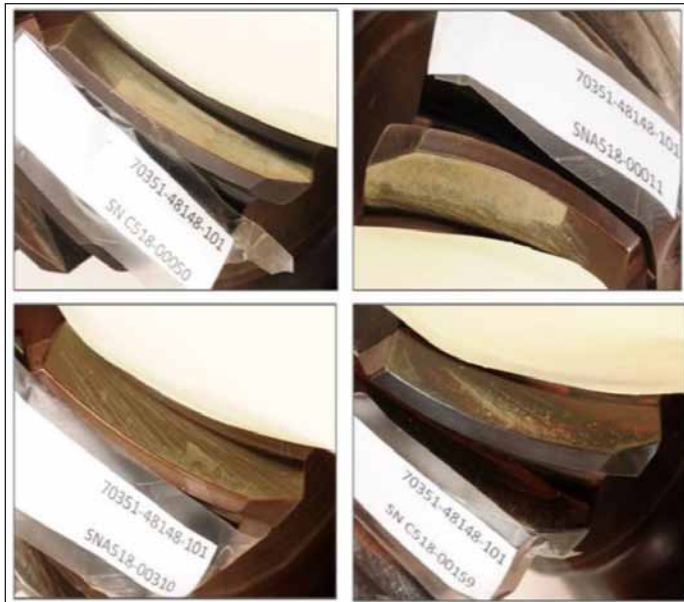
Figure 5 Driving tooth surfaces of candidate pinions.

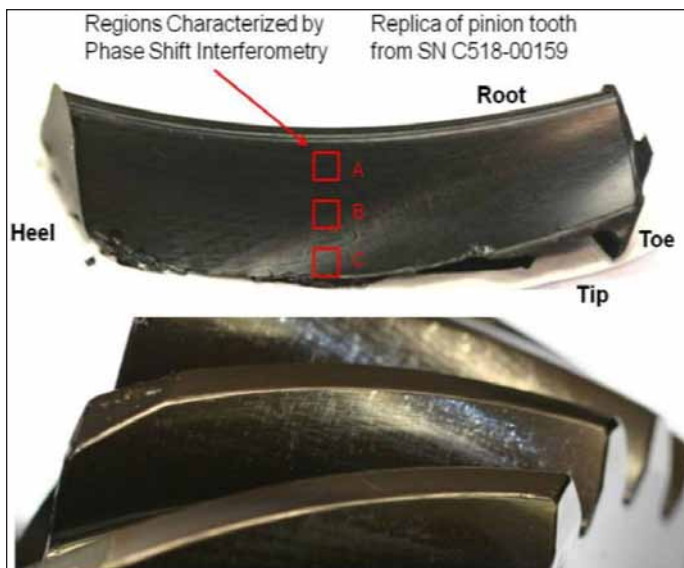
Figure 6 Silicone replica of TTO bevel pinion SN C518-00159.

The surface of the TTO pinion SN C518-00159 was generally characterized as having minor damage consisting of surface scratches and some scattered superficial scuffing near the tooth tip. The surface of the TTO pinion SN A519-00011 showed severe micropitting and scuffing originating from the mid-section of the tooth out to the tip. The depth of damage in this region was 100-200 micro-inches, with a maximum pit depth of 400 micro-inches.

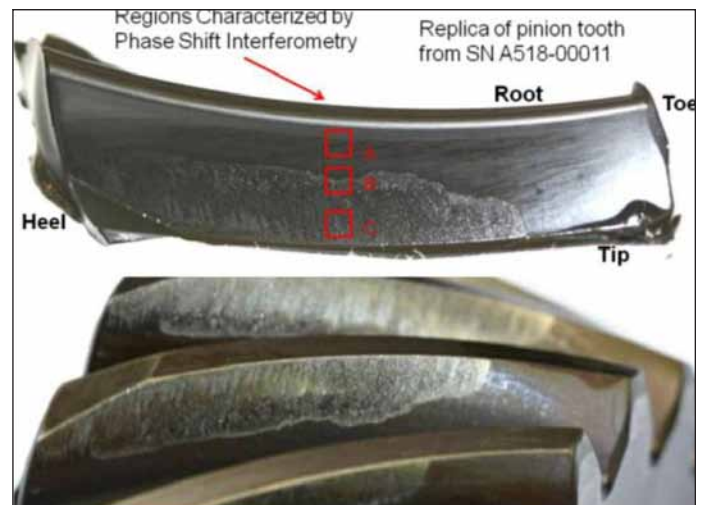
Figure 7 Silicone replica of TTO bevel pinion SN A518-00011.

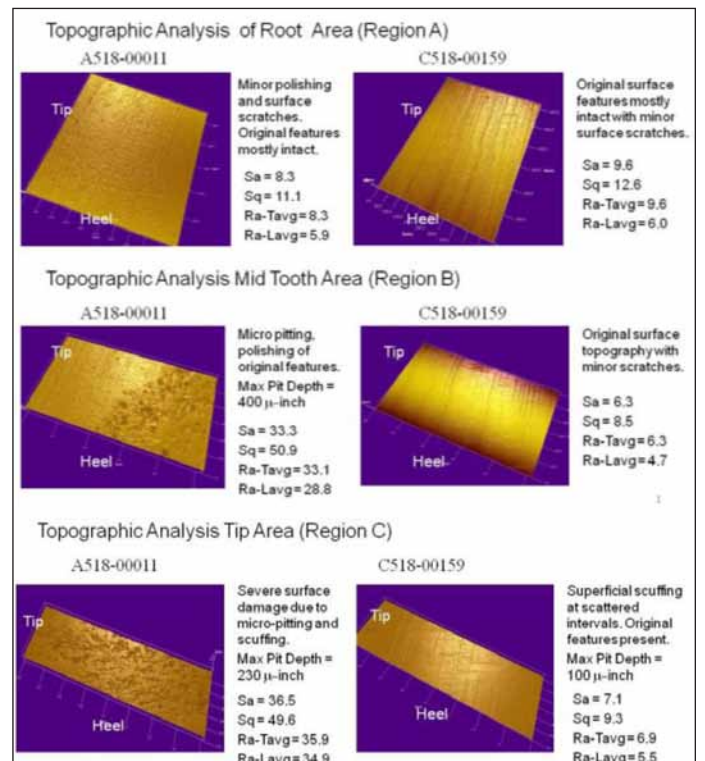
Figure 8 As-received surface finish and topography of candidate-TTO bevel pinions.

The approximate tooth height from root to tip is 0.31 inches. Three-dimensional analysis of the replicated surfaces was conducted at mid-span of the tooth facewidth, as shown in the figures. Specific regions near the root, center and tip were analyzed for mean surface roughness (Sa) and maximum pit depth (Fig. 8). To enhance the visual appearance of the surface features, a 20× magnification in the Z direction (depth) was applied.

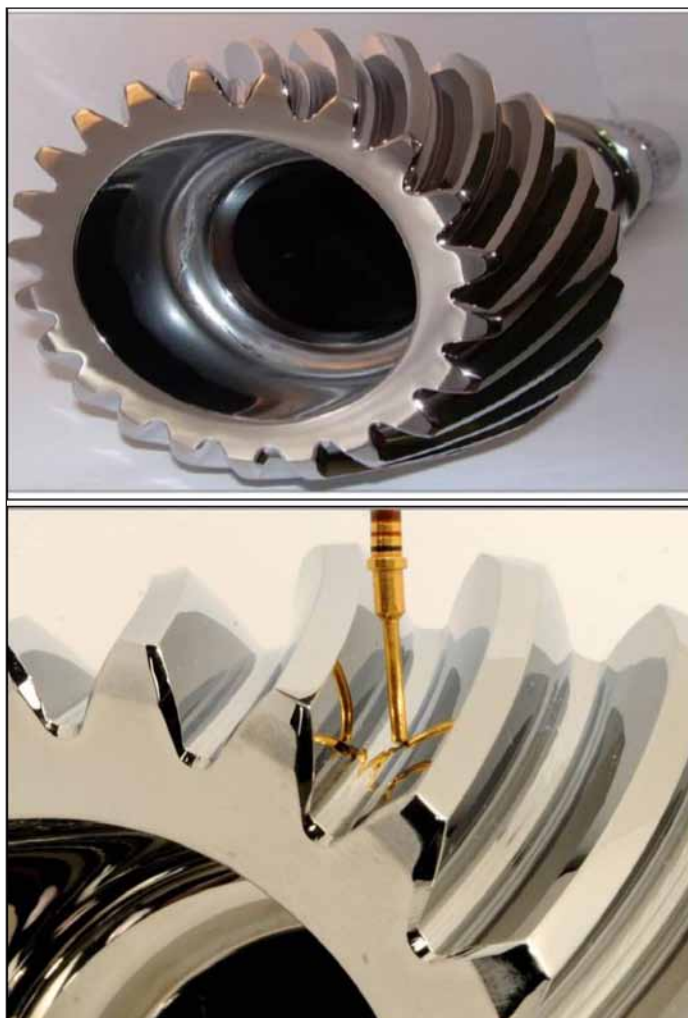
Figure 9 TTO bevel pinion post-MMP treatment.

Upon completion of the surface characterization, both pinions were delivered to MicroTek's facility to undergo MMP surface treatment. The MMP process produced a very highly polished surface with a high degree of reflectivity (Fig. 9). The effect appears to be uniform, as the root and fillet areas have the same appearance as the tooth faces and top lands. To the casual observer the part may appear to have been chrome-plated, post-MMP.

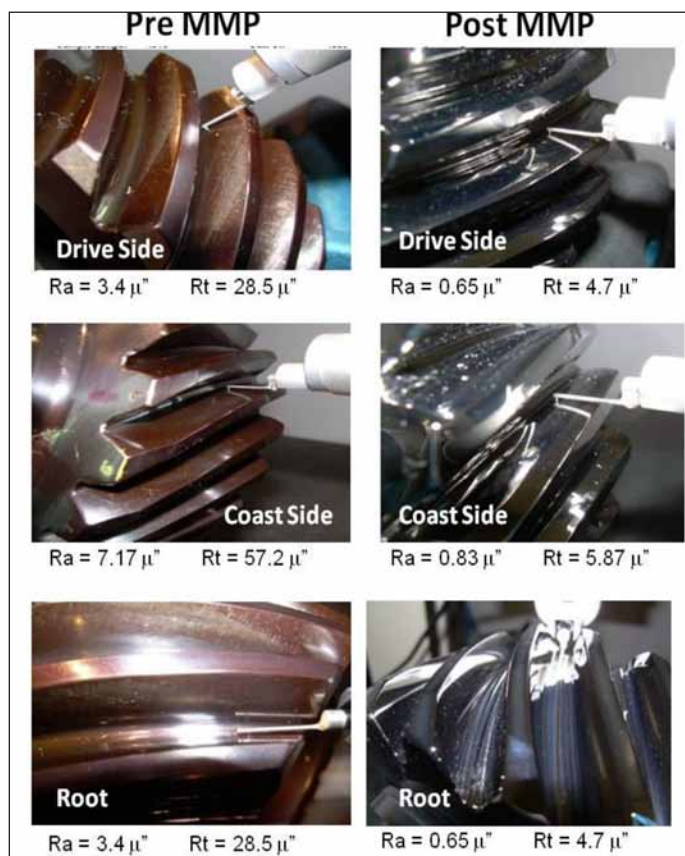
The pre- and post-MMP surface roughness of both candidate-TTO bevel pinions were measured by MicroTek using a stylus-based surface profilometer. Figure 10 shows the results for the TTO bevel pinion C518-00159; the values shown are an average of six individual measurements. It should also be noted that the drive- and coast-side measurements are in the transverse direc-

Figure 10 Pre- and post-MMP surface roughness of TTO bevel pinion C518-00159.

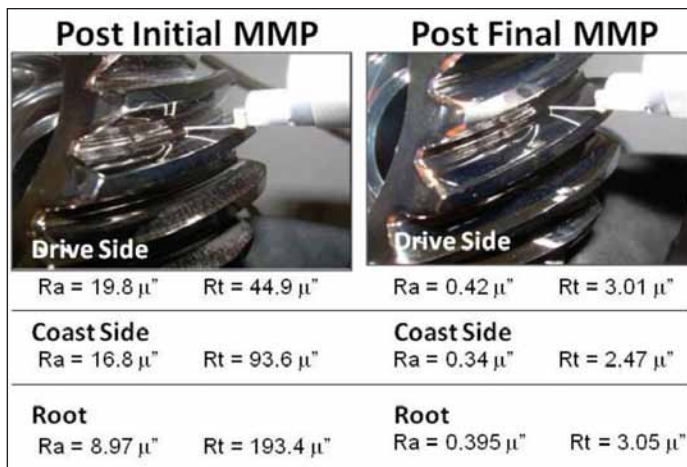
Figure 11 Pre- and post-MMP surface roughness of TTO bevel pinion A518-00011.

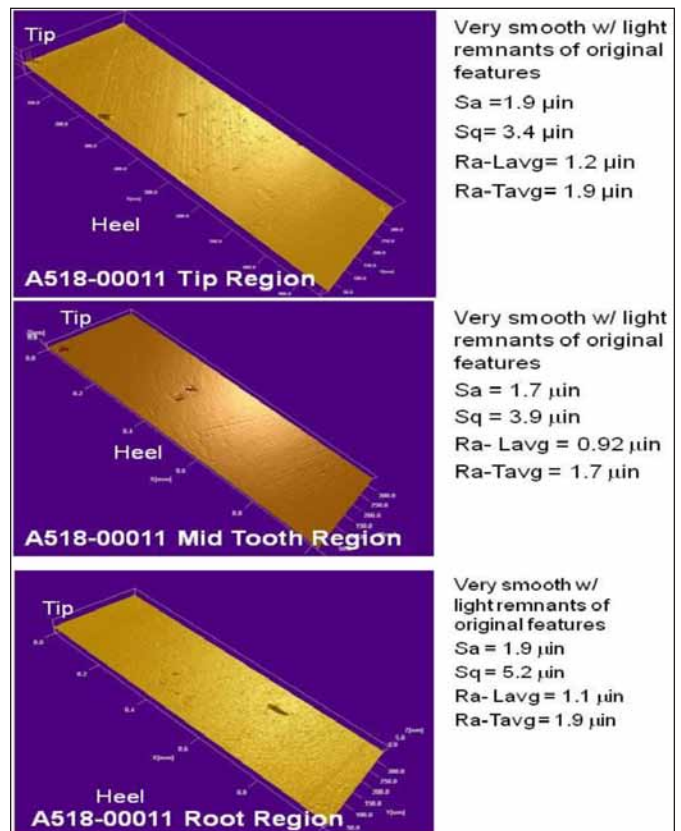
The surfaces of the gear teeth had a significantly improved finish and exhibited a nearly isotropic texture, with only faint remnants of the original wear and machining features. It should be noted that pinion A518-00011 had several randomly distributed pits in each of the three regions. The depth of these pits was approximately 10–20 micro inches (0.23–0.45 microns) and was probably a remnant from the original surface damage as received (Figs. 7 and 8). Additional MMP treatment may have been able to reduce further the number of these pits. This type of investigation was not possible during the effort, due to the small quantity of available assets and associated risk of removing too much material and driving the gear physical geometry past the allowable minimums for tooth thickness and deviation from the desired tooth topography.

Figure 15 Pinion A518-00011 post-MMP surface finish and topography characteristics.

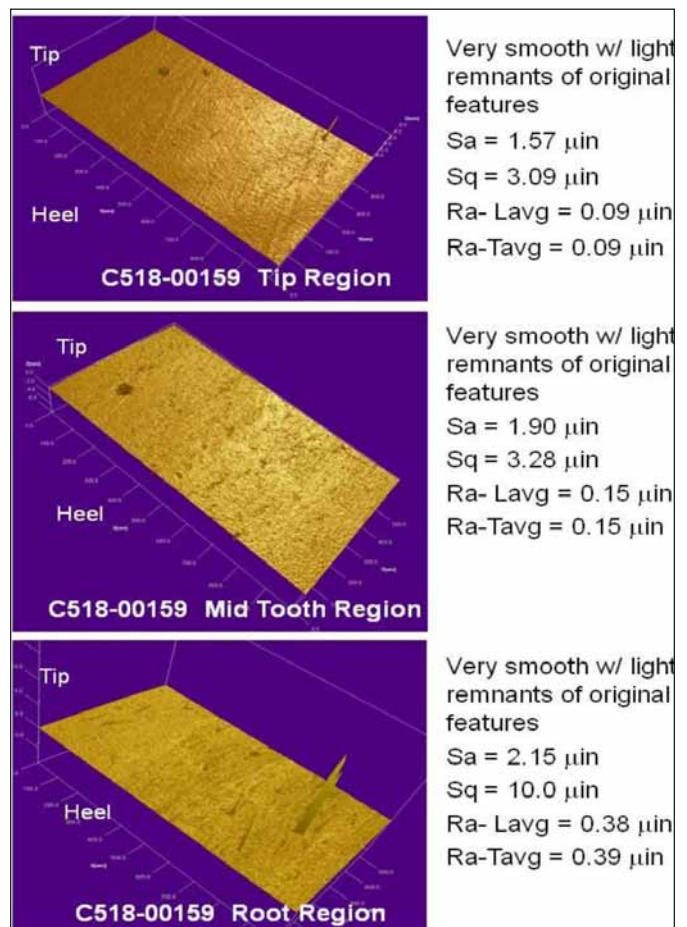
Figure 16 Pinion C518-00159 post-MMP surface finish and topography characteristics.

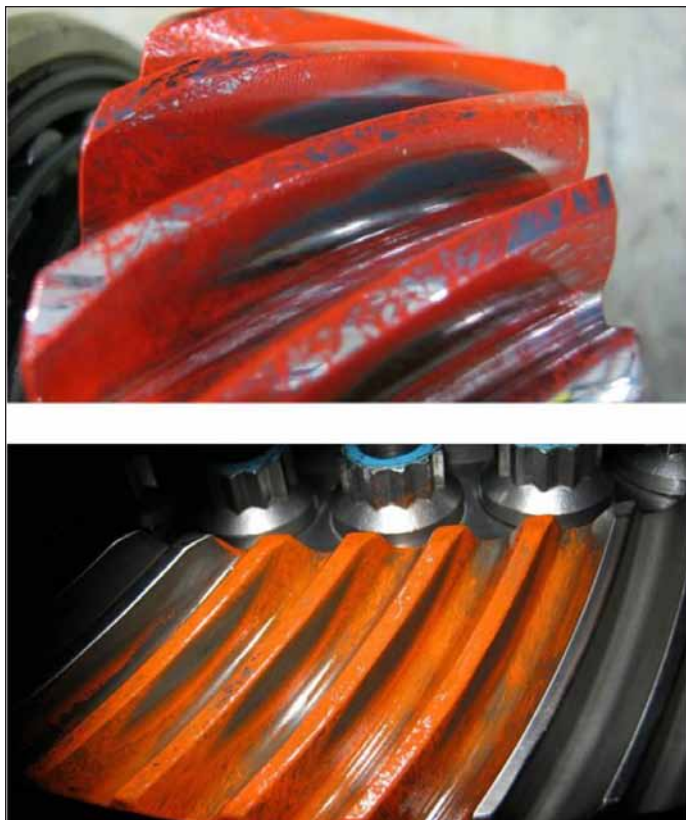
Figure 17 Contact pattern achieved during assembly with pinion C518-00159.

issue. An acceptable contact pattern was achieved and is shown (Fig. 17); the full gear mesh can be seen (Fig. 2).

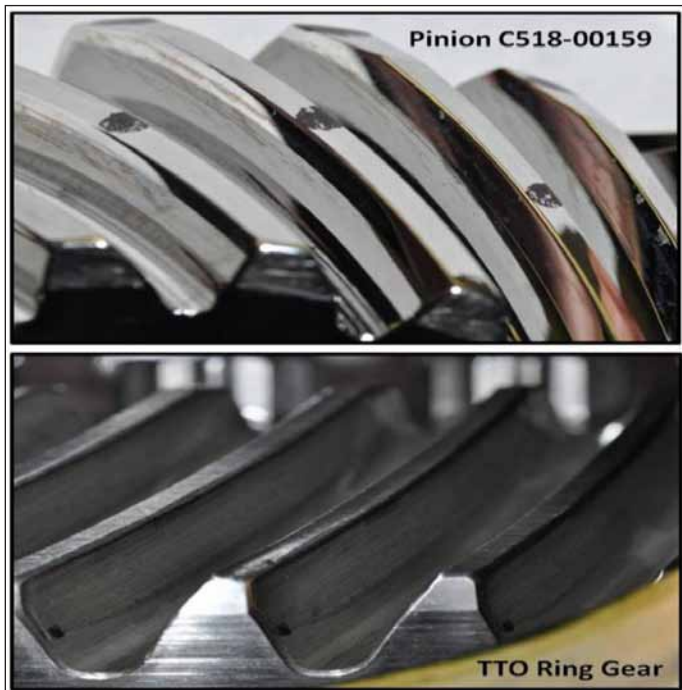
Figure 19 Post-test TTO pinion and bevel gear.

The tests were performed at the Naval Aviation Warfare Center-Aircraft Division (NAWC-AD), Helicopter Drive System (HeDS) test facility located in Patuxent River, Maryland. The HeDS consisted of a structural rig capable of physically supporting the MH-60K Main Gearbox MGB, the input modules, the IGB, and the TGB. Two T700-GE-701C (one engine operation was adequate for providing the necessary HP to the tail drive system) engines were used to drive the test gearboxes. The horsepower developed by the single engine was transmitted through the main input module and MGB. The IGB and TGB were driven as they are in the aircraft by the tail rotor take-off flange out of the MGB. The MGB was only lightly loaded for the test. The IGB and TGB were loaded through a single-disk waterbrake dynamometer manufactured by The Kahn Company. The test gearboxes as installed in the HeDS facility are shown in Figure 18. Testing was completed in September 2010. Approximately 32 hours of total operation was accomplished, with 16 hrs accumulated at 800 hp, 1 hr accumulated at powers exceeding 900 hp, and 47 minutes at powers slightly exceeding 1,050 hp. It is worth knowing that the TTO gear mesh is currently qualified for maximum continuous operation at 524 hp. Figure 19 shows the post-test condition of the TTO pinion and mating bevel gear.

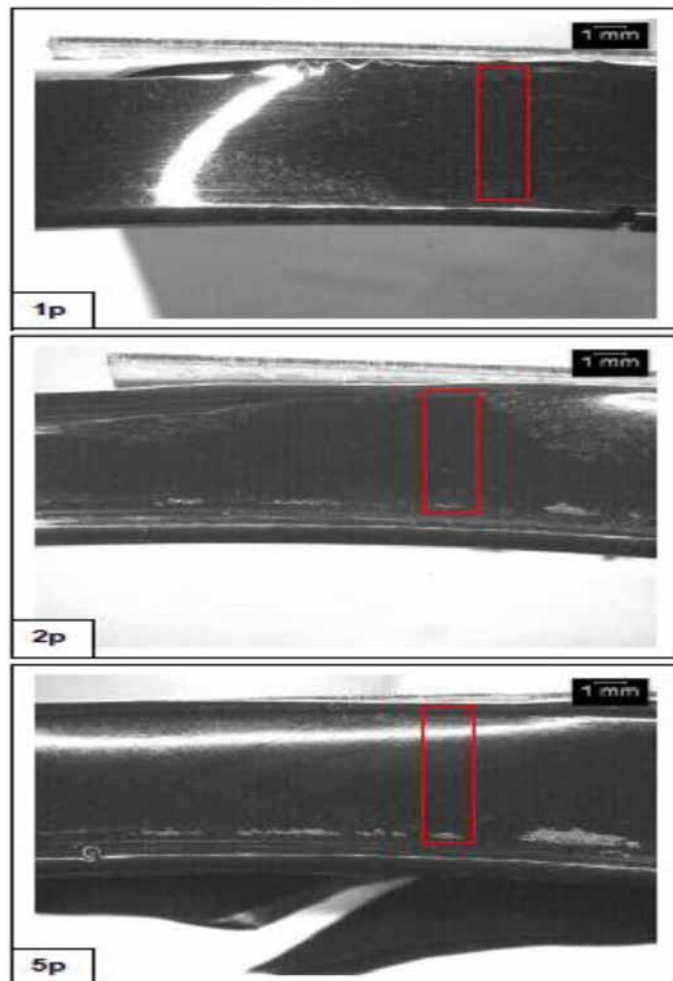
Figure 20 Replicas of TTO pinion C518-00159 taken at two hours (1p), 12.5 hours (2p) and 33.5 hours (5p) of test time.

In order to observe the changes in surface finish and topography as the gear mesh accumulated cycles, silicone replicas were taken at several intervals during the test. This process included removal of the TTO pinion and thorough cleaning of both the pinion and the driving gear to get a quality replica. This proved to be a challenge for the TTO bevel gear as it was only accessible through the TTO pinion housing bore. After some trial and error, HeDS technicians were able to develop a technique that produced high-quality replicas. Replicas of the MMP-treated pinion and the mating gear were taken after the two-hour break-in run, after 12.5 hrs of running at 800 hp, and after 33.5 hrs of running which included the 900 hp operation and the transient runs to 1,050 hp. Photographs of the replicas themselves are shown (Fig. 20). The development of a line of micro-pits can clearly be seen in replica 2p which was taken at 12.5 hrs of running. This area corresponds to the root area of the actual pinion and is likely the result of an area of high contact stress due to the lack of adequate tip relief at the very high overload conditions applied during the testing. The growth of the line of these pits along the root of the pinion face can be clearly seen in replica 5p, which was taken at the conclusion of testing. A replica taken of the mating gear at the conclusion of the testing is shown (Fig. 21). There were no indications of damage to the gear. The directionality of the surface topography of the gear, which was a new production part without the MMP treatment, can clearly be seen in the replica. The directionality of the surface was a direct result of the original grinding process.

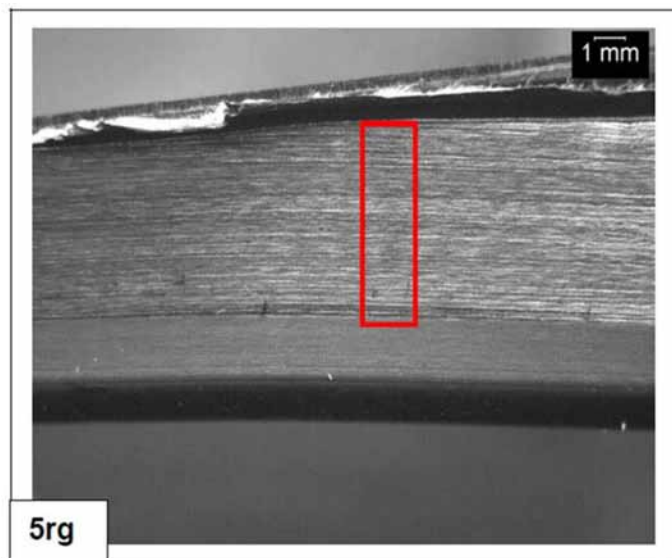
Figure 21 Replicas of TTB gear taken at 33.5 hours (5p) of test time.

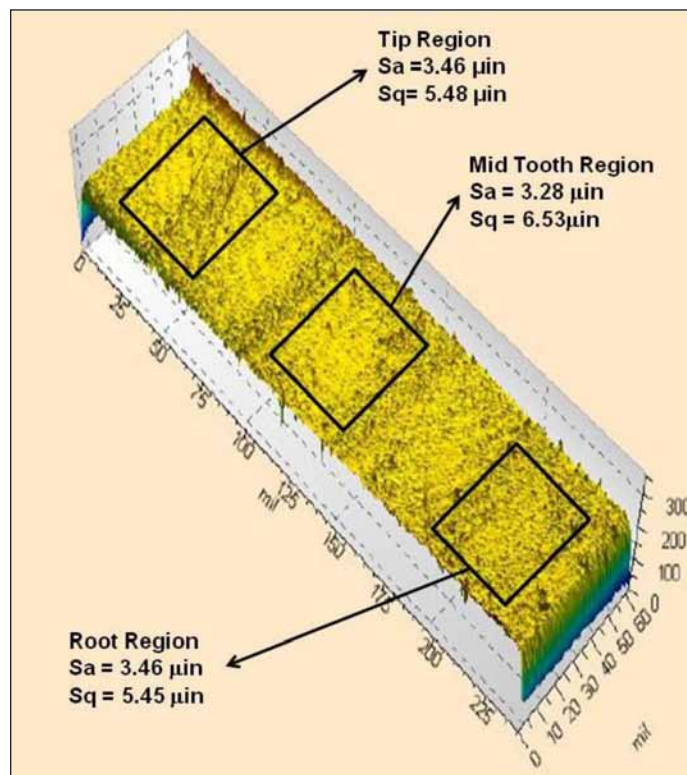
Figure 22 Surface roughness and topography of TTB pinion after two hours of testing.

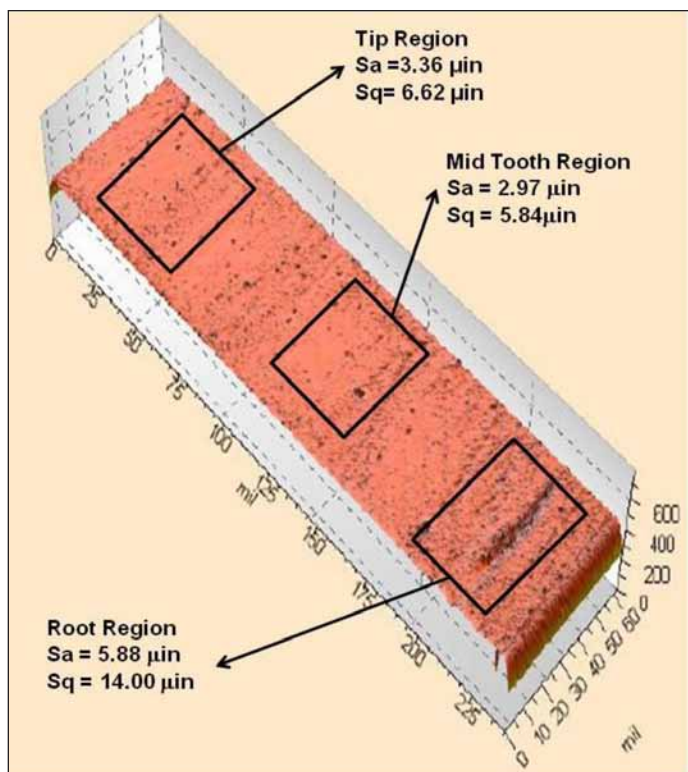
Figure 23 Surface roughness and topography of TTO pinion after 12.5 hours of testing.

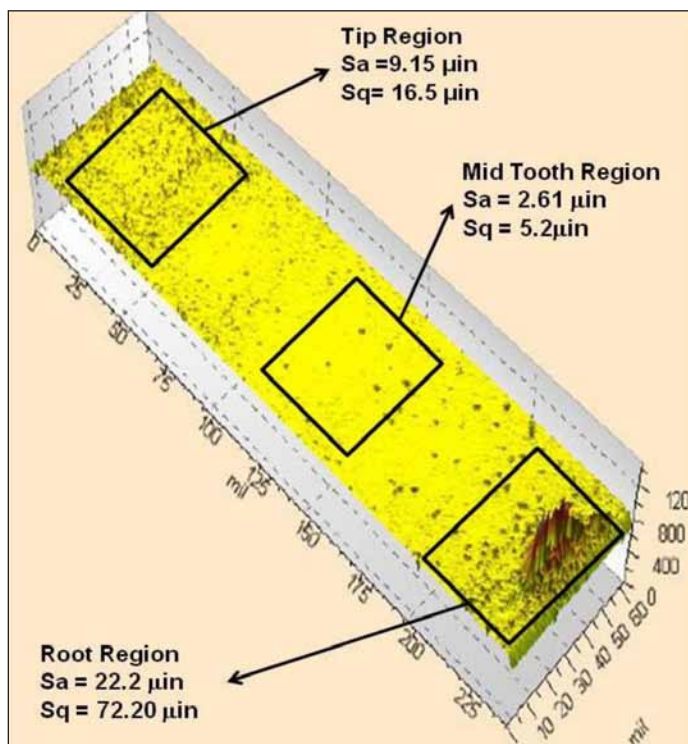
Figure 24 Surface roughness and topography of TTO pinion after 33.5 hours of testing.

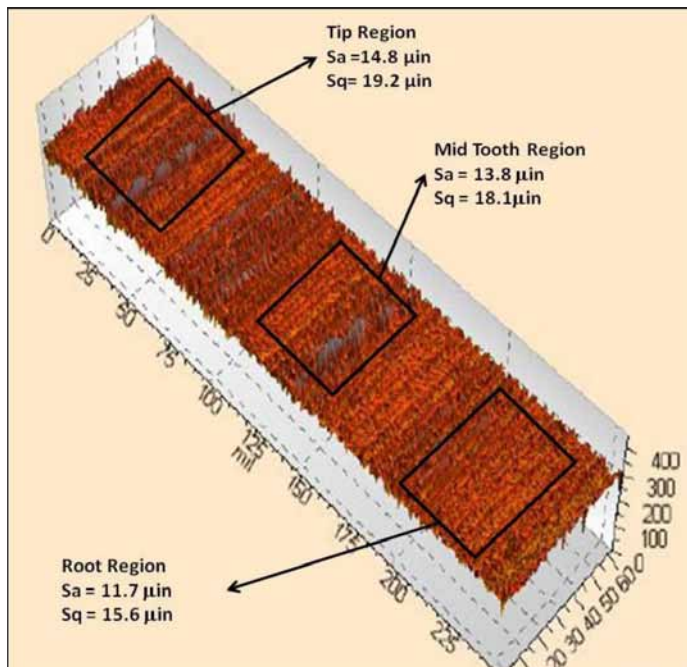
A detailed 3-D analysis of these replicas was performed by Coubrough Consulting, LLC Independence, Ohio. The replica surfaces were measured using a NanoFocus μsurf topometer employing confocal technology. Localized regions of the tooth tip, mid, and root areas were evaluated similar to the pre-test evaluation; the pinion surfaces are shown (Figs. 22–24). The roughening of the tip region, slight polishing of the mid tooth region, and formation of a line of micropits in the root area can clearly be seen. The surfaces of the TTO gear that mated with the pinion are shown (Figs. 25 and 27–28). The TTO gear replica taken after two hours of testing was of poor quality and prevented detailed analysis. Figure 25 shows the surface roughness and topography of the TTO bevel gear prior to testing. The surface finish was measured as 15 micro inches (Sa). It should be noted that the TTO gear was not shot peened. Measurements of a production intermediate gearbox spiral bevel pinion, which was ground and shotpeened (Fig. 26) show a surface roughness of 12 micro inches (Sa). While the measured Sa values were similar, the texture of the two surfaces was clearly different, with the shot peened surface having less directionality as the peaks of the grinding features were reduced. As the endurance testing progressed, a dark line developed on the root area of the TTO bevel gear (Fig. 19). The replica analysis failed to show indications of any change in topography associated with this feature, which may be an oil stain. The effect of additional running at 800 hp and the higher transient loads appeared to have little further influence upon the TTO gear surface finish and topography, with only slight changes in surface finish (Figs. 27–28).

Figure 27 Surface roughness and topography of TTO gear after 12.5 hours of testing.

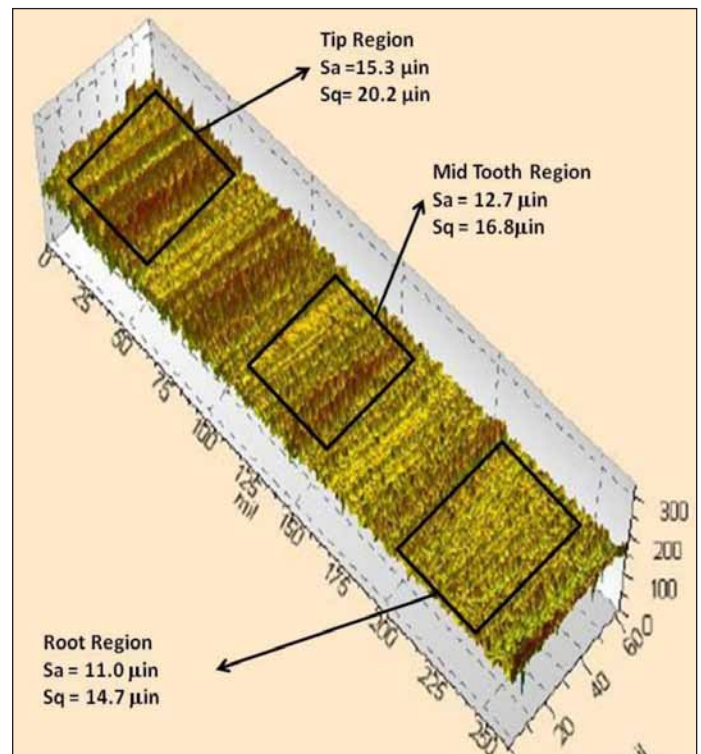
Figure 28 Surface roughness and topography of TTO gear after 33.5 hours of testing.
