# Morphology of Micropitting

R. L. Errichello

Understanding the morphology of micropitting is critical in determining the root cause of failure. Examples of micropitting in gears and rolling-element bearings are presented to illustrate morphological variations that can occur in practice.

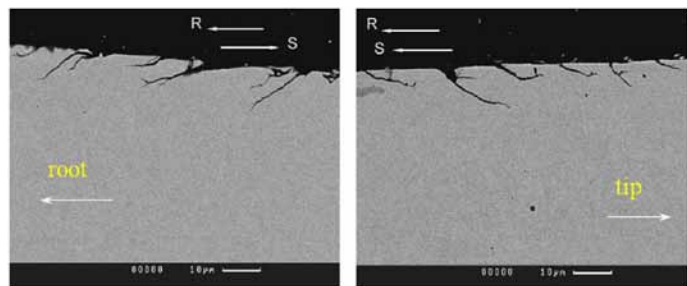
Figure 3 shows metallurgical sections cut transversely through micropits that show cracks start at or near the gear tooth surface and grow at a shallow angle (typically 10–30°, but sometimes as steep as 45°) to the surface.

Figure 3 Micropitting cracks on a driven gear (courtesy of Newcastle University).

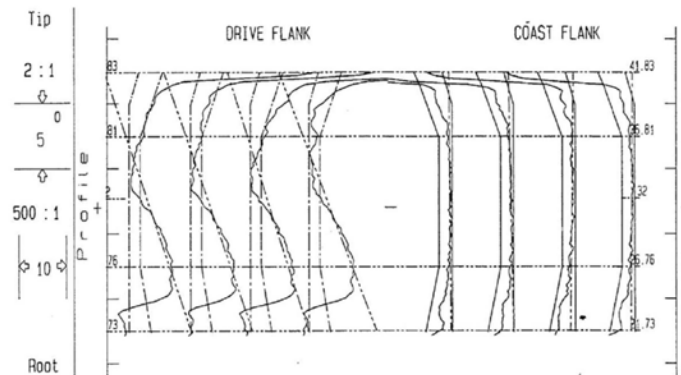
Figure 4 shows profile inspection charts that demonstrate typical profile damage due to micropitting on the drive flanks of a wind turbine high-speed (HS) pinion.

The charts for the coast flanks show the original accuracy of the pinion was high, but the micropitting caused severe deterio-

ration of the drive flanks. Note that the entire active drive flanks were damaged, but the damage was most severe in the dedenda in the area of negative sliding.

Figure 4 Typical profile damage due to micropitting on wind turbine HS pinion.

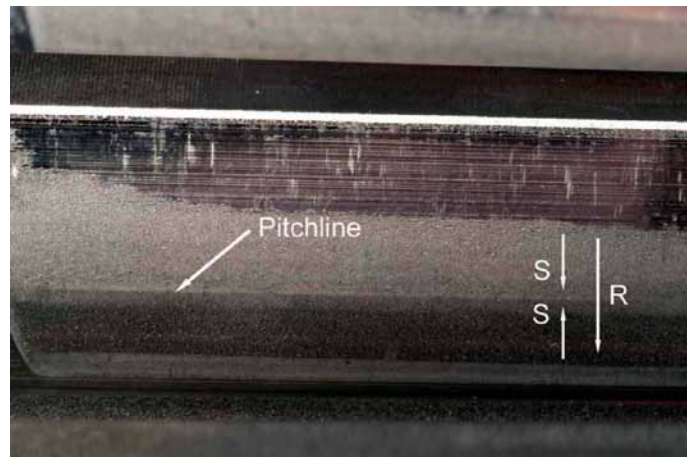
Figure 5 shows a form-ground wind turbine intermediate (INT) pinion with micropitting that crosses the pitch line.

Because slide directions reverse as the pitch line is crossed, micropitting cracks grow in opposite directions above and below the pitch line. Figure 5 shows that when micropitting grows across the pitch line, it makes the pitch line readily discernible because opposite inclinations of the floors of micropit craters scatter light in opposite directions above and below the pitch line.

Figure 5 Pitch line is readily discernible on a driven wind turbine INT pinion.

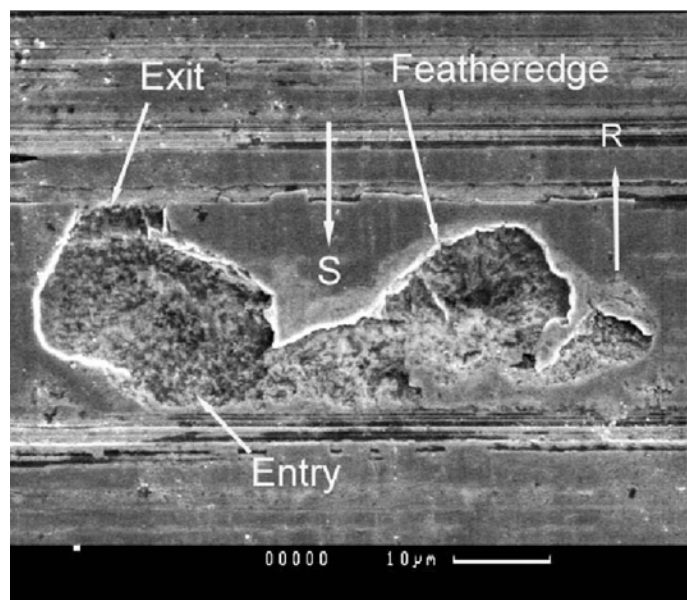
Figure 6 is an SEM image of micropitting on a high asperity of a ground tooth surface.

Micropitting begins by attacking high points on gear tooth surfaces such as crests of undulations, peaks of cutter scallops, ridges of grinding lay, and edges of grinding scratches. Figure 6 shows the surface of the asperity has been severely plastically deformed. Tractional stress from sliding has caused material to flow over the micropit craters and form a featheredge at the exit side of the craters. Growth of the micropits is opposite to the slide direction and begins at the entry (first point reached by the roll direction) and ends at the exit (last point reached by the roll direction).

Figure 6 SEM image of micropitting on asperity peak of ground tooth surface (courtesy of Newcastle University).

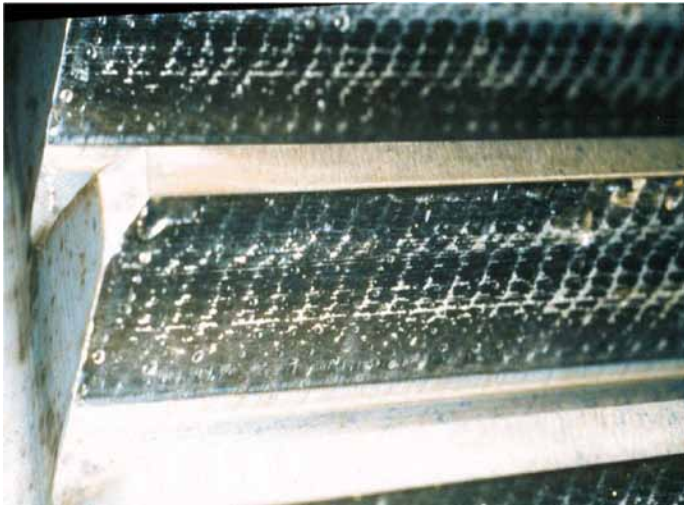
Figure 7 shows a skive-hobbed wind turbine low speed (LS) wheel with micropitting on peaks of the hob scallops. Figure 8 shows a form-ground wind turbine INT wheel with micropitting on peaks of longitudinal grind scratches. Multiple cracks originate at these sites and coalesce to form micropits along lines that follow high points of surface topography. If ridges are periodic, micropitting might form in regularly spaced rows. Micropitting generally progresses until surface peaks are removed, and might continue until large areas of tooth surface become porous and continuously cracked.

**Figure 7** Wind turbine LS wheel with micropitting on peaks of hob scallops.

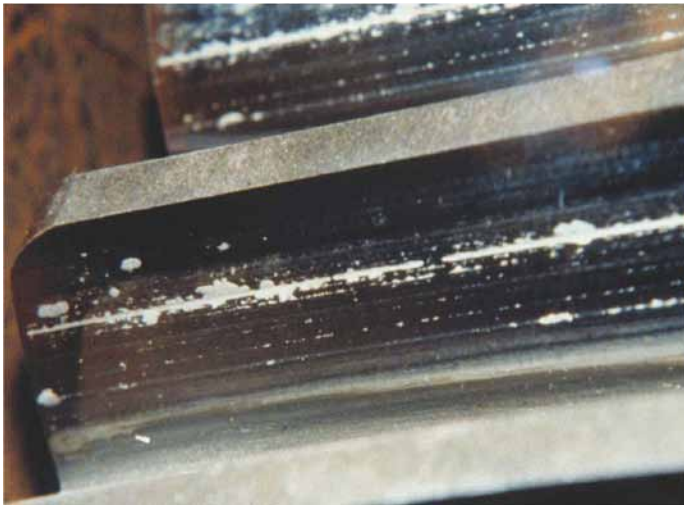
Figure 8 shows a form-ground wind turbine INT wheel with micropitting on peaks of longitudinal grind scratches.

**Figure 8** Wind turbine INT wheel with micropitting on peaks of grind scratches.

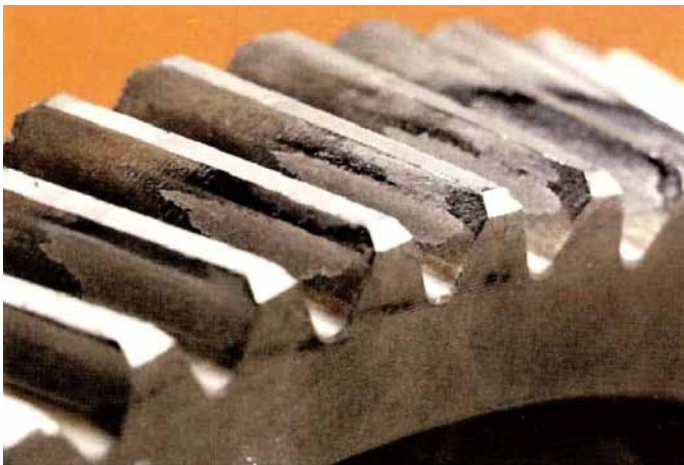
If the pinion and wheel were initially accurate and had little run-out, micropitting damage might be similar from tooth-to-tooth. In these cases micropitting patterns can be interpreted in much the same way contact patterns are used to assess gear tooth alignment and load distribution. For example, Figure 9 shows a helical wheel that had some misalignment.

**Figure 9** Micropitting pattern on a helical wheel that had some misalignment (courtesy of Caterpillar).

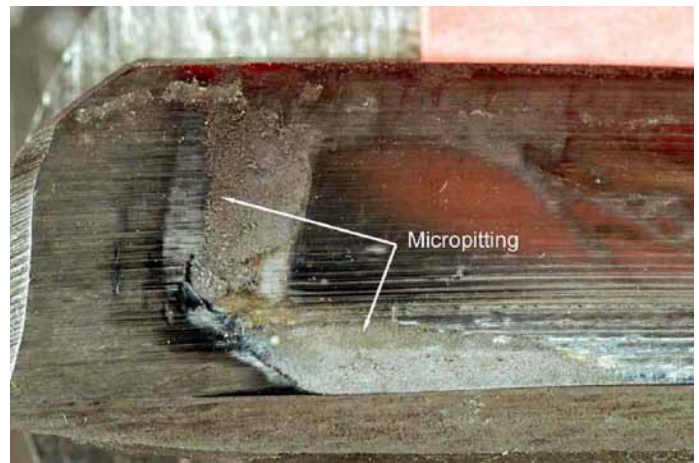
Figure 10 shows a form-ground wind turbine HS pinion with micropitting at the edge of contact at the drive end of the active face width.

Figure 10 Wind turbine HS pinion with micropitting at edge of contact.

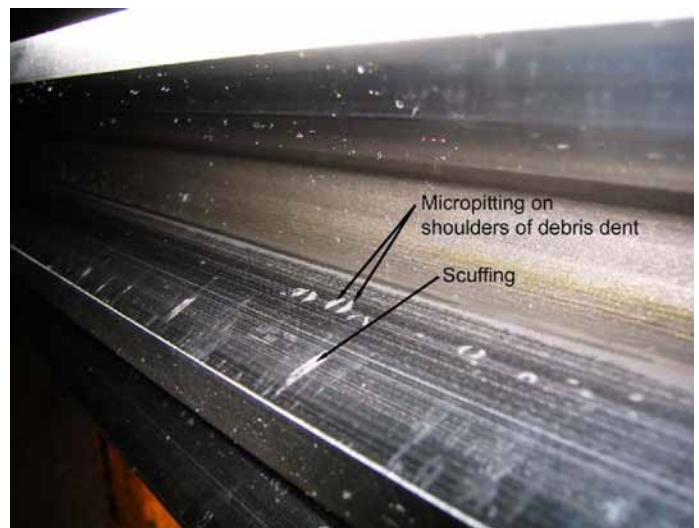
Figure 11 shows a form-ground wind turbine sun pinion with micropitting on shoulders of debris dents. Debris dents are local depressions that cause loss of EHL film thickness and lead to GSC at shoulders of dents. Cyclic contacts at these sites generate pressure spikes, plastic deformation, and tensile residual stresses that eventually initiate micropits.

Figure 11 Wind turbine sun pinion with micropitting on shoulders of debris dents.

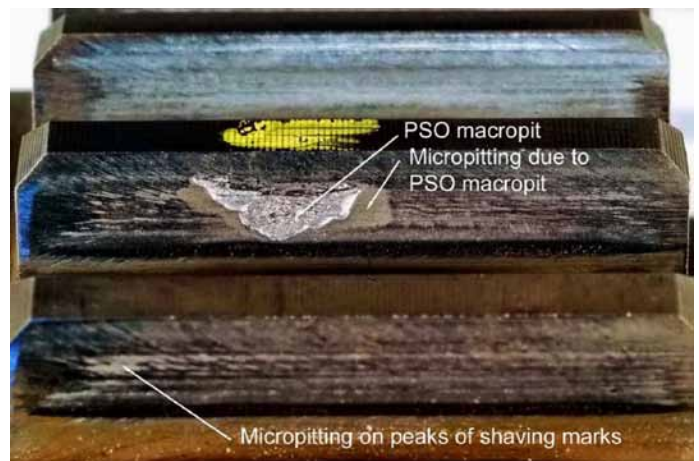
Figure 12 shows a shaved automotive planet wheel. In addition, Figure 12 shows micropitting at edges of a PSO macropit. It is a secondary failure mode that occurred because the PSO macropit disrupted the EHL lubricant film. Other teeth show there is also micropitting on peaks of the shaving marks.

Figure 12 Micropitting at edges of PSO macropit on shaved automotive planet.

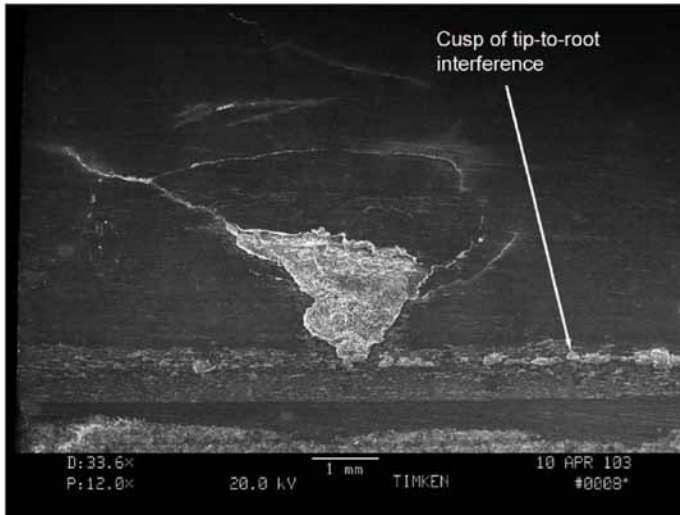
Figure 13 shows a FZG PT-C pinion with a PSO macropit that initiated at the cusp above tip-to-root damage at the SAP.

The root cause of the PSO macropit shown in Figure 13 is GSC caused by tip-to-root interference (Ref. 3). The FVA micropitting test (Ref. 4) requires the test to be terminated when a macropit occurs.

**Figure 13** FZG PT-C pinion with PSO macropit starting from GSC at SAP (courtesy of Afton Chemical).

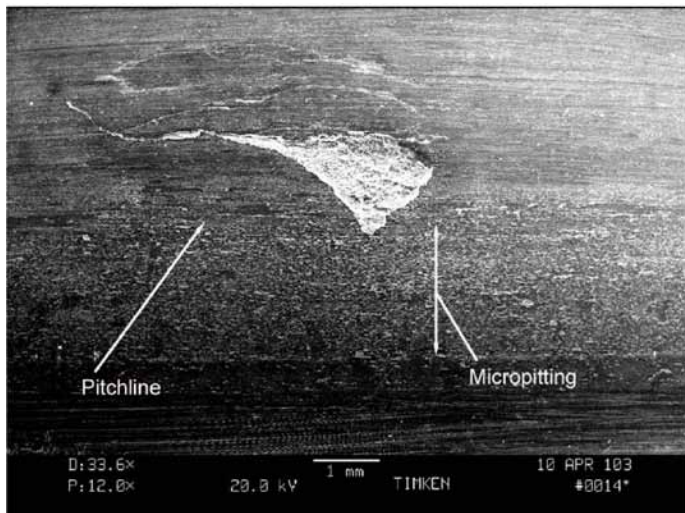
Figure 14 shows a FZG GF-C pinion with a PSO macropit that initiated at the upper edge of a 2 mm-high band of micropitting.

The root cause of the PSO macropit shown in Figure 14 is GSC caused by micropitting (Ref. 5).

**Figure 14** FZG GF-C pinion with PSO macropit starting from GSC near pitch line (courtesy of Afton Chemical).

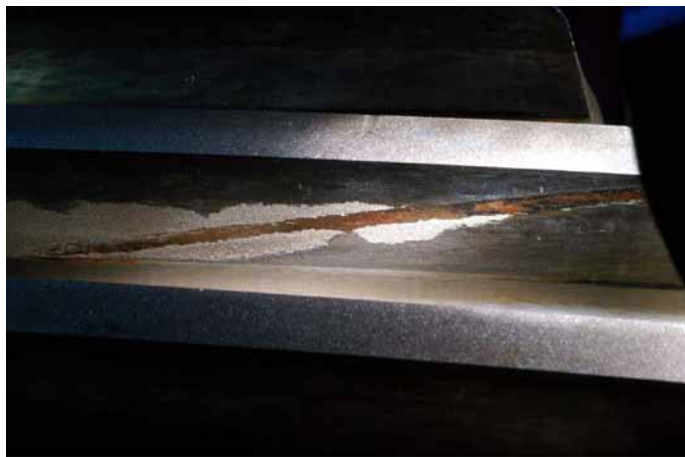
Figure 15 shows a contact line with fretting corrosion on a wind turbine INT wheel, as well as micropitting at edges of the fretting line. The fretting corrosion occurred when the wind turbine was parked; the micropitting occurred later during operation due to GSC at the edges of the fretting line. Therefore, fretting corrosion was the primary failure mode and micropitting was a secondary failure mode.

**Figure 15** Wind turbine INT wheel with micropitting at edges of fretting line.

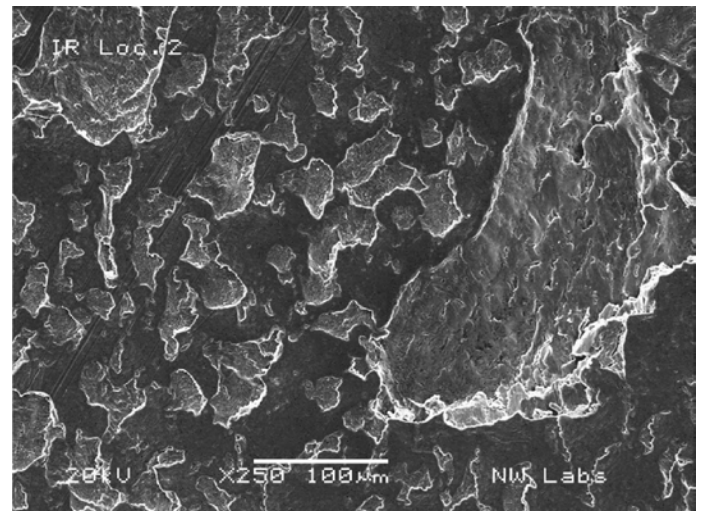
Figure 17 is an SEM image of the central part of Figure 16, showing an enlarged view of the micropitting.

Figure 17 shows that micropitting in rolling-element bearing components has a directional randomness that differs from the more directionally oriented micropitting that is typical in gear teeth. This is probably caused by differences in sliding directions, which are more random in rolling-element bearings than in gears.

Figure 17 SEM image of micropitting on pinion (courtesy of Northwest Labs).

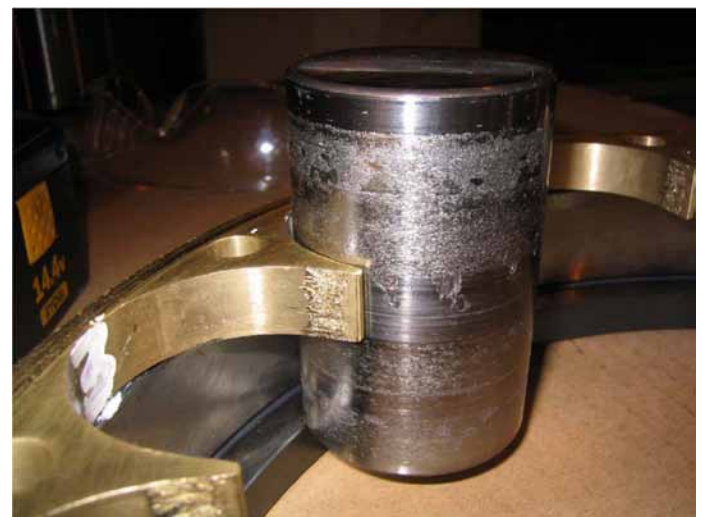
Figure 18 shows a roller from a CRB from a wind turbine INT pinion. The roller has scuffing in two circumferential bands that were caused by skidding between the roller and the outer ring (OR) raceways.

The bearing has a disc-shaped cage that is guided by a groove in the two-piece OR. No contact occurs between the roller and OR raceway in the central portion of the roller because the OR raceway is interrupted by the cage groove. Consequently, no scuffing occurred in the central portion of the roller. Furthermore, the roller has end-reliefs that prevented scuffing at the roller ends.

Figure 18 Scuffing on CRB roller from wind turbine INT pinion bearing.

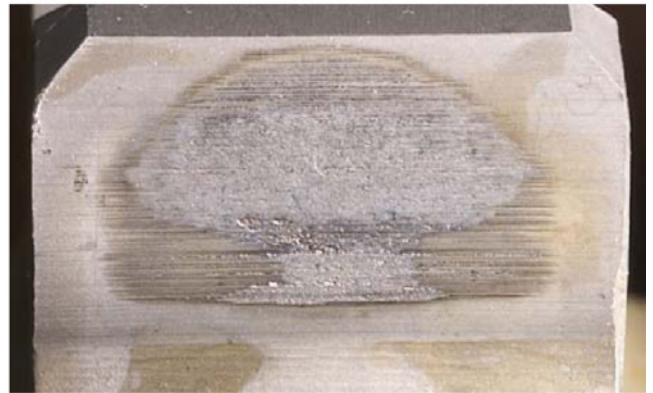
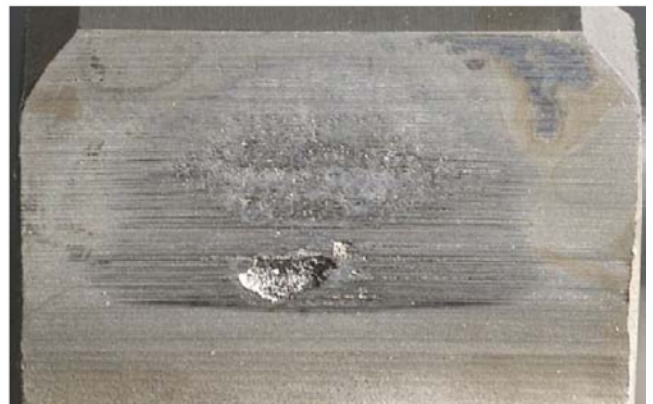
Figure 21 Influence of oil type on micropitting (courtesy of ExxonMobil).

Figure 21 shows Oil-A had the lowest micropitting resistance and Oil-E had the highest micropitting resistance. Oil-A and Oil-B initiated macropitting due to GSC at the top of the micropitting band. Oil-F had the second-best micropitting resistance, but a PSO macropit initiated due to GSC caused by tip-to-root interference.
