“Premature” Gear Failure

Expert response provided by Chuck Schultz (PE).

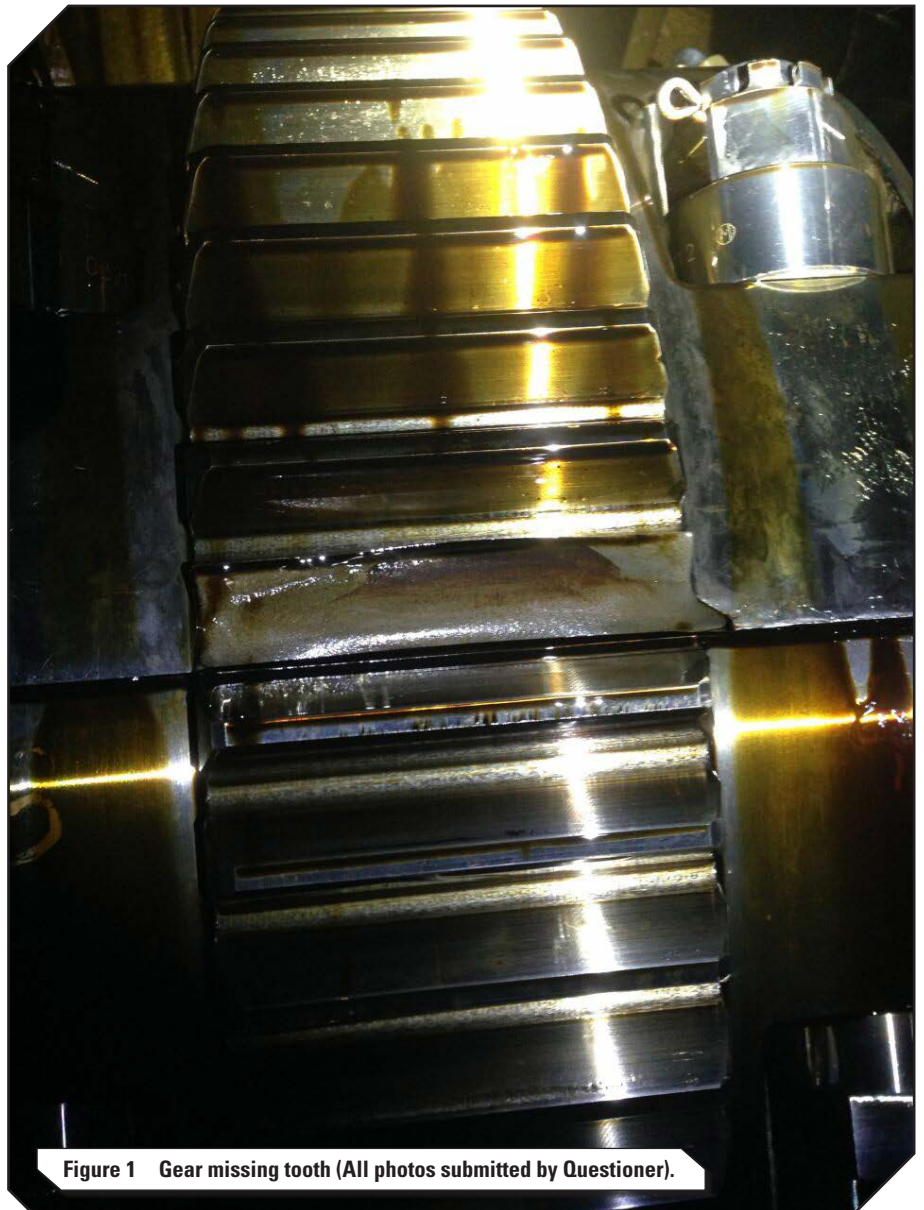
I would appreciate if you could assist with a gear failure (occurring) after just seven weeks in service, post installation. This driving gear wheel has been installed in a medium-speed engine with backlash present at four different positions; with additional backlash checked on the mating surfaces. All backlash was found within (OEM)-recommended values. Please note included photos – it seems that the crack has started at the root fillet. Any comments would be appreciated.

Figure 1 Gear missing tooth (All photos submitted by Questioner).

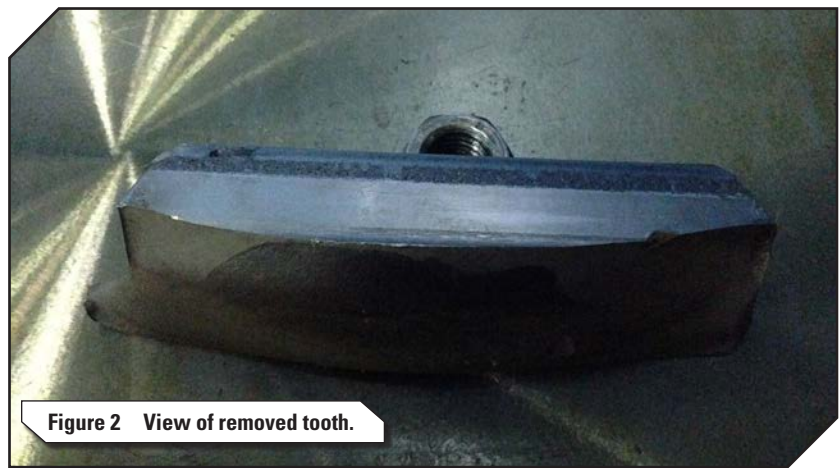
Figure 2 View of removed tooth.

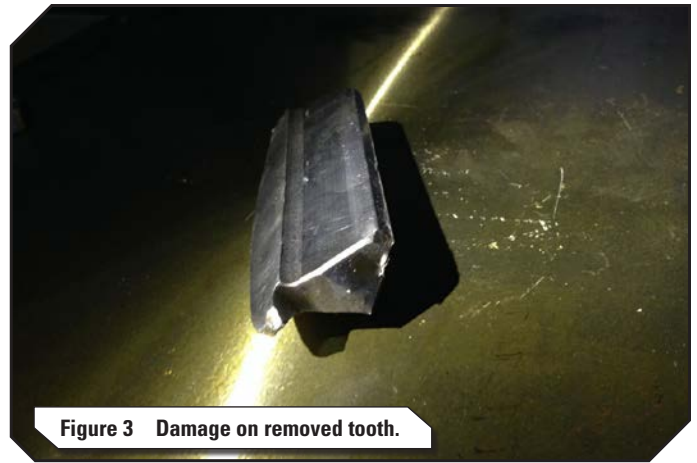
Figure 3 Damage on removed tooth.
