Morphology of Wear on Tapered-Roller Bearing Roller Ends and Thrust Ribs

Robert Errichello, Rainer Eckert, and Andrew Milburn

This report investigates the wear morphology on the large end of tapered rollers and the inner ring's large end rib on a planet carrier TRB from a multi-megawatt wind turbine gearbox. The literature (Ref. 1) on abrasive wear has many classifications, including 2-body abrasion, 3-body abrasion, scratches, grooving abrasion, rolling abrasion, cutting abrasion, and plowing abrasion. For this analysis, we have selected grooving abrasion, a common problem in wind turbine gearboxes and a prominent failure mode on many bearings, particularly planetary carrier bearings and planet bearings. Grooving abrasion is frequently observed on cylindrical roller bearings (CRB) and tapered roller bearings (TRB).

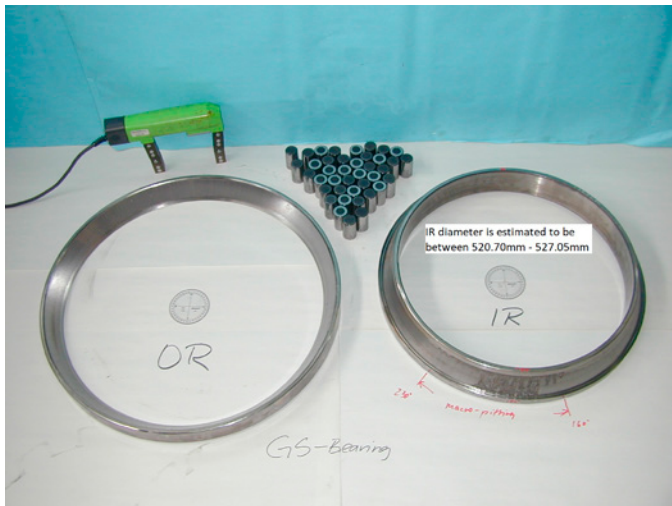
Figure 1 shows a generator side (GS) planet carrier TRB. The image displays the inner ring (IR), outer ring (OR), and a few rollers. However, the cage has been removed. The IR, OR, and rollers have extensive micropitting. Moreover, a section of the IR has severe macropitting. See Figure 30 for the geometry and nomenclature of a TRB.

Figure 1—GS planet carrier TRB.

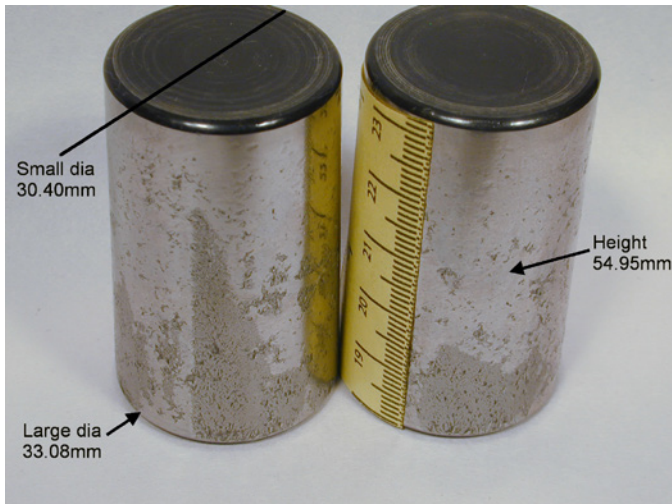
Figure 2 displays two rollers with micropitting on the larger end, indicating bearing misalignment.

Figure 2—TRB rollers with micropitting toward large ends.

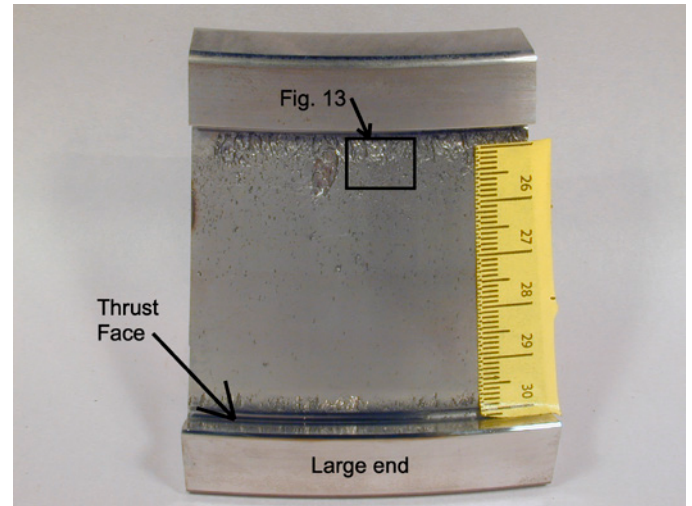
In Figure 3, one can see a section of the IR. The raceway in this section is entirely affected by micropitting, and as a result, secondary macropitting occurs at both edges of the raceway due to geometric stress concentration (GSC). For more details about micropitting and GSC, refer to Ref. 3.

Figure 3—section of the IR with micropitting and macropitting.

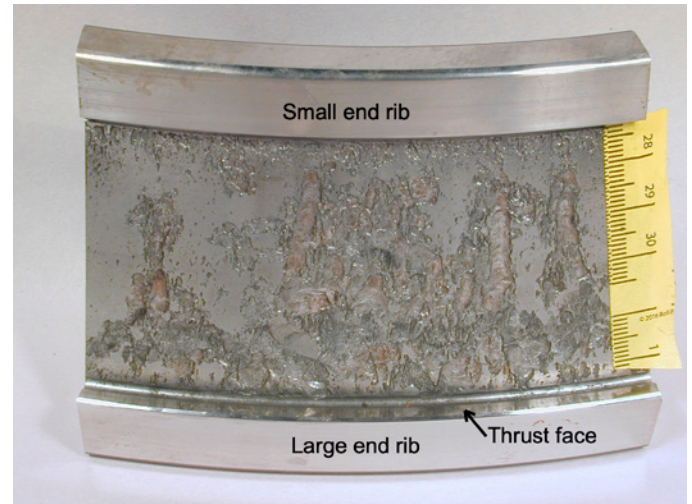
Figure 4 shows the section of the IR with severe macropitting.

Macropitting is a type of failure that often occurs after micropitting. This is because micropitting can damage the accuracy of some components, such as the OR, IR, and rollers, and increase the internal clearance of the bearing. When the components lose their accuracy and the internal clearance increases, the bearing can become misaligned, leading to GSC. One can identify macropitting by looking for beach marks left by fatigue growth and fretting corrosion in the craters caused by rubbing between the faces of the subsurface micropitting cracks.

It is important to recognize that micropitting is the primary failure mode, with macropitting being a secondary failure mode that occurs due to micropitting.

Figure 4—section of the IR with severe macropitting.

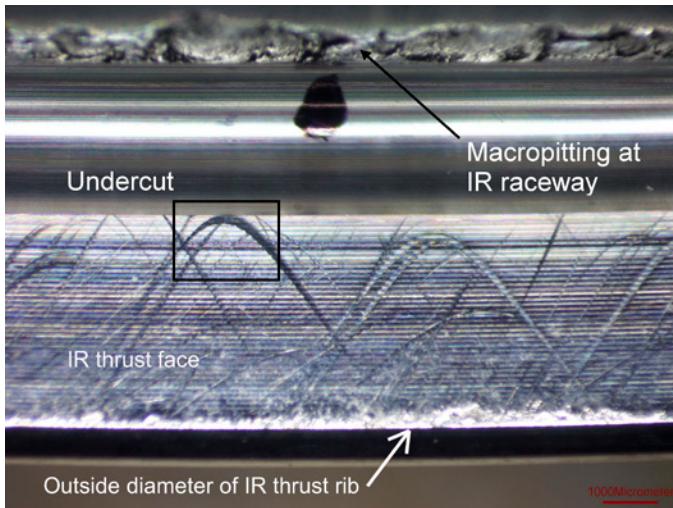
Figure 5—LOM image of the IR thrust rib.

Figure 5 is a light optical microscopy (LOM) image of the face of the IR thrust rib.

The macropitting at the edge of the IR raceway is at the top of the image and the outside diameter of the IR thrust rib is at the bottom of the image. The undercut of the grinding relief is between the macropitting and the face of the IR thrust rib. See Figure 21 for an enlarged view of the area within the rectangle.

The arc-shaped marks on the face of the IR thrust rib are grooving abrasions that were caused by hard particles that were trapped between the roller ends and the IR thrust rib. Each arc-shaped mark was caused by a particle that got fixed on the end of a roller and forced to follow a specific path called a curate epitrochoid (see “Annex A” section for description of epitrochoids). The various positions of the arc-shaped marks were caused by separate particles that were fixed at various positions on the roller ends.

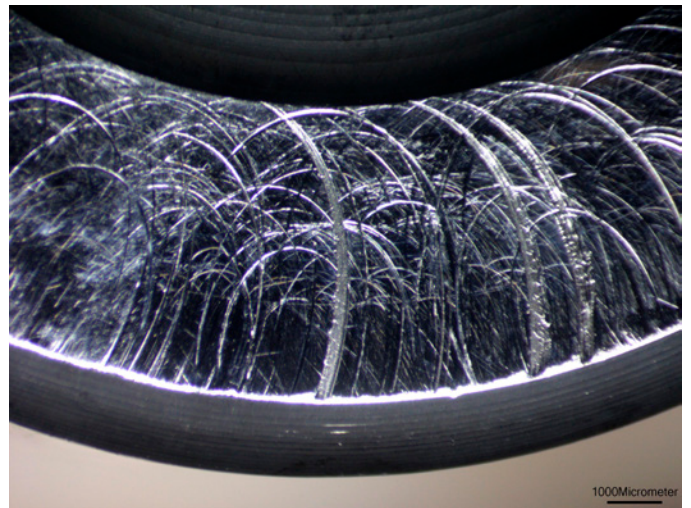
Figure 7—LOM image of an enlarged view of Figure 6.

Figure 7 is a LOM image that is an enlarged view of Figure 6.

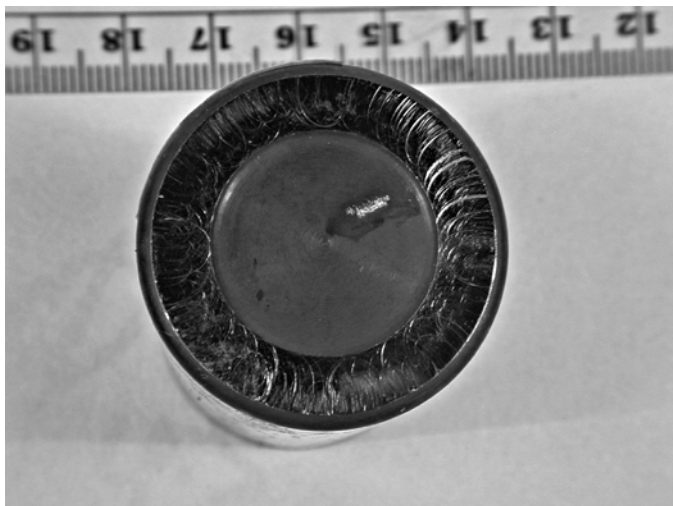
Figure 6—LOM image of the roller large end with a multitude of scratches.

Figure 6 is a LOM image of the large end of a roller with a multitude of scratches.

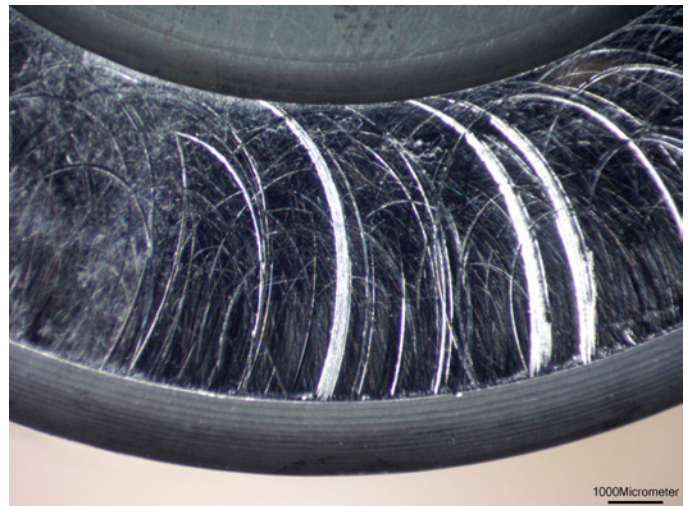
Figure 8—same as Figure 7 except with a different light direction.

Figure 8 is like Figure 7 except that a different lighting direction was used for the photo. LOM has an advantage over scanning electron microscopy (SEM) because scratches are emphasized by specular light reflection.

The recess on the roller end is at the top of the image, and the outside diameter of the roller is at the bottom of the image.

There are marks on the roller end face that are shaped like an ellipse. These marks were caused by grooving abrasion, which was caused by hard particles that got trapped between the roller end and the IR thrust rib. A fixed particle on the IR thrust rib traces an ellipse-shaped curve called a prolate epitrochoid on the end of the roller. The positions of the ellipse-shaped marks varied because separate particles were fixed at different positions on the IR thrust rib. If you want to know more about epitrochoids, see Annex A for a detailed description.

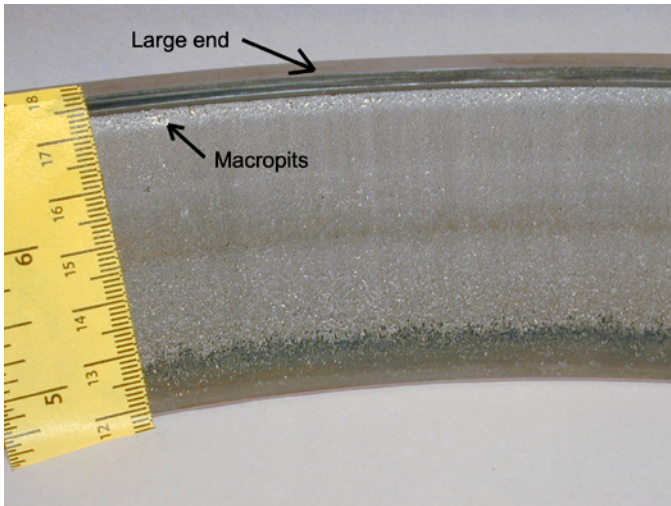
Figure 9 is a LOM image of the bearing OR. It shows micropitting biased toward the large end of the OR raceway and small macropits starting at the edge of the OR raceway.

Figure 9—Micropitting biased toward the large end of the OR raceway.

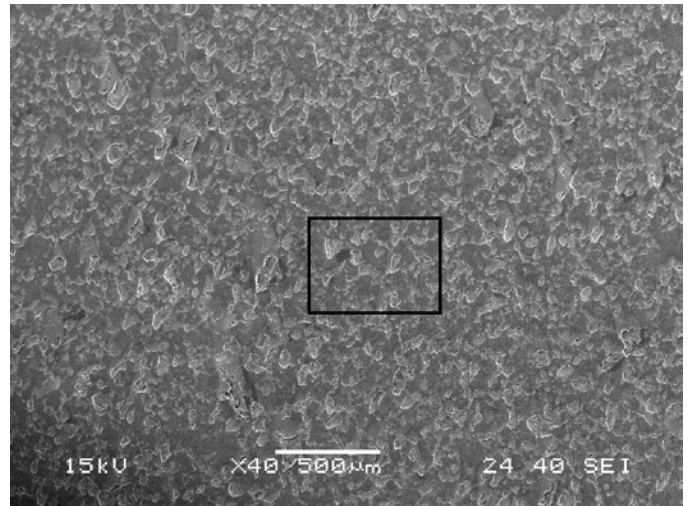
Figure 11—SEM image of the IR raceway at 40x magnification.

Figure 11 is an SEM image of the IR raceway at 40x magnification.

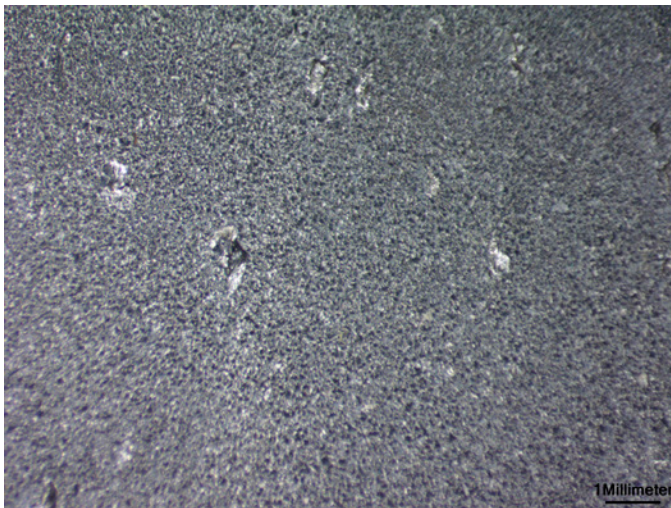
Figure 10—LOM image of the bearing IR raceway at 10x magnification.

Figure 10 is a LOM image of the bearing IR raceway at 10x magnification.

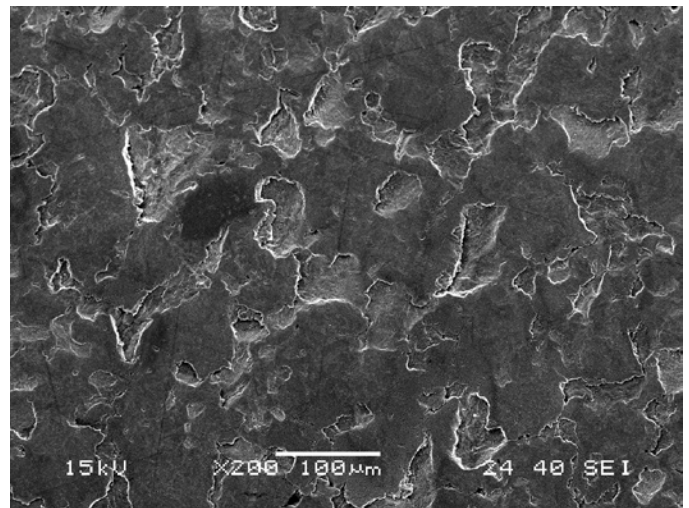
Figure 12—SEM image of the IR raceway at 200x magnification.

Figure 12 is an SEM image of the IR raceway within the area of the rectangle in Figure 11 at 200x magnification.

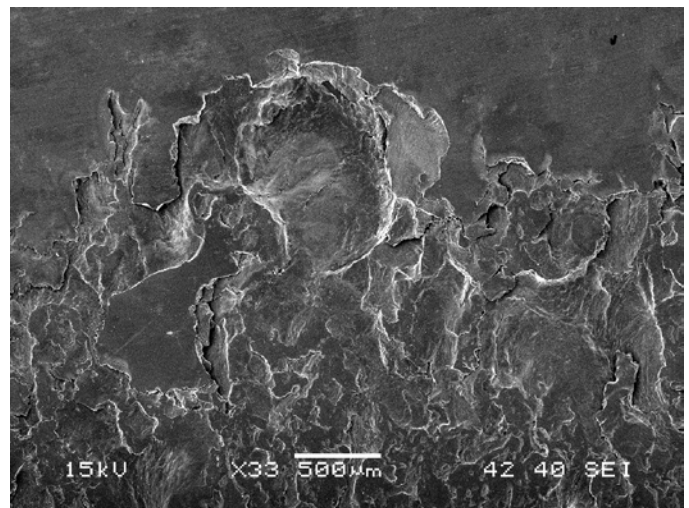
Figure 13 is an SEM image of macropitting at the edge of the small end of the IR raceway.

Macropitting was detected at both edges of the IR raceway. Figure 13 shows macropitting at the small end of the IR raceway. This area is just to the right of the large macropit shown in Figure 3. The macropitting was caused by GSC, which occurred due to the abrupt edge of the micropitting on the IR raceway. Furthermore, the micropitting increased the internal clearance of the bearing, leading to misalignment and further aggravating the GSC.

Macropitting is a secondary failure mode that often occurs at the edges of bearing raceways, following the primary failure mode of micropitting. This occurs because micropitting causes the IR raceway to conform to the rollers and eliminates

Figure 13—SEM image of macropitting at the edge of the small end of the IR raceway.

the crown on the rollers, which creates GSC at the ends of the rollers. For more detailed information on this mechanism, please refer to Ref. 3.

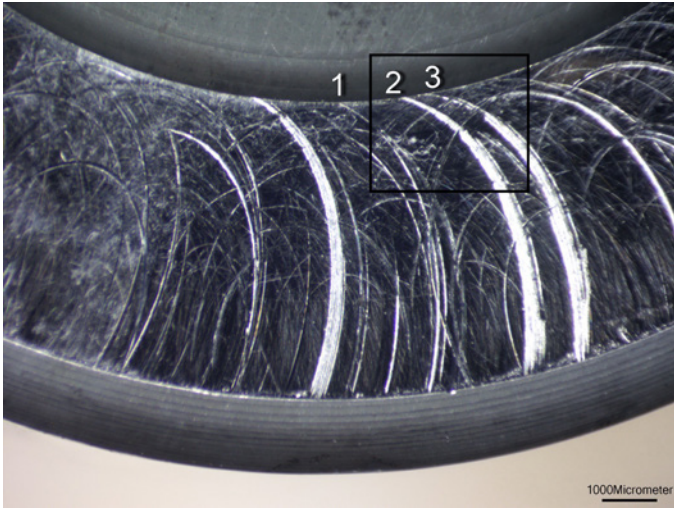
Fig 14—LOM image of roller end (same as Figure 8).

Figure 14 is the same LOM image as Figure 8, repeated here for clarity.

For discussion, we identify three prolate epitrochoid curves—Curve 1, Curve 2, and Curve 3. Curve 1 is narrower than 30 μm and is referred to as a scratch, while Curve 2 and Curve 3 are wider (up to 400 μm) and referred to as grooves. During the grooving abrasion process, hard particles on the IR thrust rib begin contact with the roller end at the bottom of Figure 14 and leave contact with the roller end at the recess near the top of Figure 14. See Figure 15 for an enlarged view of the area within the rectangle.

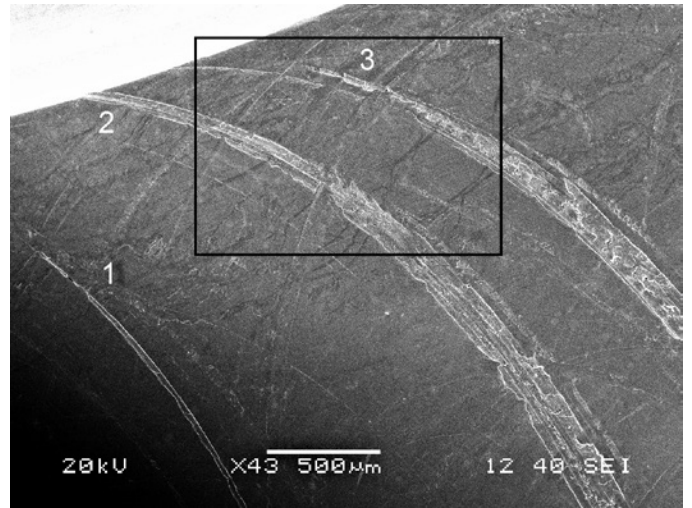
Figure 15 is an SEM image of the roller end within the area of the rectangle in Figure 14 at higher magnification.

Curve 1 in Figure 15 is a smooth and clean scratch that ends near the number 1. The particle that created Curve 1 left contact with the roller end near the number 1. At its widest point, Curve 1 measures about 30 μm , which is close to the limit of detection for the naked eye. However, with intense directional light, the specular reflection makes the scratches easily detectable, as shown in Figure 14. See Figures 16 and 17 for enlarged views of the area within the rectangle at higher magnification.

On the other hand, Curves 2 and 3 are rough and plastically deformed grooves that are as wide as 180 μm near the bottom of Figure 15. The roughness of these curves causes light rays to scatter in all directions, resulting in diffuse reflection. This makes grooves 2 and 3 appear frosted, as shown in Figure 14.

Figure 15—SEM image of the roller end at higher magnification.

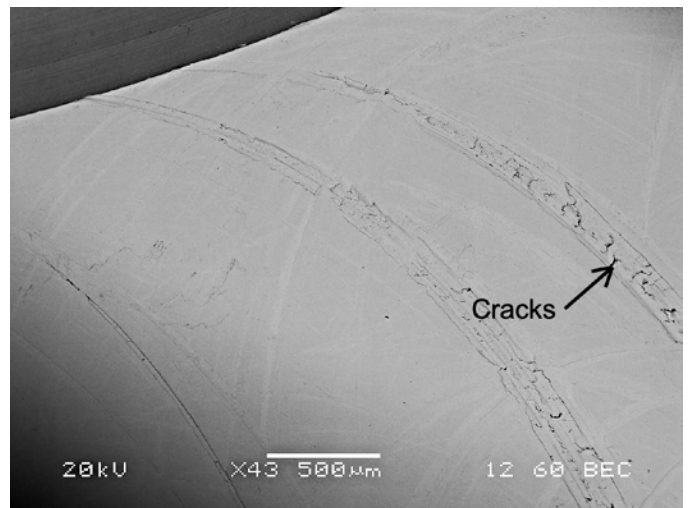
Figure 16—BSE image of Figure 15.

Figure 16 is a BSE image of the roller end within the area of the rectangle in Figure 15 at higher magnification.

BSE images can easily detect foreign particles that may be embedded in a surface. Some common types of particles include grinding dust (such as aluminum oxide, cubic boron nitride, or silicon carbide), or environmental dust like silica sand. BSE images can distinguish between different elemental compositions based on their atomic weight. In a BSE image, aluminum and silicon appear dark as they have low atomic numbers of 13 and 14 respectively, while iron, which has a relatively high atomic number of 26, appears bright. By examining Figure 16, one can see that there are no dark particles present, indicating that there are no hard, foreign particles embedded in the roller end. Therefore, the abrasants are likely to be debris particles from micropitting and macropitting of the bearing components that have been work-hardened by overrolling.

BSE images can aid in detecting cracks because carbon from hydrocarbon lubricant gets trapped within the cracks, making them appear dark in BSE images. Figure 16 displays multiple

cracks within two broad grooves. It's worth noting that these cracks are not noticeable in the SEM image shown in Figure 15.

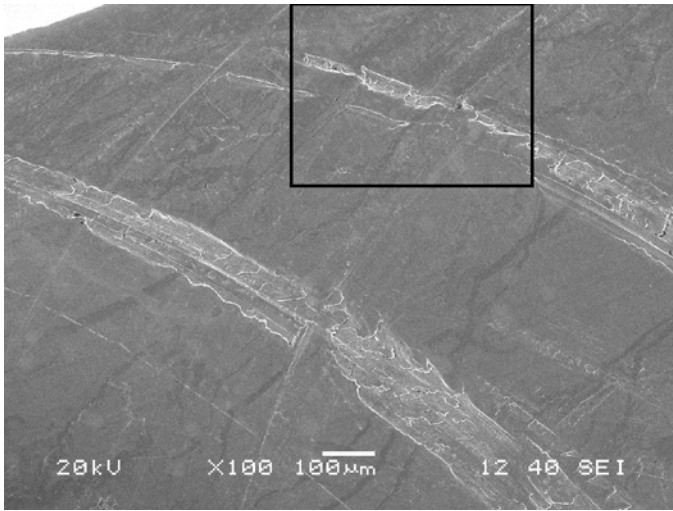
Figure 17—SEM image of roller end at higher magnification.

Figure 17 is an SEM image of the roller end within the area of the rectangle in Figure 15 at higher magnification.

The image displays the rough surfaces inside the grooves, with plastic material flowing into them due to intersecting scratches. See Figure 18 for an enlarged view of the area within the rectangle.

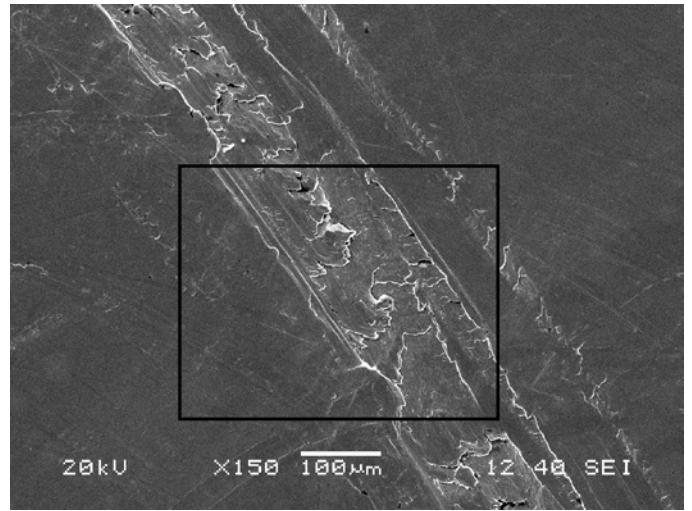
Figure 19—SEM image of roller end at higher magnification.

Figure 19 is an SEM image of the roller end at another area.

This image shows a wide groove with flattened platelets due to plastic deformation in the groove, cracks on the upper shoulder,

and plastic flow on the lower shoulder caused by intersecting scratches. See Figure 20 for an enlarged view of the area within the rectangle.

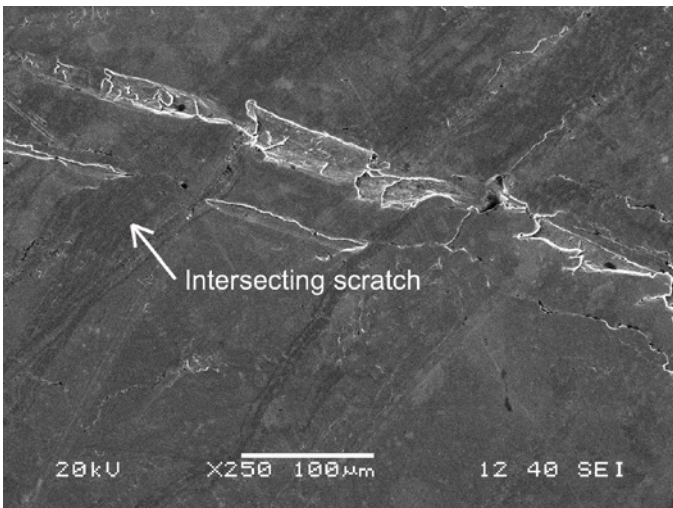
Figure 18—SEM image of roller end at higher magnification.

Figure 18 is an SEM image of the roller end within the area of the rectangle in Figure 17 at higher magnification.

The upper rough groove is the groove labeled 3 in Figure 15. The lower smooth groove is a scratch that was interrupted by plastic deformation caused by intersecting scratches.

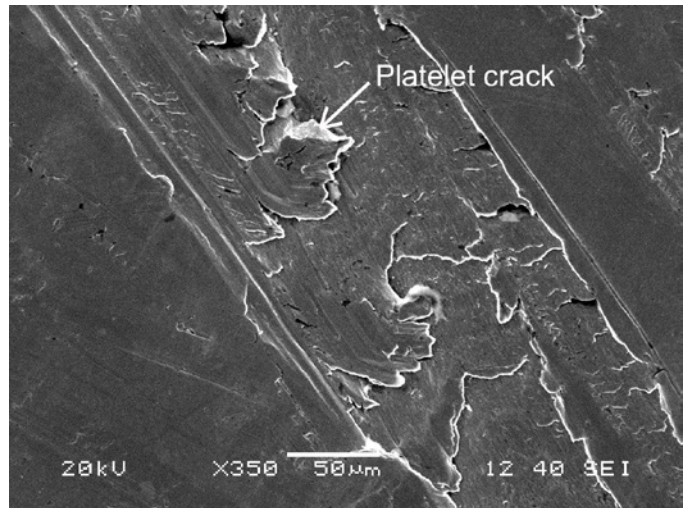
Figure 20—SEM image of the roller end at higher magnification.

Figure 20 is an SEM of the roller end within the area of the rectangle in Figure 19 at higher magnification.

Grooving abrasion creates raised shoulders on both edges of the grooves. When the raised shoulders encounter a mating surface, they get flattened, which we call ironing. As the roller rotates, it causes angular displacement and cracking of the thin platelets of plastically deformed surface material.

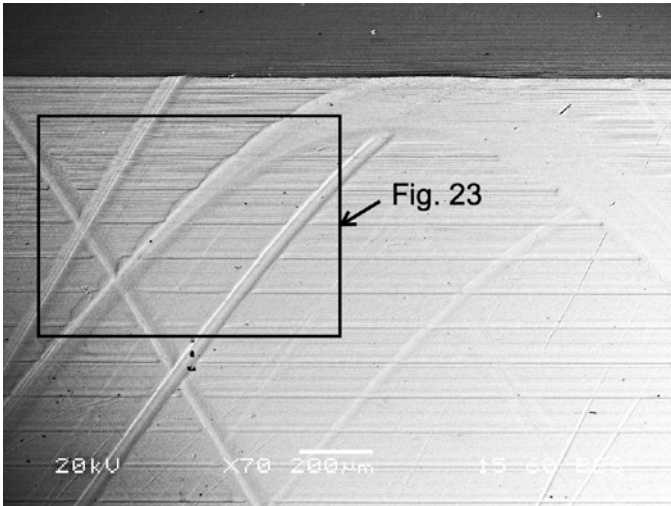
Figure 21—BSE image of the IR thrust rib.

Figure 21 is a BSE image of the IR thrust rib within the area of the rectangle in Figure 5 at higher magnification.

In the image, the top part shows the undercut of the grinding relief. The horizontal grooves that can be seen are a natural part of the surface topography that was created by grinding the face of the IR thrust rib. There are also finer grinding marks on the surface between the horizontal grooves. Below the rectangle, three black dots are believed to be from a fractured hard particle, which is a rare occurrence for the images in this report. See Figure 23 for an enlarged view of the area within the rectangle.

When comparing Figures 20 and 21, the IR thrust rib in Figure 21 appears more ductile than the roller end in Figure 20 because there were no cracks in the IR thrust rib.

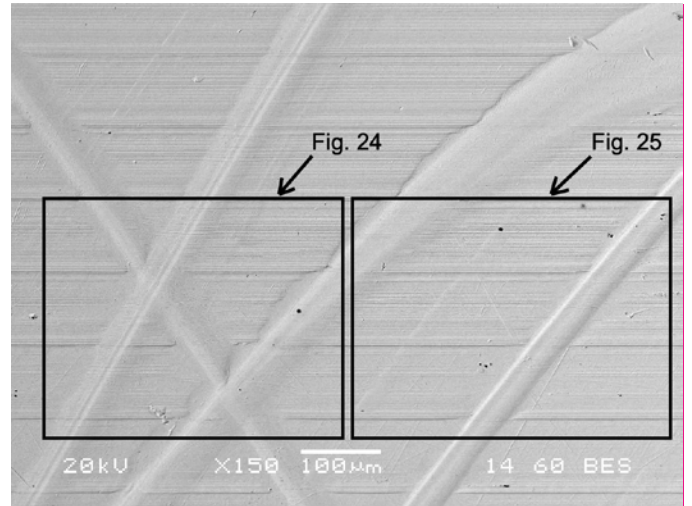
Figure 23—BSE image of the IR thrust rib at higher magnification.

Figure 23 is a BSE image of the IR thrust rib within the area of the rectangle in Figure 21 at higher magnification.

The curtate epitrochoid groove in the central part of the image displays ironing plastic deformation of the upper shoulder of the groove. The narrow groove at the right of the image has less plastic deformation of the upper shoulder. See Figure 24 for an enlarged view of the area within the left rectangle. See Figure 25 for an enlarged view of the area within the right rectangle.

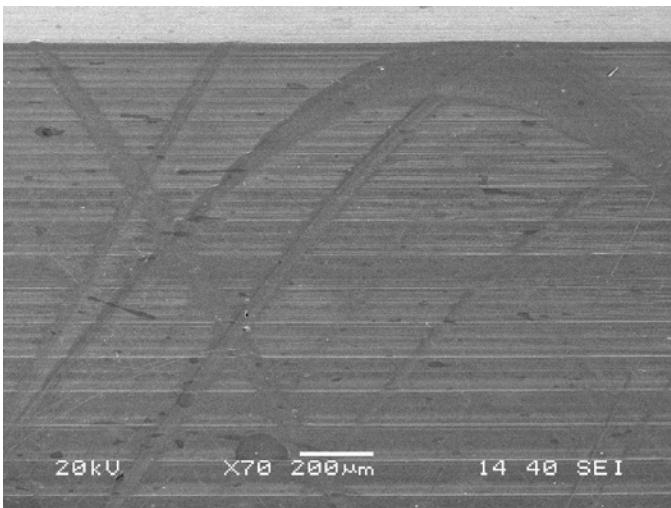
Figure 22—SEM image of the IR thrust rib.

Figure 22 is an SEM image of Figure 21.

Comparing Figures 21 and 22, it is evident that BSE images provide a higher resolution of surface topography and are ideal for displaying grooving abrasion features compared to SEM images.

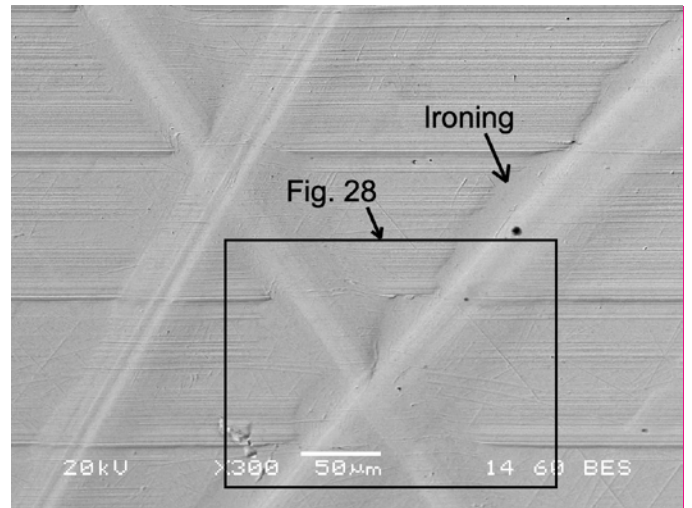
Figure 24—BSE image of the IR thrust rib at higher magnification.

Figure 24 is a BSE image of the IR thrust rib within the area of the left rectangle in Figure 23 at higher magnification.

Ironing of the upper shoulder of the larger groove caused the material to flow on top of the original grinding marks on the

face of the IR thrust rib. See Figure 28 for an enlarged view of the area within the rectangle.

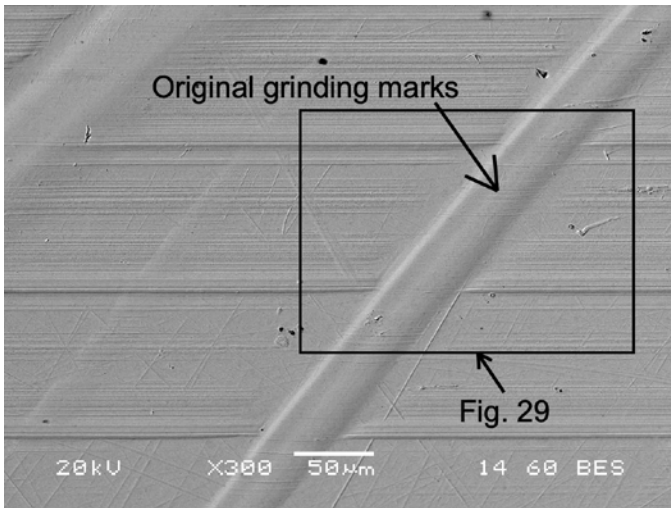
Figure 25—BSE image of the IR thrust rib at higher magnification.

Figure 25 is a BSE image of the IR thrust rib within the area of the right rectangle in Figure 23 at higher magnification.

The groove on the right-hand side of the image is a common example of a narrow groove with a small upper shoulder and original grinding marks present within the groove. This shape is indicative of grooving abrasion, which occurs due to plastic deformation without any evidence of cutting abrasion. Additionally, since the width of the narrow groove is approximately 30 µm, the narrow grooves were likely produced by micropitting debris. See Figure 29 for an enlarged view of the area within the rectangle.

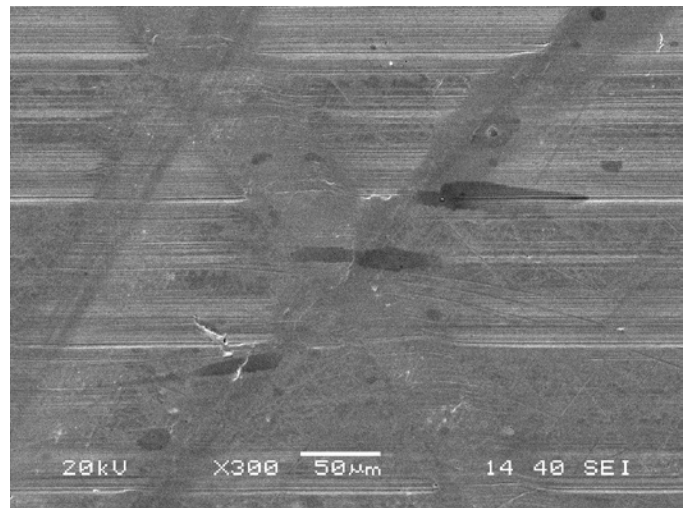
Figure 27—SEM image of Figure 24.

Figure 27 is an SEM image of Figure 24.

Compared to Figure 24, Figure 27 shows that BSE images are best for showing surface topography, and SEM images are best for showing surface films. The black marks are artifacts created by a residual cleaning agent.

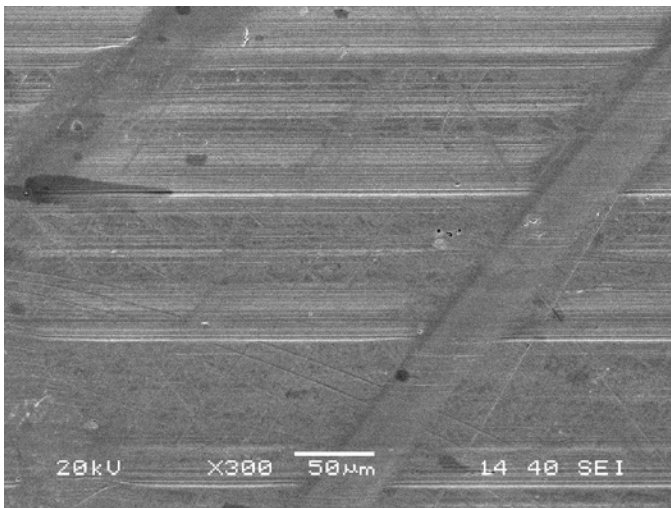
Figure 26—SEM image of Figure 25.

Figure 26 is an SEM image of Figure 25.

In comparison to Figure 25, Figure 26 demonstrates that BSE images are ideal for displaying surface topography, while SEM images are better suited for displaying surface

marks, films, and contamination. Although SEM only produces black-and-white images, when paired with energy dispersive spectroscopy (EDS), it can identify the chemical composition of surface films.

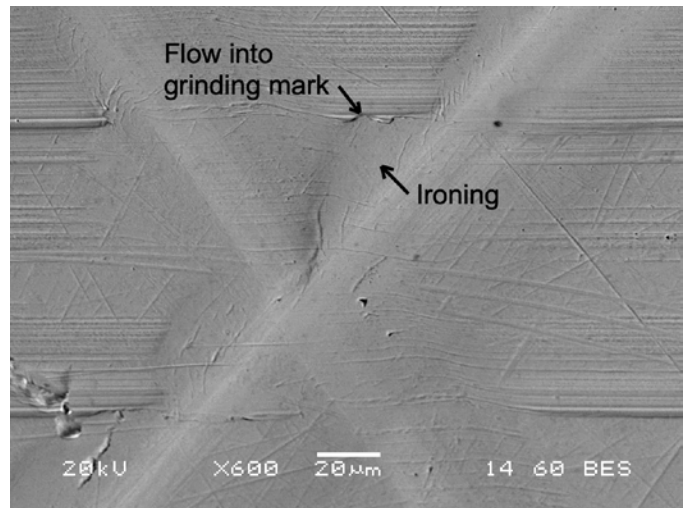
Figure 28—BSE image of the IR thrust rib at higher magnification.

Figure 28 is a BSE image of the IR thrust rib within the area of the rectangle in Figure 24 at higher magnification.

This image demonstrates an instance of plastic deformation caused by ironing the shoulders of grooving abrasion. It is apparent that the ironing process has resulted in the distortion of the original grinding marks, and in some cases, the material has flowed into sections of the deeper grinding marks.

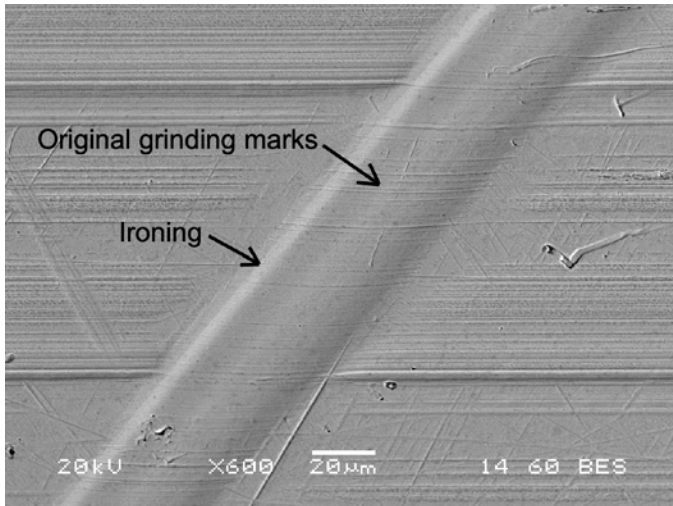
Figure 29—BSE image of the IR thrust rib at higher magnification.

Figure 29 is a BSE image of the IR thrust rib within the area of the rectangle in Figure 25 at higher magnification.

This image displays the presence of original grinding marks inside the groove. This phenomenon is quite like the circular indentation formed by a tungsten ball of a Brinell tester. When the Brinell indentation is made, plastic deformation occurs below the surface and the original grinding marks remain preserved within the indentation because the surface stays elastic.
