# The Effect of Material Defects on Gear Performance—A Case Study

Raymond J. Drago, P.E. and Alejandro Font Filax, Ph.D.

## Abstract

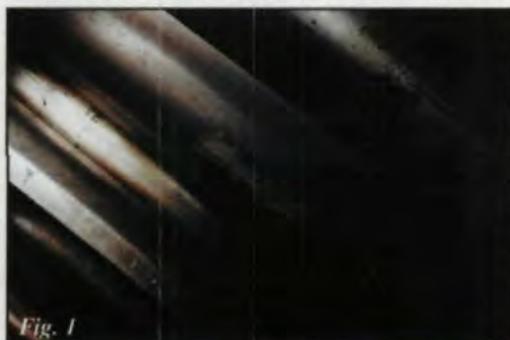
*Fig. 1—Distress observed on ball mill pinion during 1994 visual evaluation.*

performed without significant incident until some pitting was discovered during a visual examination conducted late in 1994. At that time, we noted only very minor surface distress, as Figures 1 and 2 show. The distress was located at about the middle of the face width and had been slightly ground out at the time of my November 1994 visit.

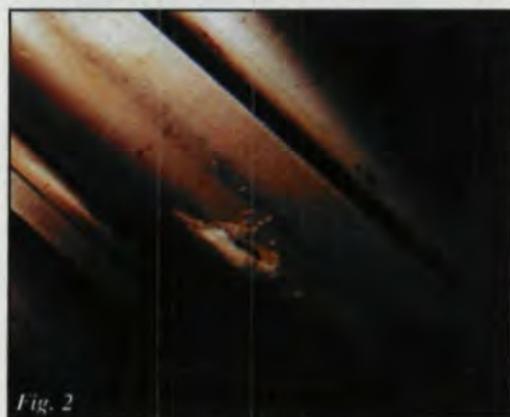
*Fig. 2—Close view of distress observed on ball mill pinion during 1994 inspection.*

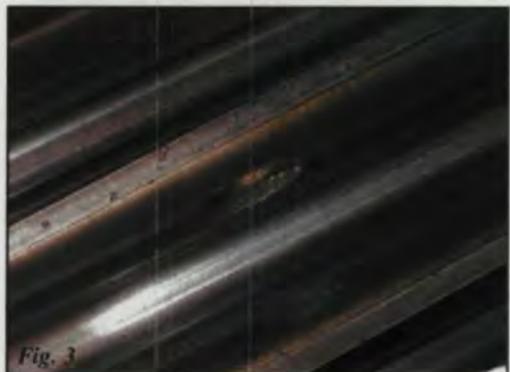
*Fig. 3—Currently installed ball mill #2 pinion showing region (near mid-face) which has been ground out to remove pitting and surface cracks and then restarted.*

The failed pinion was replaced and the mill restarted. During a visual inspection conducted in early 1999, the new replacement pinion was found to be exhibiting pitting very similar in both extent and location to the pitting in the original pinion. This pitting was hand dressed out and was found to have not progressed significantly during a visual inspection, which was conducted during April 1999, as Figure 3 shows.

During an inspection in April 1999, we did not observe any cracks on this pinion (we were unable to dye check it). However, the pinion was reported to have some cracks in the pitted region which were discovered during a previous dye check inspection. The cracks were ground out and the pinion was returned to service. At the time of our inspection, it appeared that only minor progression of the pitting was occurring.

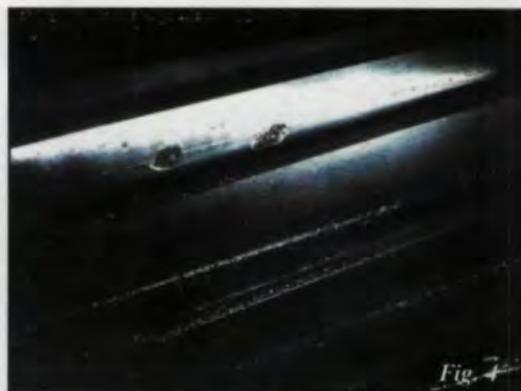
As noted above, there are two identical mill gear systems on line at this site. The second mill was running at the time of our visit and we were unable to shut it down for a good look at the teeth. We examined the teeth through the inspection port with the aid of a strobe, which allowed the pinion and gear rotation to be "stopped" artificially. As Figure 4 shows, this pinion exhibited moderate surface distress in the form of pitting.

We could not detect any cracks on the surface of this pinion; however, it would be almost impossible to do so under the conditions of this inspection. The regions of pitting observed were similar in size to those observed on the first (failed) mill pinion, but they were in a somewhat different location along the face width. In the profile direction, the pitting was located near the pitch line on both mill pinions.

Fig. 4—Pitting distress on second mill pinion teeth.

The distress is located about 2/3 of the face width from the motor end of the face width. While Figure 4 shows typical distress, it is important to note that not all pinion teeth exhibit this distress. Figure 5 shows another group of pinion teeth on

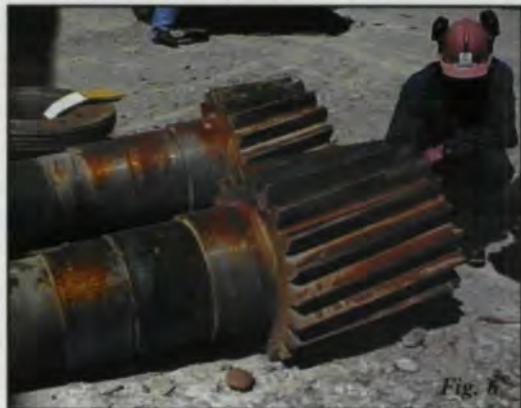
Fig. 6—Failed pinion removed from #2 ball mill in August 1998.

The pinion, which failed in August 1998, was available for our visual examination; however, as Figure 6 shows, it was quite rusted. Still, our visual evaluation provided valuable clues regarding the cause of the failure.

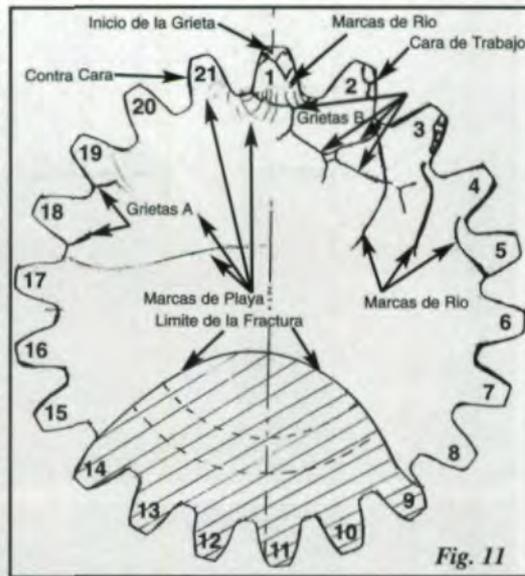
Fig. 11—Pinion fracture face. Mating surface shown in Figure 12.

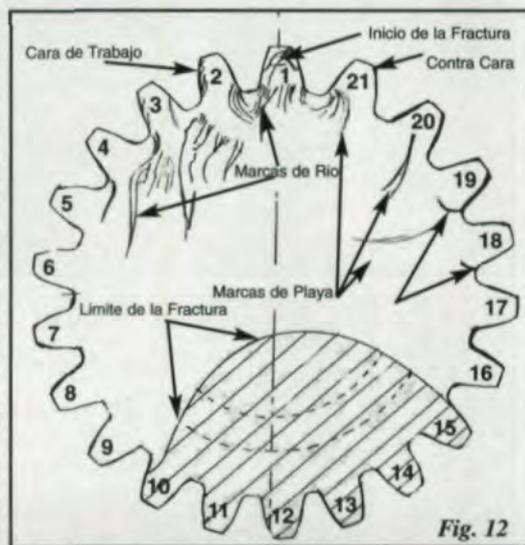
Fig. 12

Fig. 12—Pinion fracture face. Mating surface shown in Figure 11.

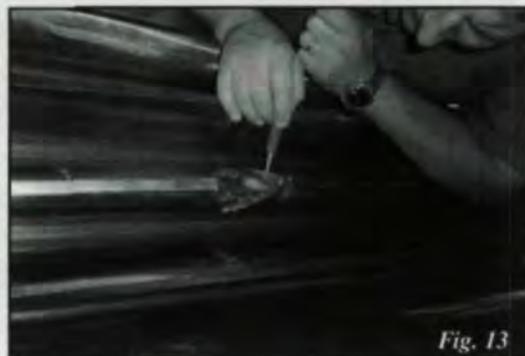
Fig. 13

Fig. 13—Fractured pinion after removal. Note the large piece fractured from one tooth.

will occur in a localized region of the face width, biased to the more highly loaded end but also uniformly dispersed on most or all teeth. The surface failures observed on this pinion were highly localized, as Figure 13 shows.

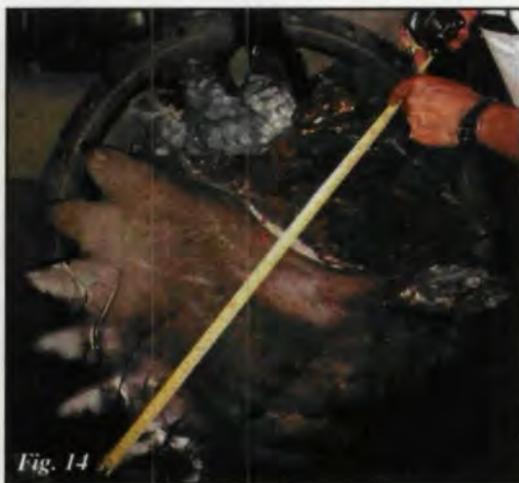
The pinion was cut through the remaining shaft section to render the fracture faces visible. Figures 14 and 15 show the fracture faces after shaft sectioning. In Figure 14, the darker region in the upper right of the photograph is the section that was cut through to reveal the fracture face, which

Fig. 14—Pinion fracture face corresponding to Figure 12.

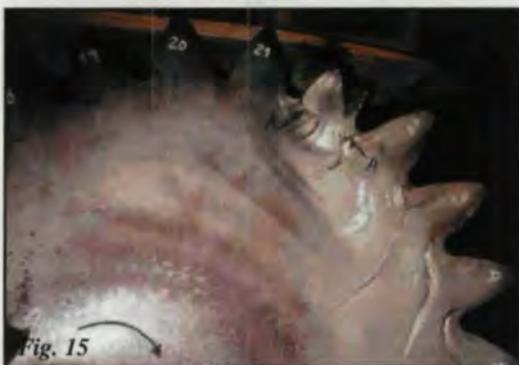
Fig. 15—Pinion fracture face corresponding to Figure 11.

is the smoother surface at the lower left of this photograph. It is clear from these figures that the origin of the crack network is in the tooth region identified by the arrows shown in Figure 15.

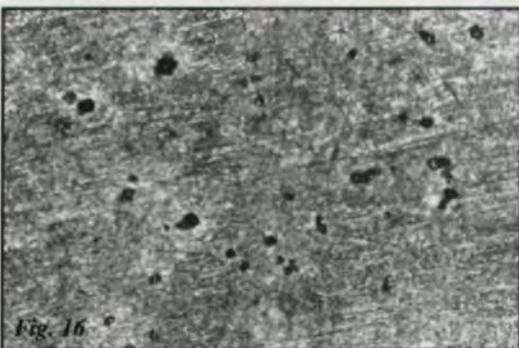
Fig. 16—Inclusions that were found in the fracture origin region.

Once polished and etched, these sections revealed the presence of large concentrations of inclusions, as Figure 16 shows. These inclusions were widely distributed in the region where the cracks originated. Such inclusions are, of course, impurities in the basic steel forging. The effect of inclusions on the capacity of the gear depends very much on their location.

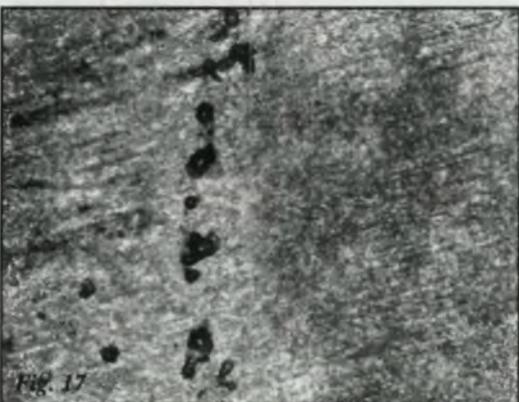
Fig. 17—Inclusions clustered in a longitudinal pattern.

Of even greater significance is the situation which occurs when inclusions occur in clusters, as Figure 17 shows. These clustered inclusions form a very large stress concentration and can adversely affect both the surface load capacity and bending fatigue strength of the teeth. When clustered, the negative effect of an inclusion is magnified many times over.

It was a group of inclusions, such as the ones shown in Figure 17, which caused the failure of this pinion. Specifically, the clustered inclusions were located below the surface but within the high stress region. As Figure 18 shows, the fracture passed through the pitted region. The pitted

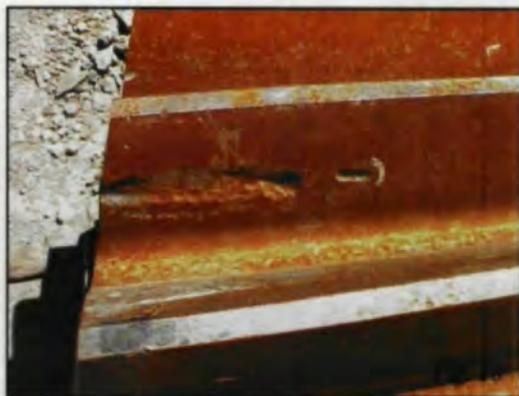
region itself, however, did not propagate in any significant manner as is also obvious from Figure 18. Early in the life of the part, inclusions contributed to the occurrence of the odd pitting pattern, which was originally ascribed solely to over crowning. It is likely that over crowning may also have played a role by further concentrating the stresses in this weakened area; however, it is not possible to determine with certainty what the proportional effects were. It is likely, however, that the inclusions were the major factor.

In Figure 18, note that the tooth before and the tooth after the pitted tooth in the center of the photograph are both essentially free of pitting. Since crowning (normal or excessive) would be essentially uniform on all teeth but the distribution of material defects such as inclusions is always nonuniform, the lack of distress on some teeth indicates that the inclusions are, in fact, the driving factor.

Fig. 18—Crack passed through pitted region. Note that the teeth before and after the pitted tooth are both free from pitting.

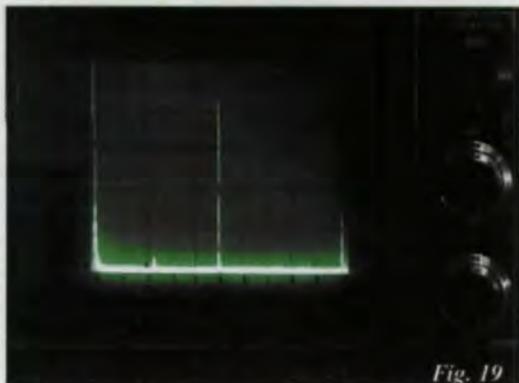
Fig. 19

Fig. 19—Ultrasonic indication of subsurface defect in a gear forging.

ed by a properly conducted UT inspection. For example, Figure 19 shows the result of a UT inspection of another forging which did exhibit a subsurface indication. It is important to note that this figure is provided for demonstration purposes only as this forging was not evaluated metallographically to define the cause of the indication. UT inspections should always be required for all critical pinion and gear blanks.

All critical forgings should be ultrasonically inspected to detect subsurface material defects before detail machining is started. In addition, material specifications for such gears should include cleanliness requirements and a definition of testing which will confirm the cleanliness rating. The use of vacuum degassed materials will also help to minimize the chance of a subsurface defect adversely affecting the load capacity or life of the finished gear. ⚙
