Gearbox Field Performance From a Rebuilder's Perspective

Charles D. Schultz

This paper was presented at the 1999 Fall Technical Meeting of the American Gear Manufacturers Association.

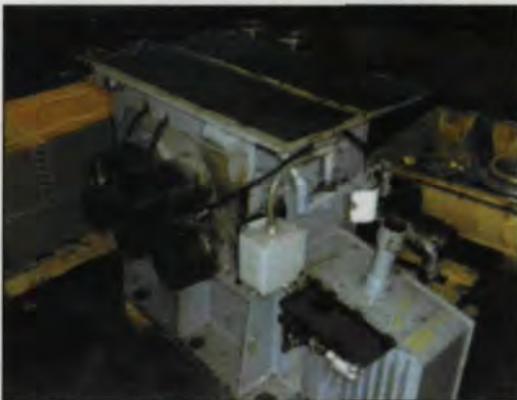
Figure 3—Oil level sensor.

We've also become believers in "low oil level" sensors. (See Figure 3.) Originally wary of putting delicate electrical devices in the rough-and-tumble mill environment, observing a plant start-up where the only gearboxes run "dry" were the only ones without the sensors was convincing evidence of their value. We've also been increasing the "robustness" of the external lubrication plumbing used on both new designs and rebuilds. Lube lines apparently make excellent ladders for climbing, serve as emergency crane hooks and are easily snagged by passing loads. One of our customers now has us fitting his more susceptible gearboxes with guards made of 0.25-in. plate to protect them from damage. (See Figure 4.) For most pressure lines, we've switched to high-quality hydraulic hose after discovering that even the bravest mechanic won't use them for a step or a lift point. (See Figure 5.) So far, the customers have been very accepting of that change, especially when they realize it is much cheaper to make a new hose than it is to repair a damaged pipe.

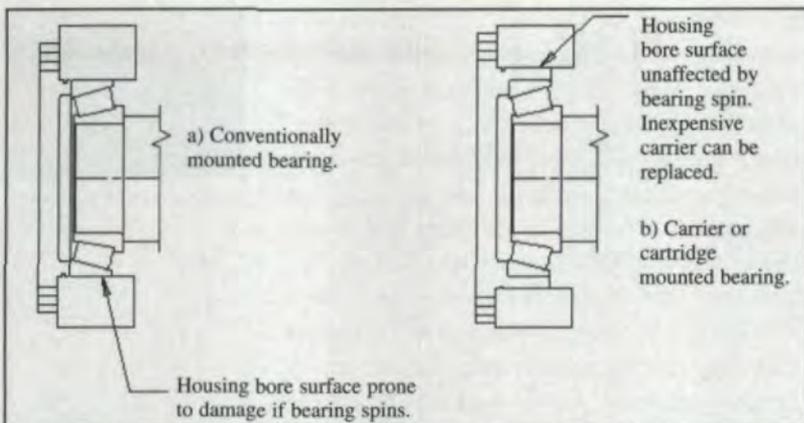
Figure 6—Bearing mounting for extended service life.

ly reduced both their maintenance staffs and their spares inventories. Among the most distressing problems we have to deal with on a regular basis is the housing bore damaged by a "spun bearing." (See Figure 6a.) Repairing a damaged housing is very time consuming and costly, especially on special units with multiple split lines or a divided power path. The AISE heavy-duty crane specification (see AISE Technical Report 6, June 1996) requires that bearings be mounted in replaceable cartridges (see Figure 6b) due to the difficulty in removing the housings from their lofty perches for re-machining. Superintendents faced with expensive in-place machining of gearbox housings grouted into the floor quickly make sure future purchase specifications follow the AISE's example. Except for bearings that must float axially, it might be worth studying the effects of tighter outside diameter fits on most housings. Where possible, anti-rotation pins (see Figures 7a and 7b) seem to be quite effective.

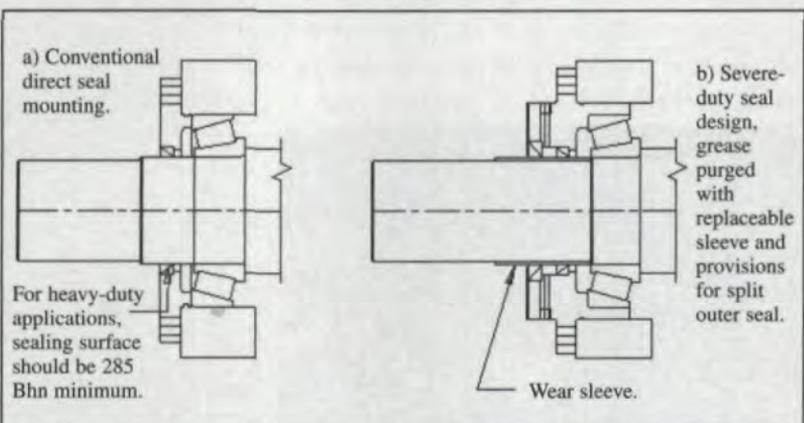
Figure 8—Seal designs for extended service life.

Some of the lubricant loss experienced in the mill can be traced to worn seal diameters. Many output shafts are made of material that has not been heat treated. Consequently, those shafts have soft seal diameters, which wear out rather quickly. After-market wear sleeves have proven to be quite effective in fixing that problem, although the units have to be removed from their mountings and stripped of their couplings to

install them. Coupling removal occasionally causes enough additional damage to the shafts to necessitate their replacement anyway. We recommend that seal diameters be at least 285 Bhn on all shafts unless wear sleeves are fitted. (See Figures 8a and 8b.) Chrome plating or induction hardening is preferred by some customers, although those processes add to the turnaround time. For severe-duty "wash down" environments, special seals, such as packing glands, are well worth the extra expense.

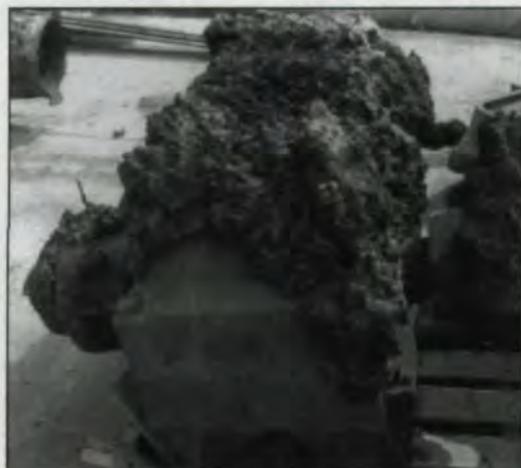
Figure 9—Example of miscellaneous damage.

5. The "Miscellaneous" category includes physical damage to the gearbox by external sources, leaks not related to seals, hand-of-assembly changes, coupling changes and modification requests (See Figure 9).
