Longitudinal Tooth Contact Pattern Shift

J.B. Amendola, J.B. Amendola III and D. Yatzook

Management Summary

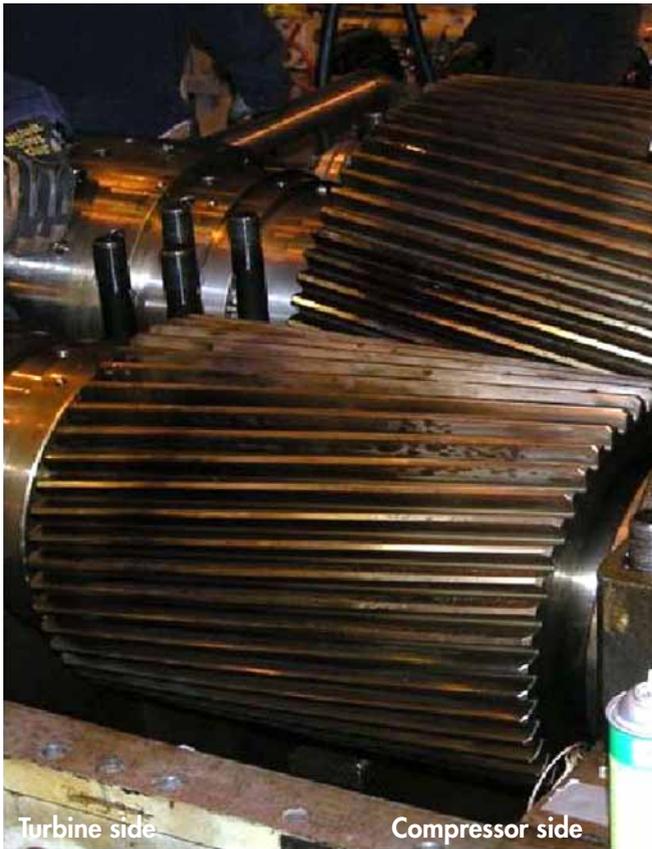
Figure 5—Varnish deposits on gear teeth.

ber of years. When a contact shift was observed, oftentimes heavy varnishing of the lubricant on the gear teeth in the vicinity of the contact face was noted in the area of the highest temperature gradient (Fig. 5).

Encourage periodic shutdown inspections, allowing the gear teeth to be cleaned of any varnish deposits according to the manufacturer's recommendations.
