# Metallurgical Investigation of “Tiger Stripes” on a Carburized High Speed Pinion

“Tiger stripes” on a high-speed pinion made of a carburized SAE 9310 steel were investigated. The morphology of the damage was typical of electric discharge damage. The cause of the stripes and potential damage to the gear tooth were analyzed and are presented in this report.

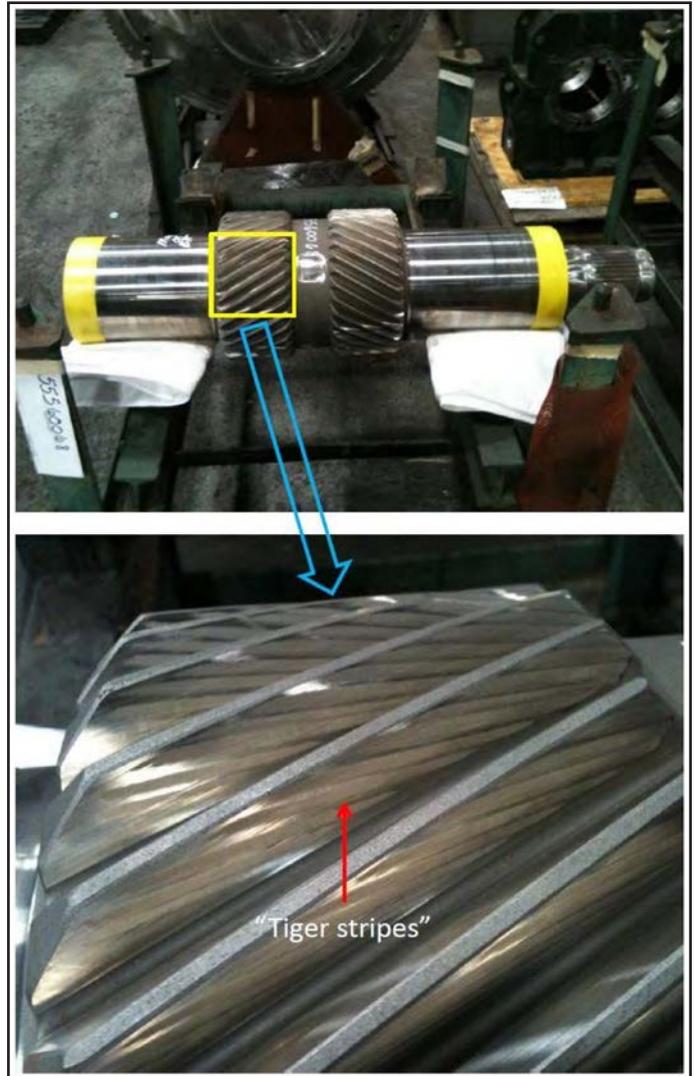
Figure 1 Tiger stripes on the pinion.

Figure 1 shows the tiger stripes on the pinion. These stripes appeared to be along lines of contact of one (load) side of the pinion teeth and distributed at different rotational positions of the pinion. Also, it was noted that the tiger stripes occurred on the pinion only; the mating gear didn't show any stripes.

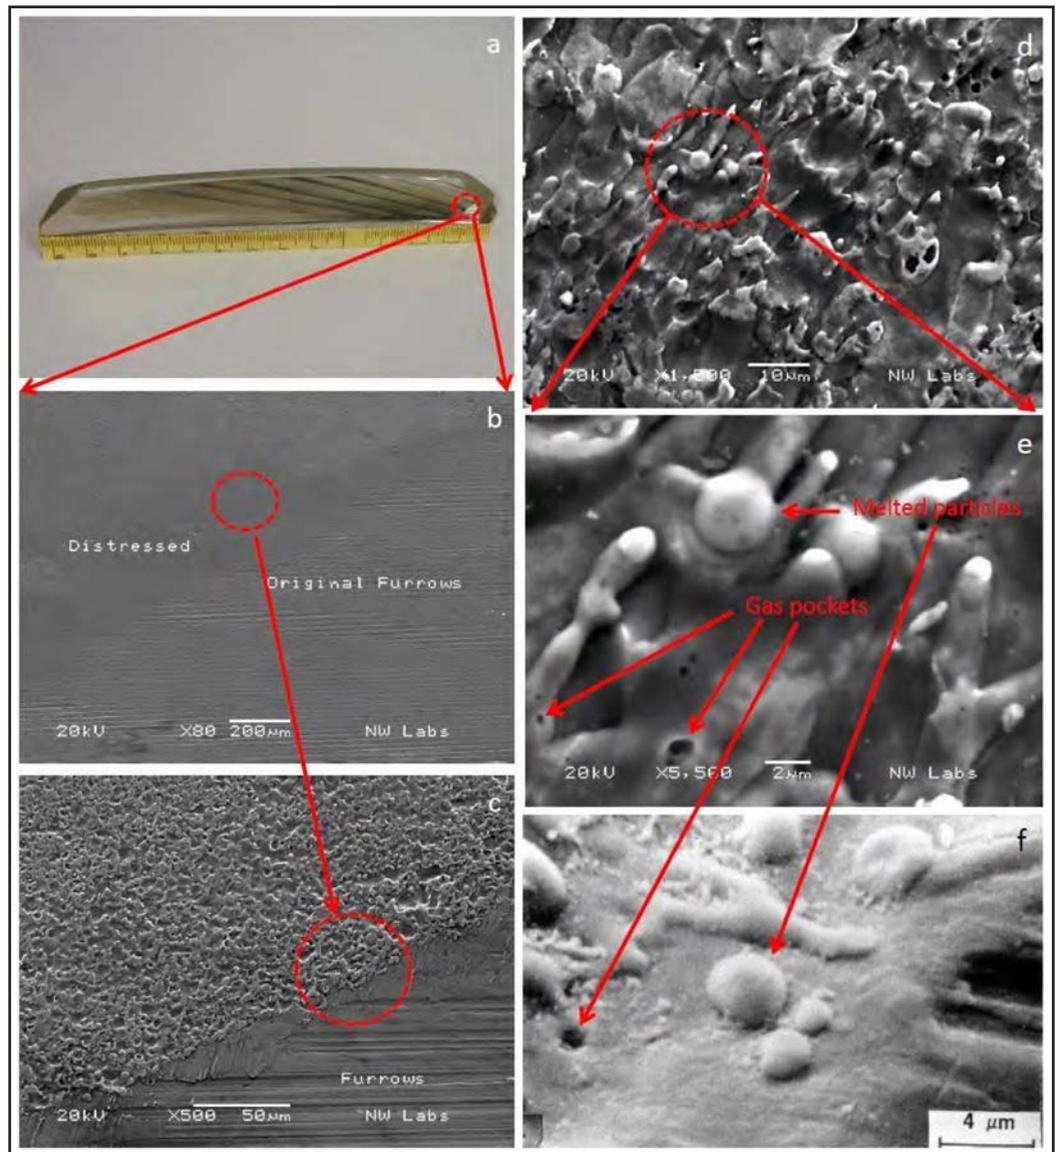
The SEM showed clearly that each stripe was composed of a high density of craters (Fig. 2c). Under higher magnification it revealed these craters were caused by electric discharge, indicated by the typical fused metal particles and gas pockets (Figs. 2d and 2e). The particles were about 1-3 micron in diameter. For comparison, Figure 3f is cited from ANSI/AGMA 1010-E95

Figure 2 Morphology of tiger stripes revealing electric discharge: a – e were taken from the sample; f is cited from ANSI/AGMA 1010-E95. Note they are under different magnifications, as indicated by scale bars.

as an example of electric discharge. Figures 2b and 2c show the original machining marks outside of the tiger stripes.

It should be noted that this tiger stripe pattern is different from normal electric discharge. While the latter shows random spots on the gear tooth, tiger stripe takes on regular patterns. Obviously, these stripes came from periodic discharge between the mating flanks. Although some composite bearings have been introduced to minimize this type of damage, proper operating grounding such as brushes is still considered to be the best solution to prevent this from happening (Ref. 3).

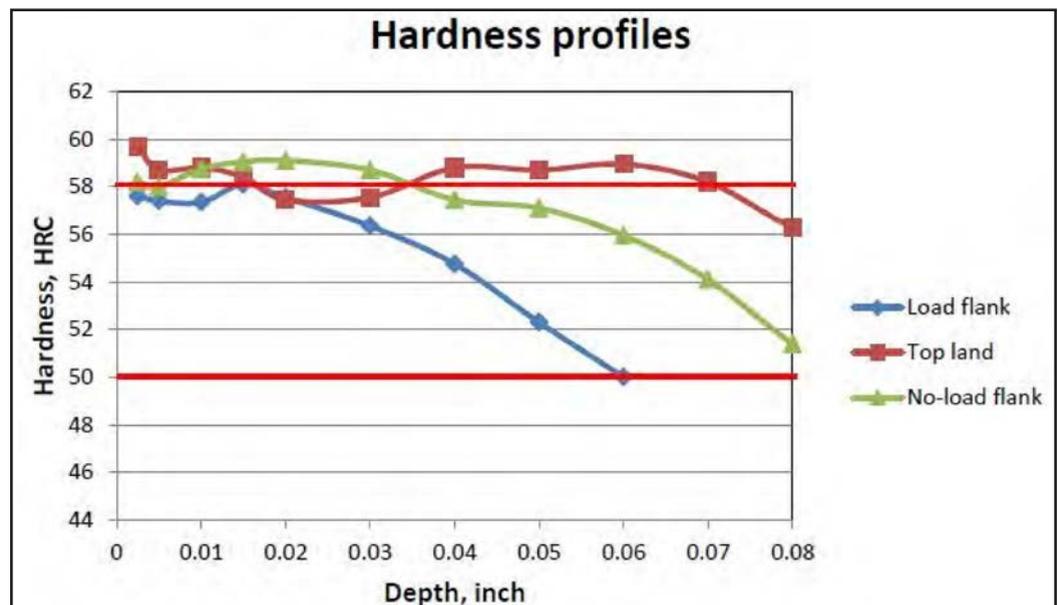
Figure 3 Case hardness profiles of the pinion tooth.

In order to evaluate the extent of damage caused by electric discharge, one pinion tooth was sectioned for microhardness profile checks across the gear flanks (load and no-load sides), and the top land from the surface to the hardened case depth (Fig. 3).

The load flank hardness profile revealed that although the depth between the surface and the location where the hardness number is 50 HRC reached 0.060" and is deeper than the specified minimum effective case depth (in this case 0.036"), both the load flank and top land lost some hardness below the surface due to the tiger stripes—especially on the load flank of the teeth. For example, the hardness was only 57.6 HRC on the load flank surface, which is lower than the required minimum 58 HRC. This made the pinion soft and lowered its contact fatigue resistance. As a matter of fact, except at 0.015", its hardness is lower than 58 HRC at any other depth. Even the top land showed some degree of hardness drop. The tiger stripes had the least negative influence on the no-load flank of the pinion teeth. Since the original manufacturing records show that the surface hardness on any flank of the pinion was 59 - 60 HRC, the hardness loss of the inspected pinion was due to the tiger stripes; i.e., electric discharge.

The hardness profiles exhibited hardness loss due to the tiger stripes. The load flank surface hardness was even lower than 58 HRC, the minimum hardness required by the AGMA standard. SEM analysis revealed that these stripes were electric discharge defects. The electric discharge generated very high local temperature and local melting of the pinion teeth. As a result, some areas of the pinion were re-tempered at high temperature. This gave rise to lowered hardness and jeopardized the contact fatigue resistance. Furthermore, as the surface hardness is lower than 58 HRC, the original gear rating is not valid. It is recommended that a new pinion should be manufactured to replace this damaged one if the user wants to keep the initial rating.
