# The Effect of Start-Up Load Conditions on Gearbox Performance and Life Failure Analysis, with Supporting Case Study

R. J. Drago

## Management Summary

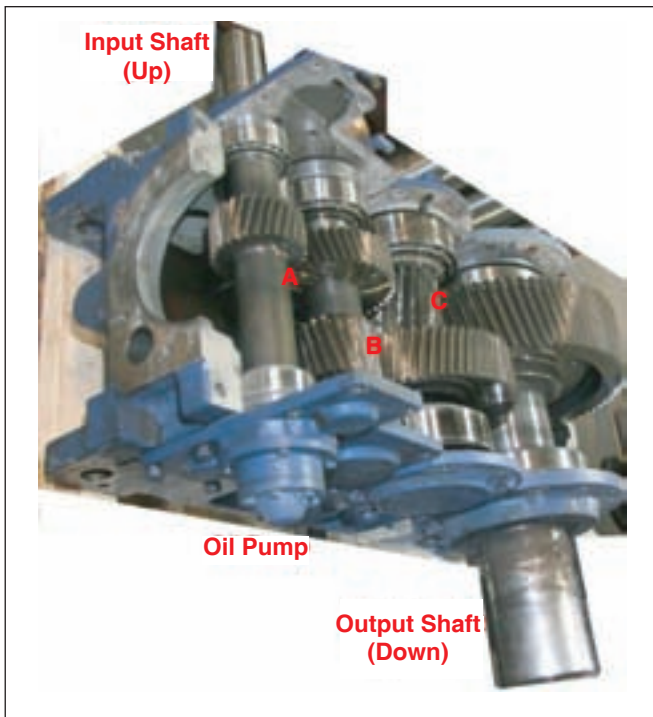
A failure was reported in the low-speed gear set of a triple-reduction, single-helical gearbox (Fig. 5). The gearboxes are used in an air-cooled condenser (ACC) facility at a power plant, and had been in service for about four years at the time this investigation was initiated.

Figure 5—Triple-reduction gearbox (shown in normally installed attitude).

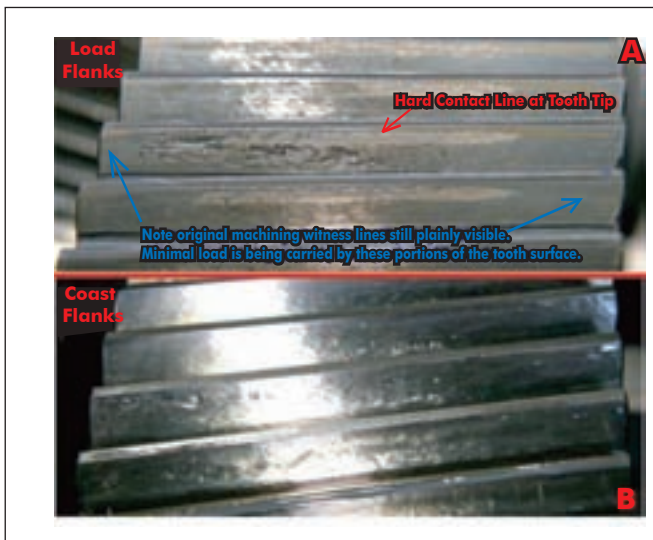
Figure 6—Low-speed gear.

Initial evaluation of the gearbox indicated that the primary damage was on the low-speed gear set. The high-speed and intermediate gear sets did show some damage, but it was largely inconsequential. The low-speed gear (Fig. 6), exhibited a very hard line of contact near the tip of the tooth. This hard, localized region of contact indicates that the tooth did not have sufficient profile modification for the applied loading. The shape of the damaged area suggests that the gear set had some crowning (probably applied to the pinion) to accommodate misalignment. The damage pattern observed on the gear tooth-loaded flanks, however, is slightly heavier on the left end of the face (Fig. 6). The relatively short area of damage indicates that the crown applied to the low-speed gear mesh is likely too large for the applied loading. This tends to concentrate the load in the center portion of the face while unloading its ends. This increases the localized stresses in the heavy-contact region. This is very apparent on the loaded tooth flanks shown in Figure 6.

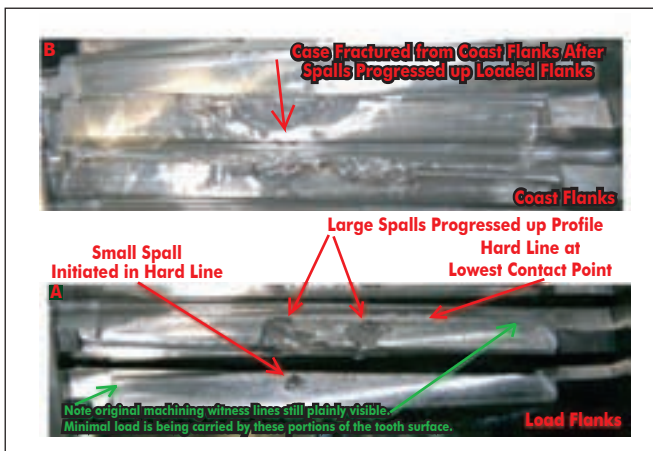
Figure 7—Low-speed pinion.

The location of the damage observed on the low-speed pinion (Fig. 7) corresponds to the damage observed on its mating gear. However, the level of damage on the low-speed pinion is much more severe than that on the mating, low-speed gear. Since the pinion sees many more cycles than the gear, the disparity in the level of damage is expected. The location of the very hard line of contact near the tips of the gear teeth corresponds closely to the similar hard line of contact at the lowest contact point on the pinion teeth. As noted above, this hard contact indicates a lack of adequate profile modification

The specific failure mode observed on the pinion is spalling, or surface durability distress. Specifically, spalling is a fatigue mechanism that occurs when very high, local stresses initiate cracks at or near the tooth surface. These cracks progress into the hard case on the tooth surface and progress up along the tooth surface, from the lowest contact point, in the direction of sliding on the tooth surface. As the cracks progress, material on the tooth surface is undermined, and eventually relatively large, somewhat fan-shaped pieces of tooth surface are liberated. This mechanism is clearly shown in Figure 7. As the cracking progresses through the carburized case on the loaded flanks of the teeth, it eventually propagates across the tooth thickness—generally fairly close to the tips of the teeth—and fractures the entire case off the tooth, even extending back onto the coast flanks. Essentially, the carburized case is “peeled” from the loaded and unloaded tooth flanks. (More detail on this failure mode is presented below.)

Careful evaluation of the failed pinion (Fig. 7) shows that it did not suffer a pitting failure at all, but rather a spalling failure induced by very high loads at the lowest contact point on the pinion. Note that the damage on the tooth shown in Figure 10 occurs mainly away from the lowest point of contact, and generally in the midsection of the tooth height. This is the typical appearance of classical gear tooth pitting. Conversely, the spalling damage shown on the pinion in Figure 7 starts at the very bottom of the contact zone—in the region of the hard line at the bottom of the tooth—and progresses upward along the tooth profile. This difference is especially significant regarding the remedial actions that are practical for this gear system, as will be explained further below.

The low-speed pinion also exhibits considerable damage on the coast flanks of the gear teeth (see the top portion of Figure 7). This damage, too, is characteristic of spalling that has progressed to catastrophic failure. To better understand this mechanism, Figure 12 shows a photomicrograph of the cross section of a tooth that has experienced a spalling failure. The cracks—“a”—initiate at or near the surface (Figure 12A) and propagate at an acute angle into the tooth and up along the profile in the direction of sliding. After cracks “a” have propagated sufficiently, the tooth surface is undermined locally, and a relatively large piece of the tooth surface breaks away as the crack “b” progresses to the tooth surface (Fig. 12B). This results in the liberation of relatively large, generally flat chips of tooth material (pitting debris, in contrast, is relatively fine, roundish, small particles) and the characteristic fan-shaped appearance of the damage on the tooth surface (Fig. 12C). As the cracking “a” and “b” progresses, the damaged region on the tooth surface grows ever larger, and the remaining, undamaged, surrounding tooth surface is subjected to ever-increasing unit loads (as the damaged surface spalls away, the remaining surface must carry the full load; thus the unit loading applied to the remaining sound surface increases).

completely stripped from the gear. The spalling on the low-speed pinion progressed completely up the loaded flanks (Fig. 7A), wrapped over the tooth tip and down the coast flanks (Fig. 7B). As a result, the low-speed pinion teeth were close to complete tooth fracture and, ultimately, total loss of torque transmission capability.

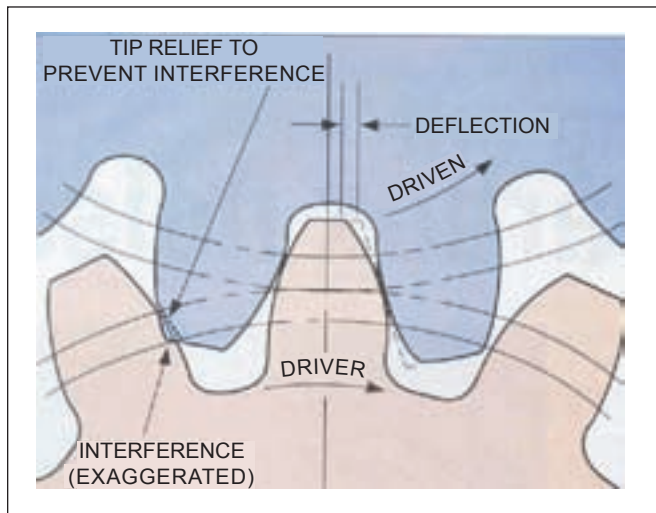
deflections, which cause very high loads to exist locally as the tip of the gear makes contact with the pinion. This condition is shown schematically in Figure 8.

Figure 8—Tip interference due to tooth deflection causes high local loading at lowest contact point.

These very high starting torque levels cause the involute interference shown in Figure 8, which leads to the spall initiation and progression observed on the low-speed gear set. If these high starting loads are applied very infrequently, they will not significantly reduce the expected life of the gears. If, however, they are applied very frequently—as appears to be the case for the subject drive—they can lead to extremely premature failure of the gear system, as we seem to be observing here.

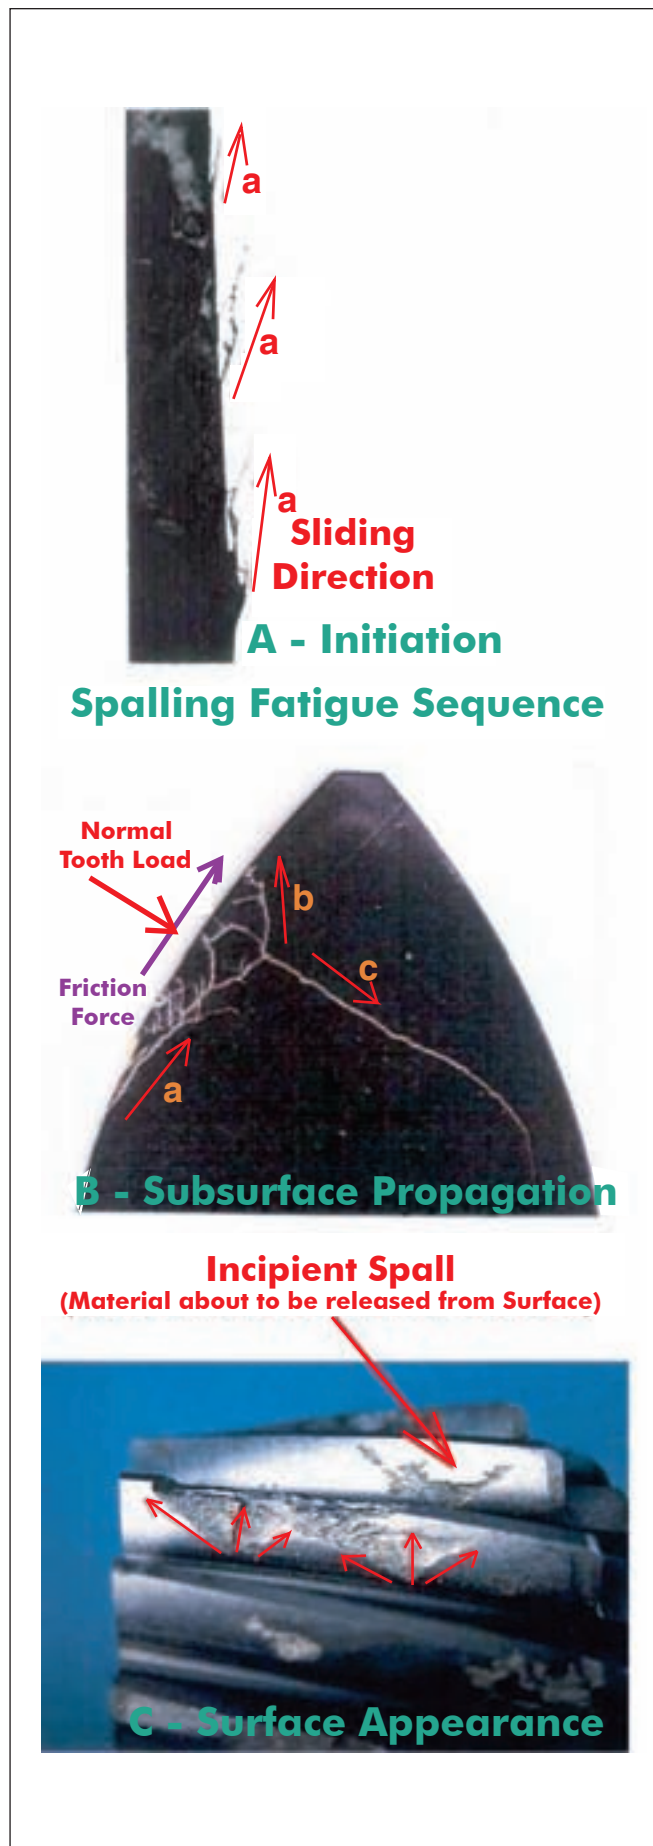
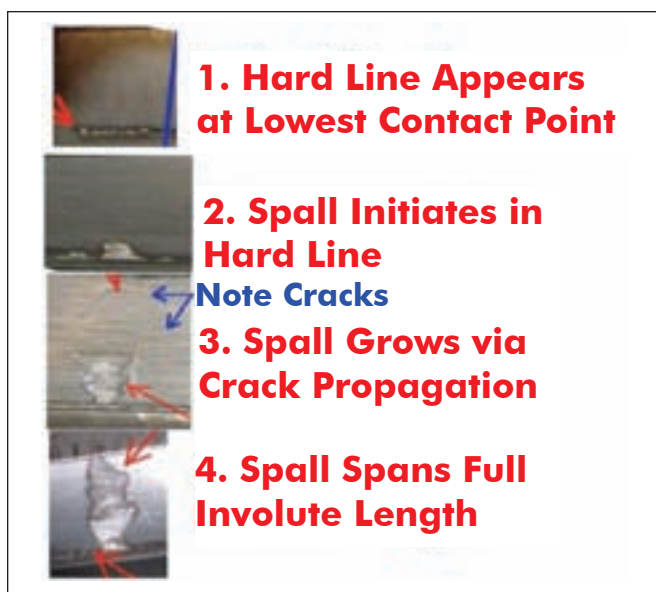
As previously noted, spalling is due, among other causes, to inadequate or improper involute profile. The specific nature of the progression of a spalling failure from initiation to complete failure is shown in Figure 11. It is important to note that the very first sign of spalling failure is a relatively innocuous hard line in the region of highest loading, deep in the pinion tooth root. This initial damage is very difficult to see (Figure 11 is shown at high-magnification; thus the damage is obvious). It is possible for the initial stages of spalling to go undetected by a casual observer. The early stages may only be apparent to an experienced, skilled gear engineer. This is an important consideration for Site B (peaking plant), as those gears are subjected to far fewer start-stop cycles, and thus may be in a much earlier stage of progression.

As is the case with the low-speed pinion shown in Figure 7, the initiation of the spalling failure shown in Figure 11

Figure 11—Typical spalling failure progression.

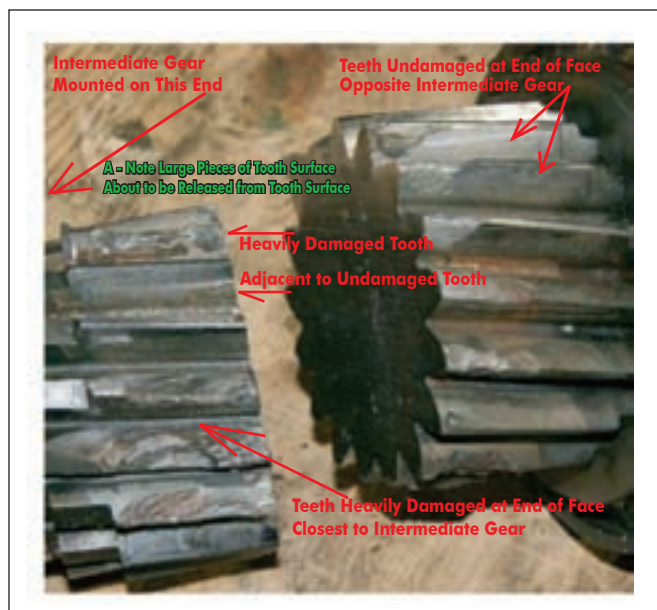
In order to be sure that our observations on this low-speed gear set were typical of the failures that have occurred on these gearboxes, rather than an isolated incident, we examined another failed low-speed gear set that was selected (by others, randomly) from the “stock” of failed gear sets. A section was removed from approximately the center of the face width of this low-speed pinion (Fig. 13), for laboratory examination.

Figure 13—Second low-speed pinion. (Photo taken after section removed for laboratory analysis.)

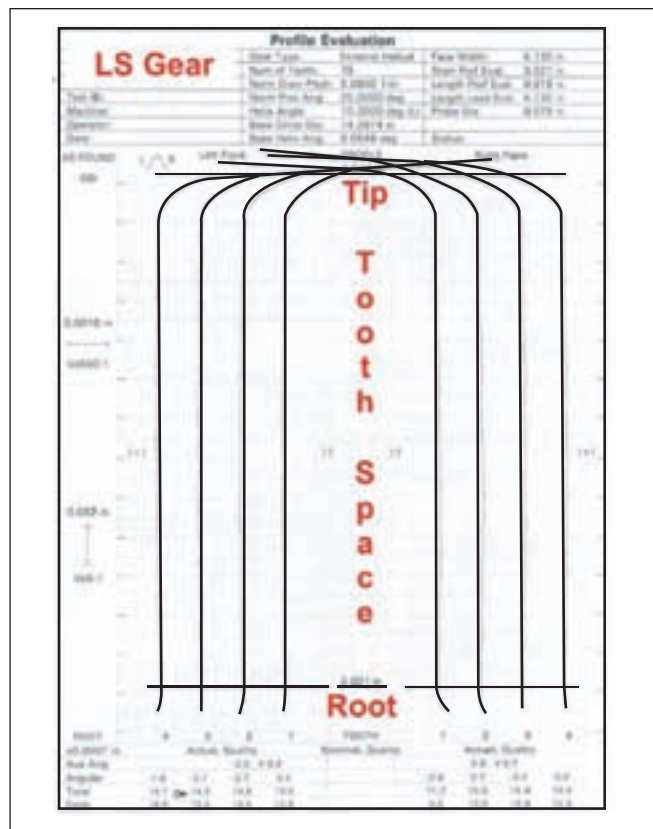
Because the failure scenario clearly points toward inadequate profile modifications in the presence of high tooth deflections, we had a local vendor conduct a complete inspection (i.e., lead, profile, pitch and pitch diameter runout) of a new, OEM, low-speed gear set before it was installed as a replacement for the damaged, low-speed gear set described above. Of these inspections, the involute chart of the low-speed gear, Figure 15, is of most interest.

This chart shows the gear involute profile to be virtually straight, with no profile modification (the sharp drop-off at the tooth tip is more chamfer than actual tip relief).

The very straight involute chart on the low-speed gear at its tip, combined with the very straight involute chart of the pinion at its flank would, under sufficient load, generate the hard line that was observed at the root of the pinion (Fig. 7). At this critical contact point, there would be about 0.0014 inch of interference due to the total tooth deflection (Fig. 9). Under starting loads, which would be significantly higher than normal operating loads, the amount of interference would be substantially greater.

Figure 15—Low-speed gear involute chart.

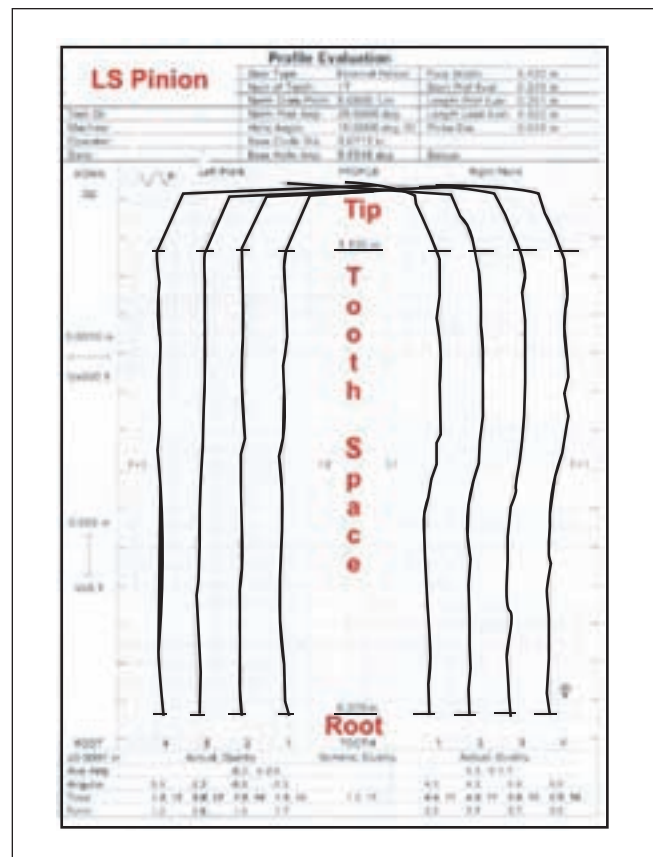
The involute chart of the pinion (Fig. 16) shows very similar characteristics. While the pinion does have a very slight amount of tip relief, the flank is completely straight.

Figure 16—Low-speed pinion involute chart.

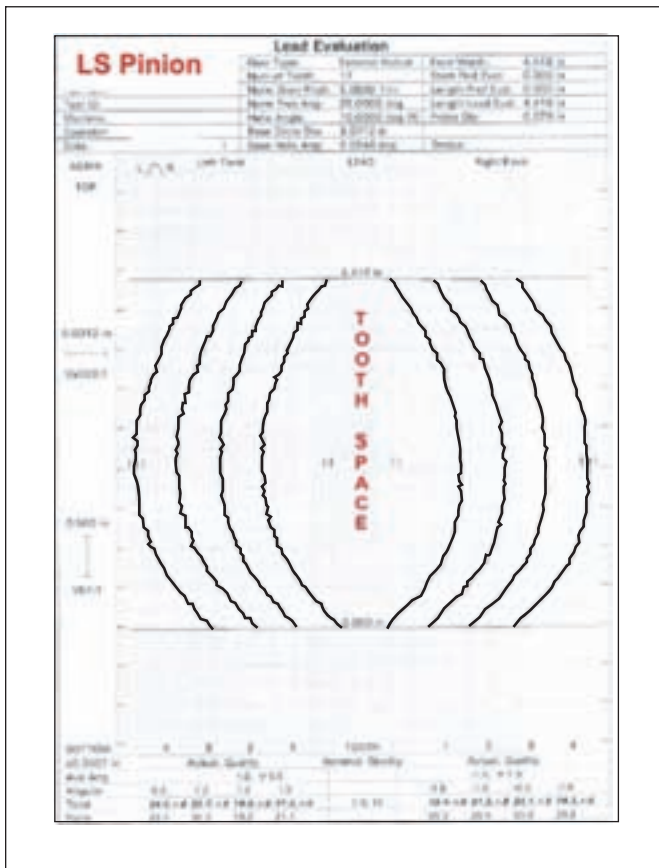
As noted earlier, the low-speed pinion also appeared to be over-crowned. The lead chart shown in Figure 17 shows this condition as well. Crowning is a very valuable feature, and should be included in any gearbox in an application where some supporting structural deflection can reasonably be expected. This is certainly true of the framework in which these gearboxes are mounted. In addition, some misalignment can also be expected from internal sources, such as bearing clearances and shaft deflections. Still, the amount of crowning and the offset of the crown must all be carefully designed for the specific application. In this case, the crown applied was slightly excessive for the conditions encountered. While this is contributory to the failures observed, it was not a major driving factor.

Figure 17—Low-speed pinion lead chart.

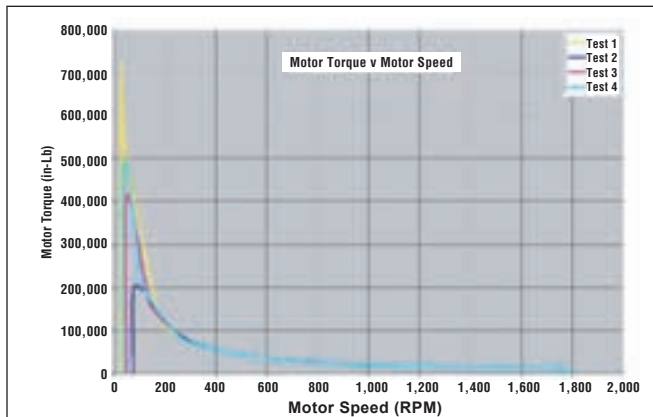
Figure 18 shows the instantaneous motor torque applied to the gearbox during the motor engagement, while Figure 19 shows the instantaneous motor power delivered to the gearbox during the start cycles measured.

Although the motor comes up to speed relatively quickly, this data shows that during this short period of time, very high torque levels are applied to the gear system. Since the system was not started from zero speed during this testing, we still do not know what the actual “start from zero speed” load would be, but we can make a projection using the data available to us. In order to do so, we plotted starting torque as a function of system speed at engagement (Fig. 20).

Figure 18—Instantaneous motor torque applied to the gearbox during start-up.

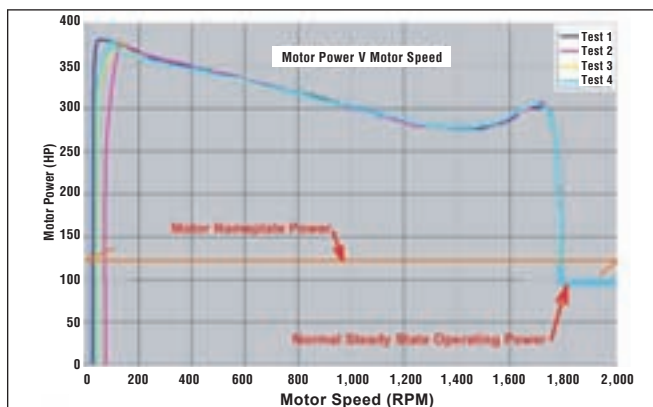
Figure 19—Instantaneous motor power applied to the gearbox during start-up.

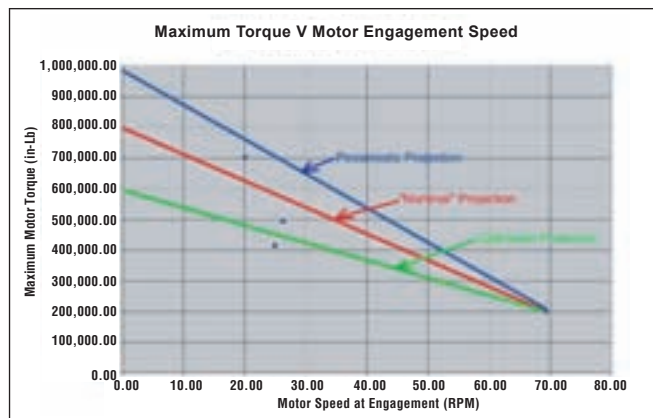
We also plotted three straight lines on this figure to represent the most pessimistic (blue), the most optimistic (green), and “nominal” (red) projections to a zero engagement speed starting torque level. (While we have plotted a straight line for simplicity, the actual starting torque will be somewhat exponential, but we do not have enough data to make a better projection at this time. In any case, the data does provide good

insight into the basic operation of the system.) It is possible, but very unlikely, that the zero speed engagement torque might be represented by the pessimistic blue line in Figure 20. We believe that the real value would be somewhere between the most optimistic (green) and the nominal (red) lines. In any case, however, the starting torque is very much higher than the nominal, full-speed running torque provided by the motor. While it is not possible to predict the exact zero engagement speed from the small amount of data available, the data does show that, by any estimate, the start-up loads are very much higher than the operating loads.

Figure 20—Motor torque vs. motor speed at engagement.
