# NASA

## GETS DOWN AND DIRTY FOR SARJ SOLUTION

Jack McGuinn, Senior Editor

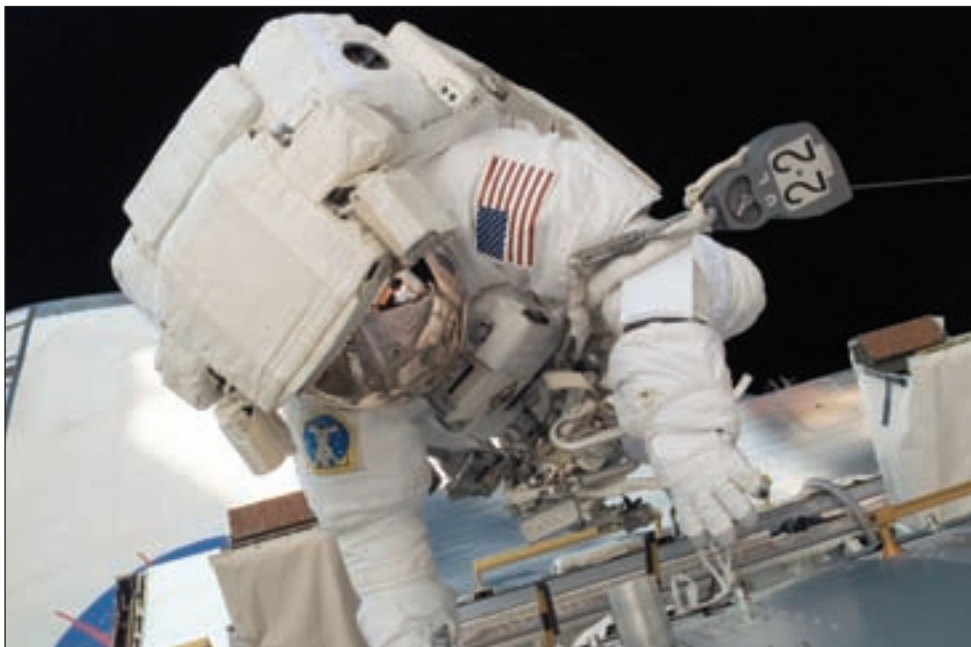
This recent spacewalk from the ISS included collection of grit from the faulty SARJ rotary joint for further analysis on the ground upon the latest mission's return to earth.

There has been progress, however, in that NASA has identified the problem to be a roller surface failure in one of the trundle bearing assembly (TBA) raceways and rings. More specifically, the “culprit,” as Johnson Space Center's Kevin Window—SARJ Recovery Team Leader—calls it, is a concentration of metallic grit, or debris, in the raceway that is causing undue vibration and is impinging upon the joint, preventing its free movement. As for the root cause of that, it remains a mystery, although Window's team believes it is on track to solve it. To do so, they have been relying on very high-resolution photos and grit samples from ISS team members in order to conduct their testing. One testing drawback, however, is the inability to replicate on the ground what is going on in space. But progress is being made, nevertheless.

“The vast majority of debris we found (in the samples) was nitrided 15-5 (steel),” says Window. “What that tells us

at this point in time is that something caused us to crack (or spall) that top layer (outer-canted surface) of the raceway.”

There was some confusion at one point in which one of the ISS astronauts, after an in-space inspection, referred to the grit-affected area as a “raised surface,” as opposed to a “depression,” which it was originally thought to be by personnel on the ground.

“That gave us concern, because a depression is a whole lot different than a raised surface,” says Window. “We had a large contingent of folks that expected it to be a depression, but it is a raised surface on the raceway surface. It is concerning because what we discovered during our (pre-mission) testing is that nitride 15-5 is very hard, but it is also very brittle once you start cracking it.”

In order to try and minimize the grit issue short term, an ISS astronaut applied a lubricant to the affected surface. The result was less unwanted friction in the raceway surface, but that led to discovery of another problem—misalignment in the trundle bearing.
