Flank Breakage on Gears for Energy Systems

Erwin Bauer and Arne Böhl

(First presented at the VDI International Conference on Gears, October 2010, Technical University of Munich)

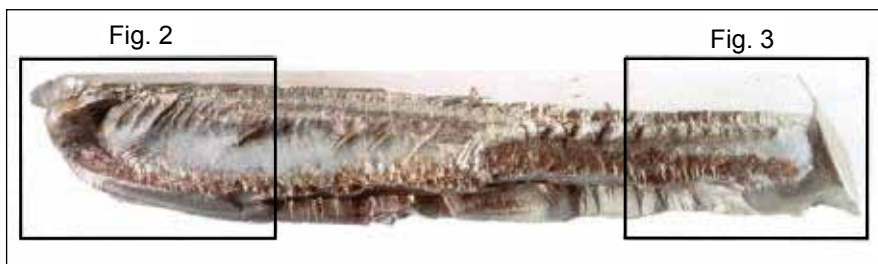
In contrast to the known classical tooth damages shown in Reference 1—where the damage starts at the surface—in this presentation the flank breakage—i.e., the primary crack starter—is found in the volume of the tooth; it propagates as a fatigue crack in vacuum towards the surface of the load flank—as well as into the core of the material. The problem of flank breakage in high-performance gears was presented in 1997 (Ref. 2). What follows here are new findings.

Figure 1—Fragment of a pinion tooth.

halves in the rear of the gap. The broken piece is situated at the turbine-side tooth half over about 30% of the tooth width.

In the middle of the fragment, the fracture surface is distinguished by a planed, finely structured surface. Towards the load flank and the lower boundary (Fig. 1), this surface is surrounded by a border comprised of fretting and fractured surface parts arranged in a terrace shape. At both ends of the fragment (Figs. 2–3), arrest lines can be detected with a local direction of crack propagation—to the left in Figure 2; to the right in Figure 3. Therefore, it can be concluded that the fatigue crack starts in an area between Figures 2 and 3 and propagates along the tooth width in both directions.

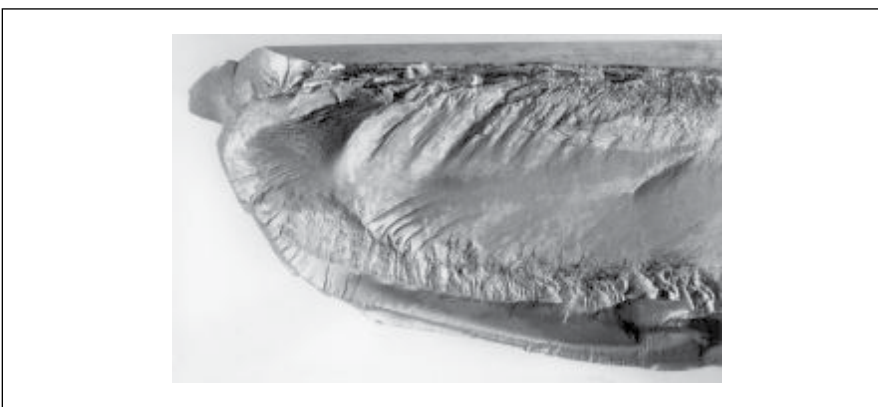
Figure 2—Section of Figure 1—left.

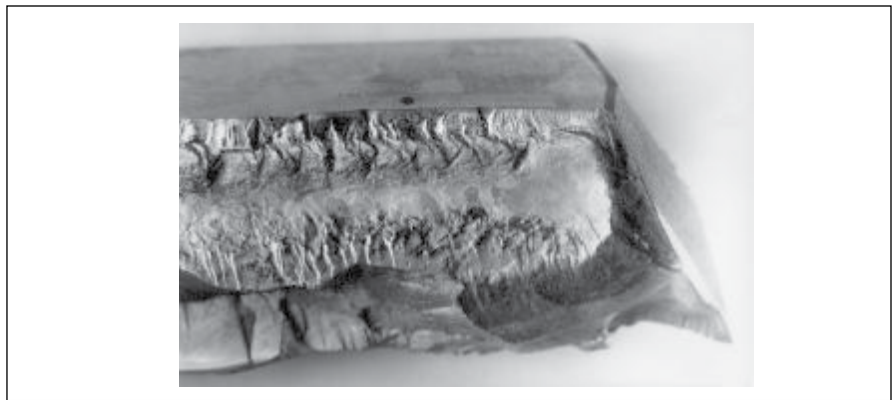
Figure 3—Section of Figure 1—right.

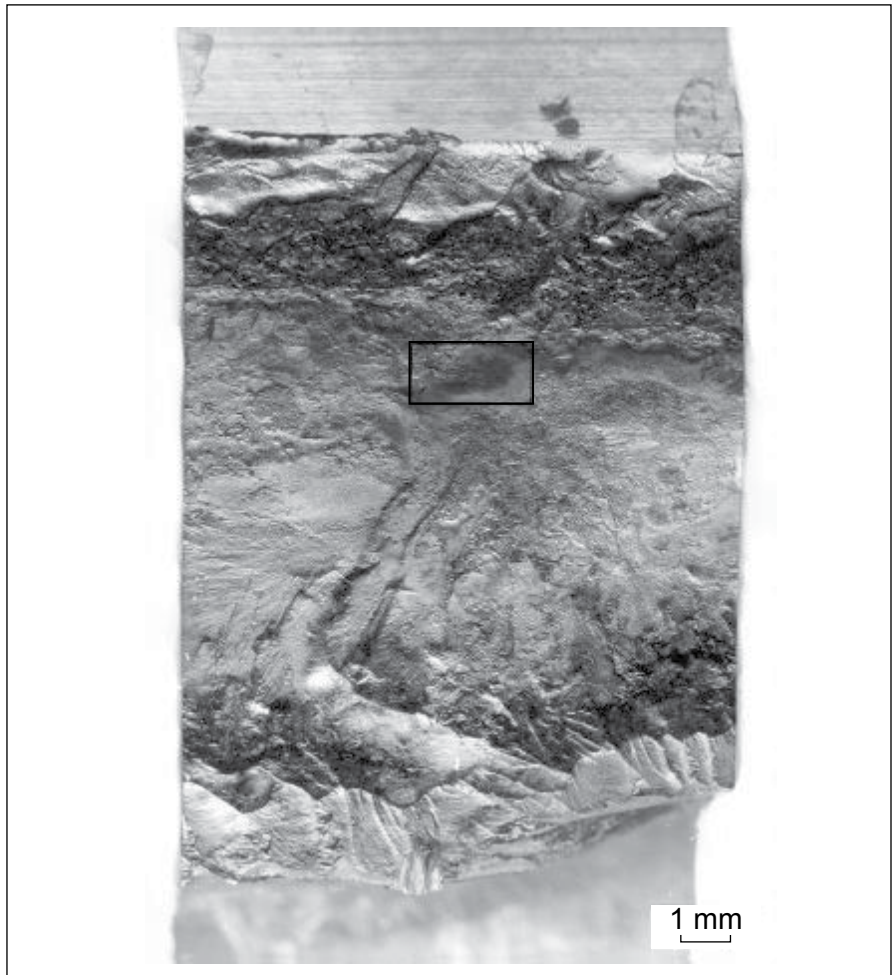
The area with the primary crack starter is shown in Figure 4; the crack initiates from the marked region. The investigations of the primary crack starter with the SEM (scanning electron microscope) provide, in general, no suitable information because the fracture surface is—as a secondary effect—strongly deformed. Therefore it is necessary to prepare a microsection through the crack starter.

Figure 4—Position of the crack starter *PR*.

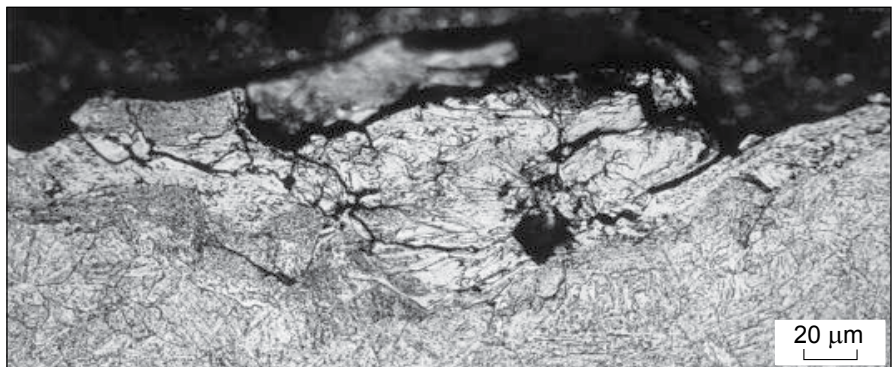
The primary crack starter (*PR*) can be characterized as a local separation; around the local separation (approx. 20 μm) the structure is plastically deformed (Fig. 5). Starting from the local separation, one can see radial cracks. This implies that the local separation was filled with a globular, non-metallic inclusion that has disappeared in the course of the metallurgical preparation.

Figure 5—Local separation with radial cracks (Fig. 4).

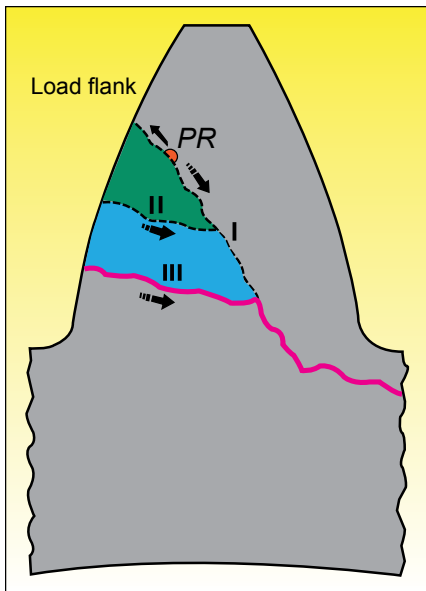
In Figure 6 a model is shown to explain the crack path. The crack starter is located in the region of the pitch diameter and can be found underneath the case-hardening depth (about $1.5 \times \text{CHD}$) where the stress is significantly lower than within the CHD (Fig. 7).

Figure 6—Path of crack.

positioned perpendicular to the direction of the tangential stress. It cannot be excluded that the microcracks are generated during or shortly after the last heat treatment process. Only those microcracks in line with the direction of the main shear stress can propagate towards the load flank and the core (Fig. 6).

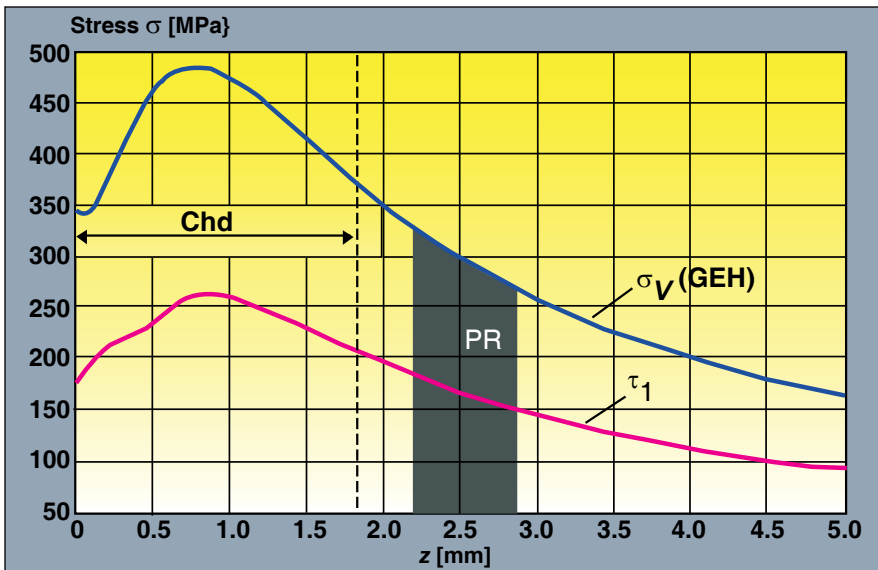
Figure 7—Distribution of equivalent stress and main shear stress over the depth.

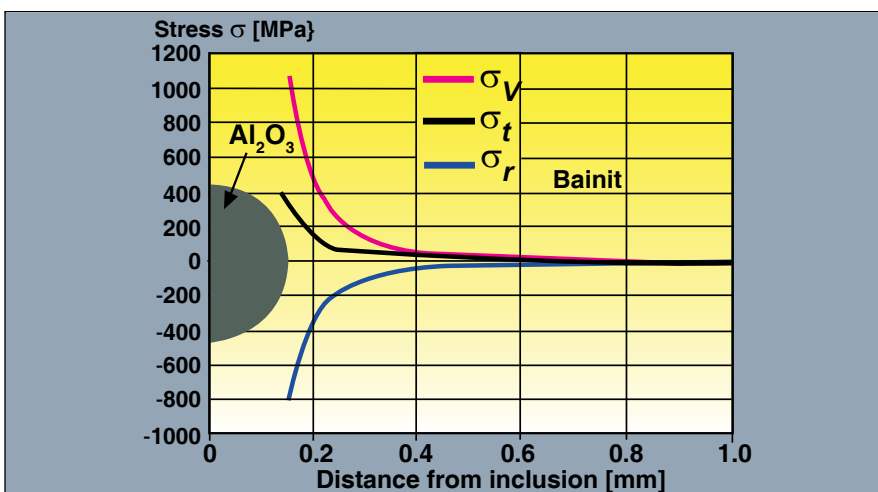
In general, the local separation is filled with a nonmetallic inclusion from the oxide type. It is known that at the boundary of the inclusion, tangential and radial stresses are induced (Fig. 8). The microcracks (Fig. 5) are

Figure 8—Internal cooling stress at the boundary of a non-metallic inclusion (Al_2O_3).

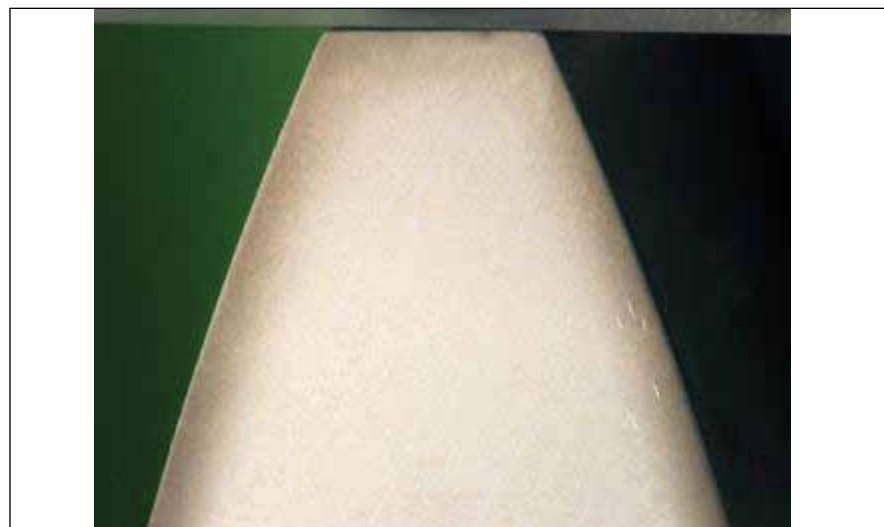
A metallographic specimen was taken through the area with indications of tooth No. 3 (Fig. 9). Several indications are present within the case-hardening zone (CHD ~ 1.8 mm) and below; they are lying parallel to the surface in the area of the pitch diameter.

Figure 9—Indications beneath the surface of the load flank.

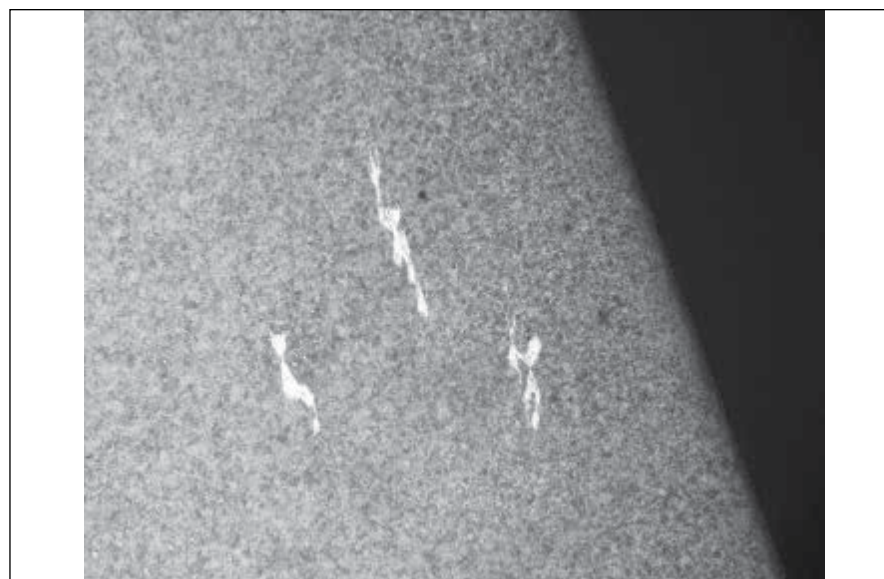
In Figure 10 it is shown that the indications consist of White Etching Areas (WEAs).

Figure 10—White etching areas (WEAs).

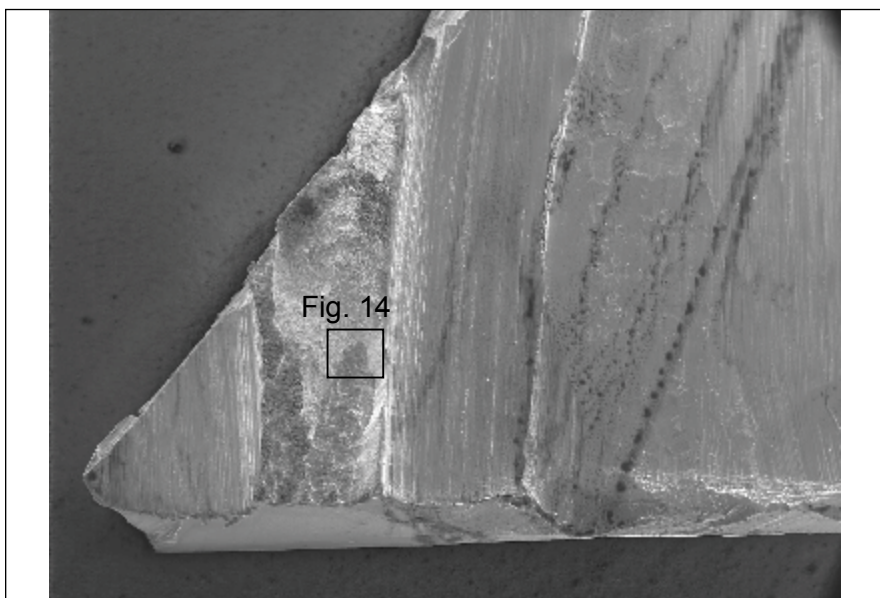
After further preparation, one of the WEAs was broken up in the laboratory (Fig. 11).

Figure 11—WEA broken up in the laboratory.

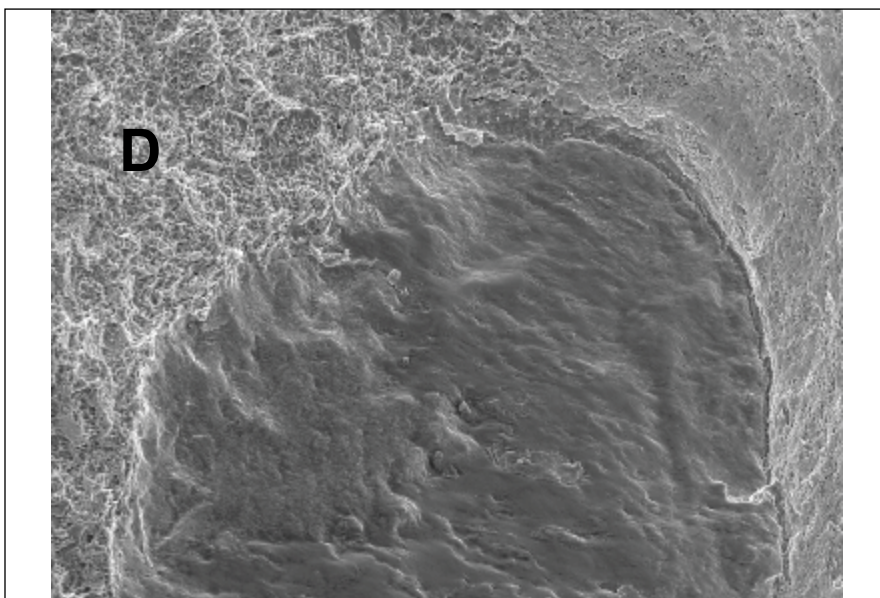
The structure of the WEA shows the effect of an intense plastic deformation caused by hydrostatic pressure with superimposed shear load (Fig. 12). This structure is quite different from the dimple fracture (D, Fig. 12) produced in the laboratory. The boundary surface between WEAs and surrounding microstructure is sharply lined so that WEAs can be easily detected by ultrasonic inspection.

Figure 12—Intense plastic deformation within WEA.

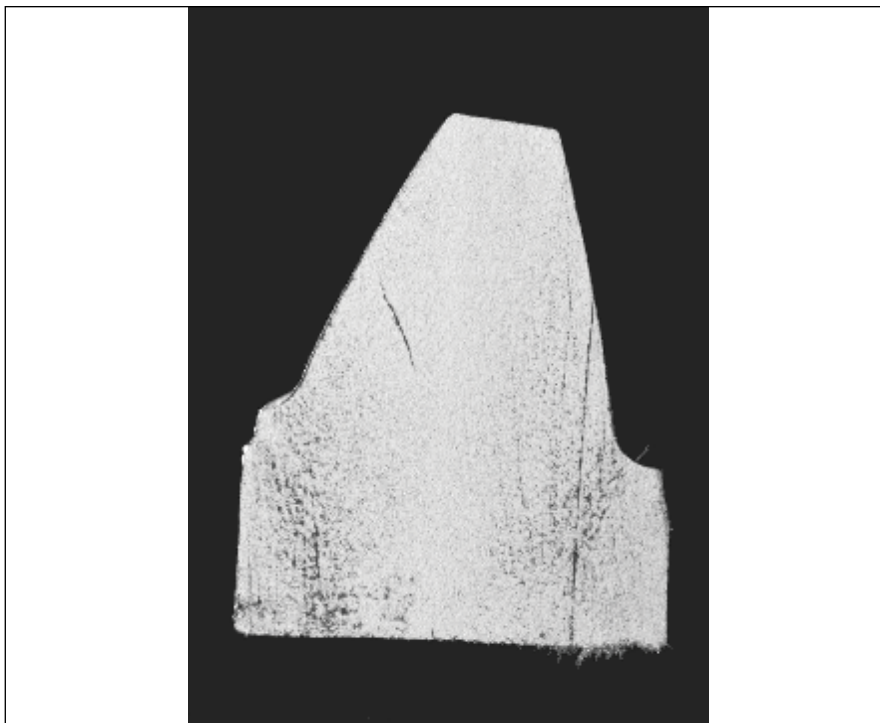
During a UT (ultrasonic testing) inspection on a gearbox after 44,000 operating hours, indications providing evidence of a large internal discontinuity were found on one tooth of the wheel. An indication with a length of 243 mm is present in tooth No. 4. When scanned from the rear flank, it reflects up to an axial extent of 243 mm from the central recess (gap) and, when scanned from the load flank, between 5 and 212 mm. A maximum reflectivity of more than 20 dB above that from the 1mm disk shape reflector is located at the axial position (153 mm). At one position of the indication, a metallographic specimen was taken (Fig. 13). Within the tooth, a crack with a length of 6 mm is visible in the normal section; the progress corresponds to the known pattern in that it is located with an inclination of approximately 45° to the load flank.

Figure 13—Crack within the volume of the tooth.

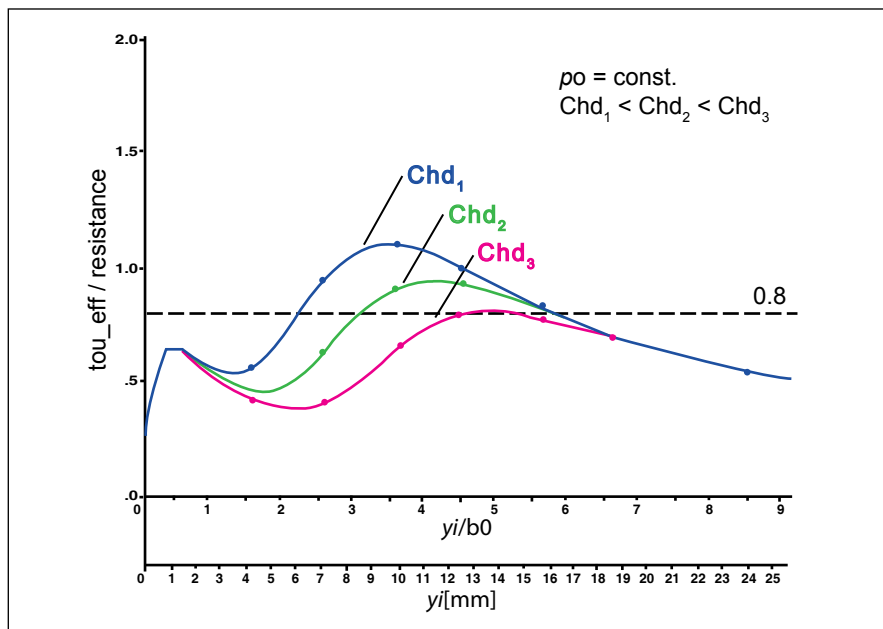
An example is provided in Figure 14. One important point of interest could not be solved within the frame-

Figure 14—Depth gradient of strain by constant load p_0 (MPa) and variable case-hardening depth (mm).

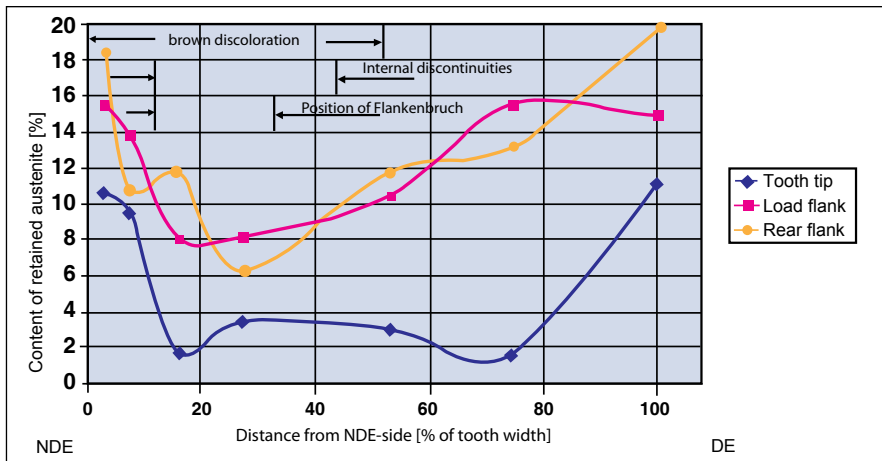
The distribution of the measured content of retained austenite of a pinion is shown in Figure 15. At one tooth a flank breakage was detected at a certain distance from the NDE side. In

this range with brown-colored teeth, an accumulation of indications was found by UT inspection. It is significant that in this area the content of retained austenite decreases from 16% to 8%.

Figure 15—Distribution of retained austenite over tooth width/discoloration, internal discontinuities, position of flank breakage.
