Large Scores and Radial Cracks on Case-Hardened Worms

Wolfgang Predki, Friedrich Jarchow, Ralf Dinter and Alexander Rhode

In the last couple of years, many research projects dealt with the determination of load limits of cylindrical worm gears. These projects primarily focused on the load capacity of the worm wheel, whereas the worm was neglected. This contribution presents investigations regarding damages such as large scores and cracks on the flanks of case-hardened worms.

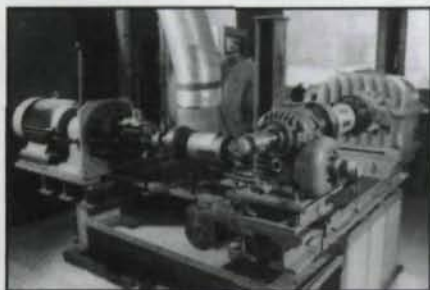
Fig. 1—Test stand for scoring damage, center distance $a = 100$ mm.

The test runs to examine score marks and cracks on hardened worm flanks were executed separately on two electrically strutted test stands. The mating materials are case-hardened worms made of 16MnCr5 steel and worm wheels made of GZ-CuSn12Ni bronze. Tests for scoring were executed with gear sets with a center distance of $a = 100$ mm, a gear ratio of $i = 41:2$, a worm shaft arranged below the worm gear and splash lubrication. Figure 1 shows the test stand that was employed for scoring tests.

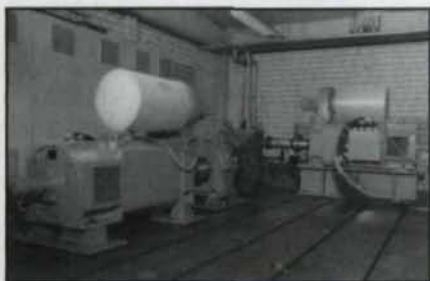
Fig. 2—Test stand for cracking damage, center distance $a = 250$ mm.

The torque varied from 1.0 to 1.75 times the nominal torque that is given by the gear manufacturer (Ref. 7). Cracks on the worm flanks were tested on larger gear sets with a center distance of $a = 250$ mm, a gear ratio of $i = 39:2$, a worm shaft arranged above the worm gear and a combined splash/circulating lubrication with an external oil cooling system. That

test stand is shown in Figure 2.

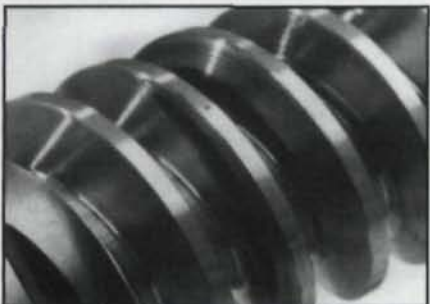
Fig. 3—Large score marks on a case-hardened worm.

Figure 3 illustrates a worm gear damaged by score marks. Compared to new, never-run worms, the flanks show a rough surface within the area of contact. These score marks are transferred during operation to the flanks of the worm wheel and cause excessively increased wear that often leads to a premature failure of the entire gear set.

Scoring on the worm flanks can be avoided by the use of PVD-coated worms such as those coated with BALINIT C (Ref. 1) or the use of the additive GH6. Compared to the basic test runs, even higher torques can be applied. No score marks appear during these tests. Concerted oil changes after 48 and 144 hours help to reduce the scoring damage. However, scoring cannot be avoided completely by this particular means.

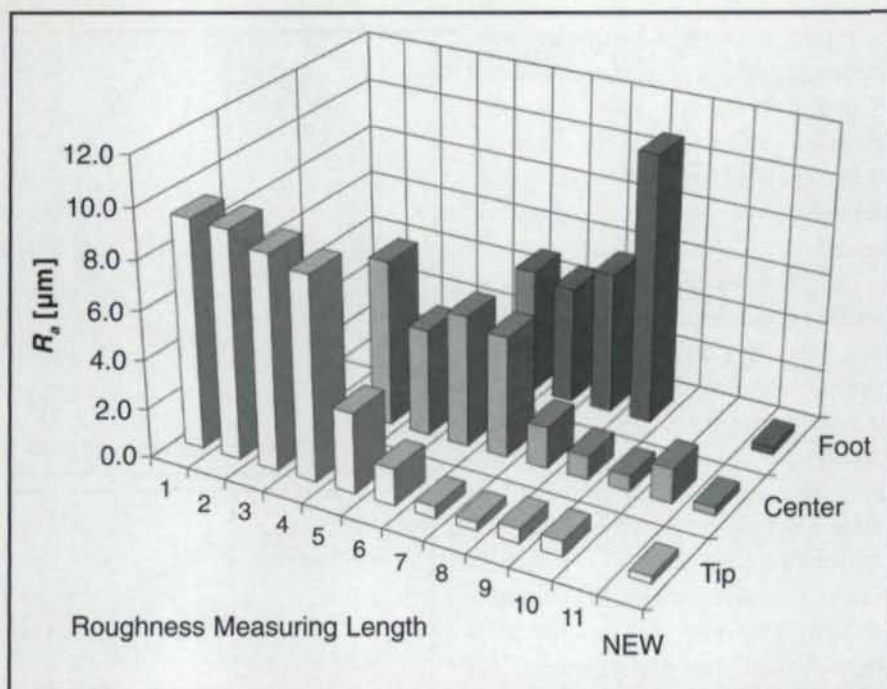
In the radial direction, parts of the teeth are separated into foot, center and tip. Tests with a low rotational speed of $n_1 = 400$ 1/min and 1.25 times the nominal torque show the largest scoring damage. The distribution of the measured arithmetic mean roughness R_a after testing is given with Figure 5. The measured values for each position from the beginning to the end of the contact area are plotted. The roughness of the flanks in the initial state is the standard of comparison. New worms have an average arithmetic mean roughness of $R_a = 0.4 \mu\text{m}$.

The distribution shown is typical for worms that are damaged by score marks. The greatest roughness always occurs at the end of the contact area close to the tip of the tooth. Towards the beginning of

the mating area, the values of the roughness decrease. Similar tendencies can be observed in the center of the teeth, but the maximum values are lower. In the area of the foot, the measured values scatter, but they reach comparatively large values.

Fig. 5—Arithmetic mean roughness after testing (336 hours), $n_1=400$ 1/min, $T_2 = 1.25 \cdot T_{2N}$ 16MnCr5 case-hardened/GZ-CuSn12Ni.

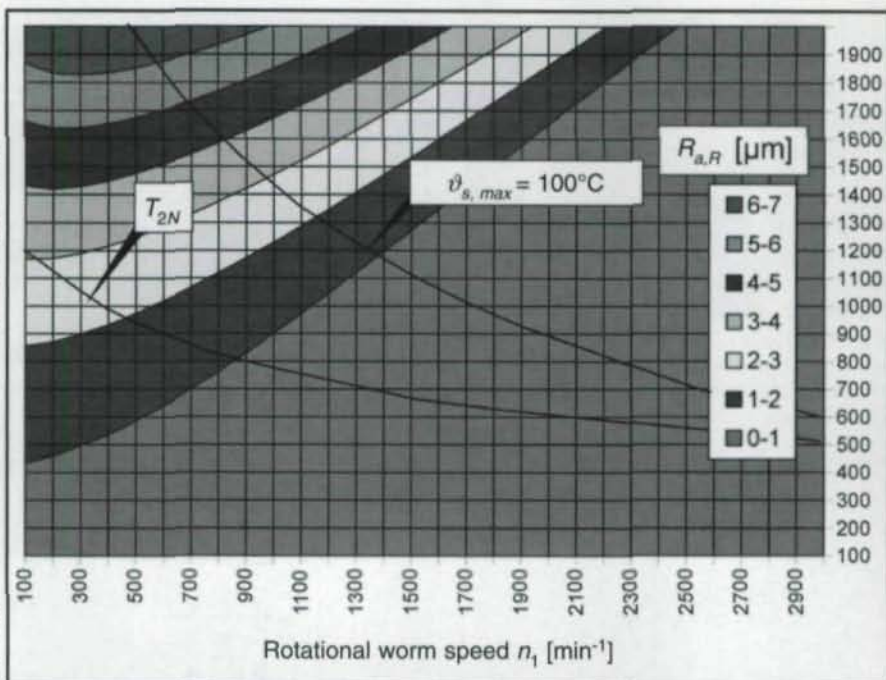
Figure 7 shows the expected arithmetic roughness $R_{a,R}$ after application of Equation 1. A data map shows the expected scoring damage for the examined material-lubricant combination depending on torque and rotational speed.

As observed during the tests, the roughness increases with increasing load and decreasing rotational speed. Measurements during the testing reveal an increased wear for $R_{a,R} = 1-2 \mu\text{m}$, and excessively increased wear if greater roughness applies. In some cases, the measured wear exceeds the values pre-calculated by DIN 3996 (Ref. 3) up to 20 times. For this reason, an arithmetic mean roughness above $R_a = 2 \mu\text{m}$ has to be particularly regarded as critical. For operation with constant torque directly after gear set assembly, the loads should be chosen in a way that the expected arithmetic mean roughness stays below $1 \mu\text{m}$, in order to avoid damaging score marks.

Fig. 7—Estimated scoring damage, calculated by Equation 1. Gear set: $a = 100$ mm, $i = 20.5$, $16\text{MnCr5h}/\text{GZ-CuSn12Ni}$, operation with nominal load, no running-in, nominal torque T_{2N} taken from manufacturer data (Ref. 7).

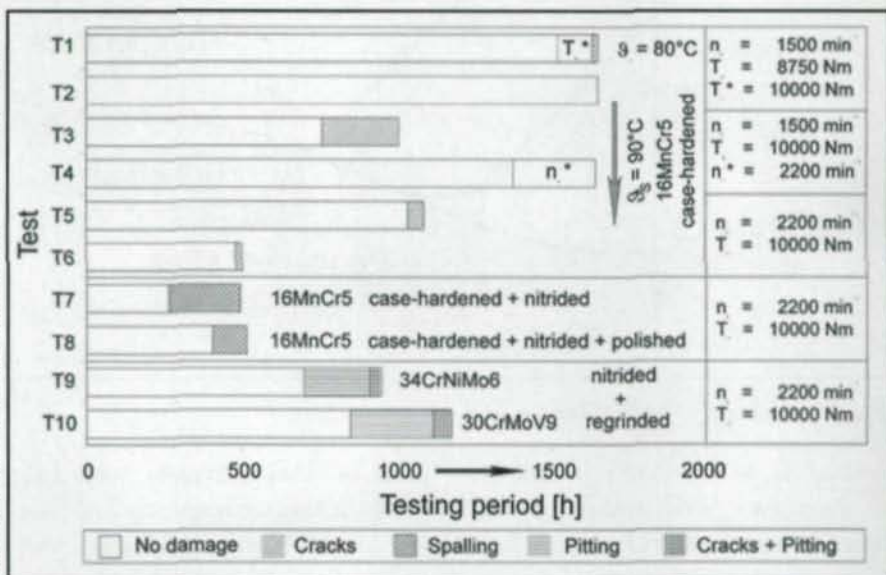
Figure 8 shows a bar chart that sums

up the results of several tests. The testing period is represented by the length of each bar. Different hatching indicates several defects on the worm flanks. The employed worm materials as well as the hardening processes are given with this figure.

The nominal torque must be exceeded by far to produce cracks. High loads lead to heavy pitting and, in some cases, excessive wear on the worm wheels. The cracks on the worm flanks always occur at the end of the mating area and show a radial alignment. There are two different areas for the origin of the cracks and their direction of growth. On the one hand, cracks start at the inner delimitation of the contact field with a growth direction towards the tip of the worm tooth (Fig. 9). On the other hand, cracks start at the tip and grow towards the tooth (Fig. 10). For both cases, the origin of the cracks is located within an area of disadvantageous lubrication conditions. After the tests, a local transfer of bronze can be observed in these areas.

Fig. 8—Test results cracking. Wheel is GZ-CuSn12Ni ; lubricant: $\text{FVA-PG4} + \text{LP1655}$

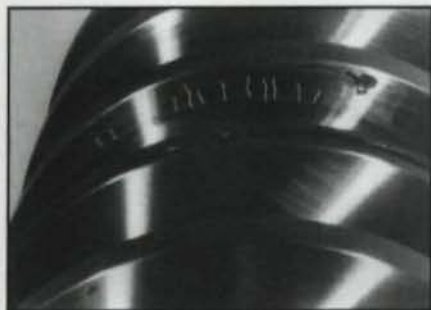
Theoretical examinations (Refs. 2, 6) show the smallest lubricant film thickness at the inner delimitation of the worm mating area. Compared to other areas on the flank, higher friction factors apply for this region. The combination of high friction factor and the existing speeds lead, particularly towards the end of the mating area, to high temperatures on the flank.

Fig. 9—Worm taken from test T3. Origin of the crack at the inner delimitation of the contact field (cracks redrawn for better illustration).

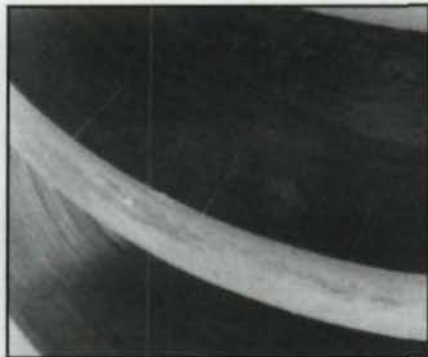
Cracks that start at the tip of a worm tooth can be observed if large pitted areas are located on the wheel teeth and increased wear commences. The tooth face tip of the worm "digs" into the foot of the wheel tooth. The development of a sufficient lubricating film in this area is restrained by the sharp-edged tip of the worm tooth and the prevailing conditions of motion.

A theoretical analysis of the mating process shows a contact or wear between the tip of the worm tooth and the foot of the wheel tooth at the end of the worm mating area, which corresponds to the test results.

Fig. 10—Worm taken from test T1. Origin of the crack at the tip of the tooth.
