# INFLUENCE OF COATINGS AND SURFACE IMPROVEMENTS ON THE LIFETIME OF GEARS

Franz Joachim, Norbert Kurz and Bernhard Glatthaar

Surface coatings or finishing processes are the future technologies for improving the load carrying capacity of case hardened gears. With the help of basic tests, the influence of different coatings and finishing processes on efficiency and resistance to wear, scuffing, micropitting, and macropitting is examined.

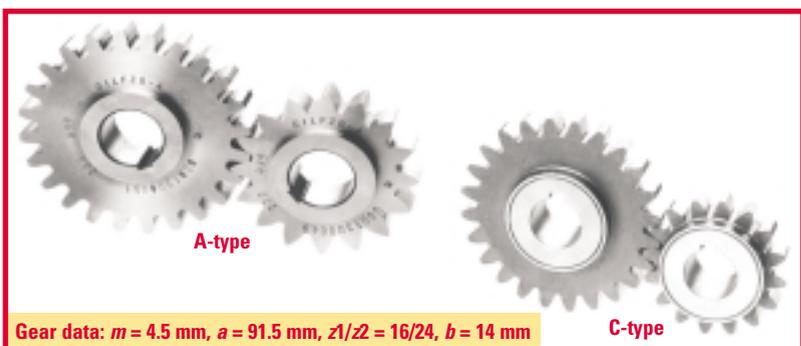
Figure 7—FZG test gears.

**Gears, test rig, test procedure.** Type FZG-A and FZG-C gears were used for the comparative tests (see Fig. 7). The FZG-A gear is a standard test gear (DIN 51354) used for scuffing tests. The gear is designed especially for high sliding speeds and therefore responds with particular sensitivity to scuffing damage. The FZG-C gear is standardized and is used for macropitting, wear, and micropitting tests. The gear geometry has balanced specific sliding. Both gear types have no modifications (crowning, tip relief) and are produced by ZF according to specifications.

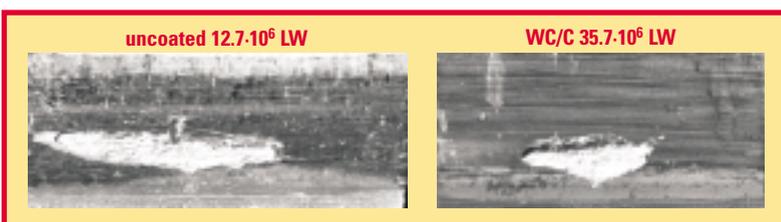
Figure 12—Macropitting failure.

The macropitting damage pattern is the same for all gears investigated. Figure 12 shows an example of a comparison of an uncoated gear and a WC/C-coated gear. As usual, macropitting occurs in the area of negative slip, with WC/C only after approximately 2–3 times the other run time. With the WC/C gear, machining/grinding marks can still be seen after this relatively long run time. Most of this will have already been removed after approximately 30% of the run time on the uncoated gears.
