Case Study Involving Surface Durability and Improved Surface Finish

G. Blake and J. Reynolds

Management Summary

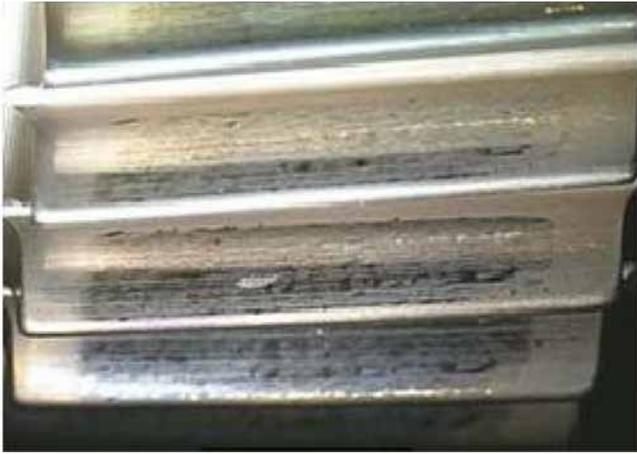
Figure 4—Baseline Gear A, Mesh 1, drive side: post-150-hour test.

Baseline 150-hour test results. The gear tooth surface condition and any failure modes were classified using ANSI/AGMA 1010-E95 (Ref. 6). Table 2 contains a summary of the baseline gears subsequent to the 150 hour test. Figures 4–7 are low-magnification, white-light photos of the active profile surfaces, post test.

Gear	Failure mode(s) per ANSI/AGMA 1010-E95		
	Failure mode class	General failure mode	Specific mode / degree
D	Wear	Polishing	Moderate
	Contact fatigue	Macropitting	Initial
	Contact fatigue	Micropitting	Progressive
	Scuffing	Scuffing	Mild
C	Contact fatigue	Micropitting	Progressive
	Contact fatigue	Macropitting	Initial
B	Contact fatigue	Micropitting	Progressive
A	Contact fatigue	Micropitting	Progressive

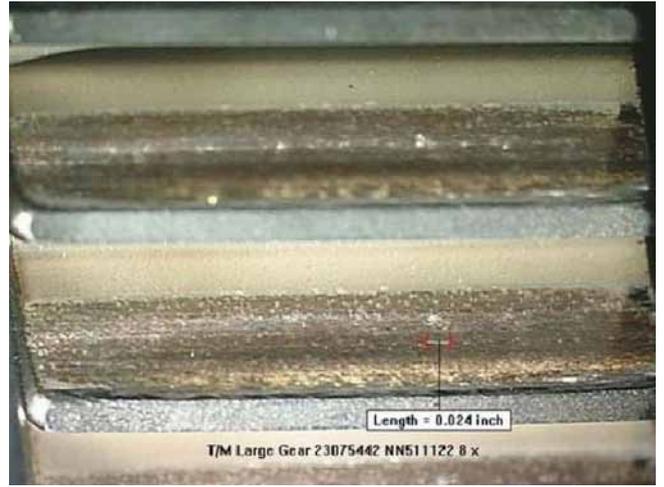
Figure 5—Baseline Gear B, Mesh 1: post-150-hour test.

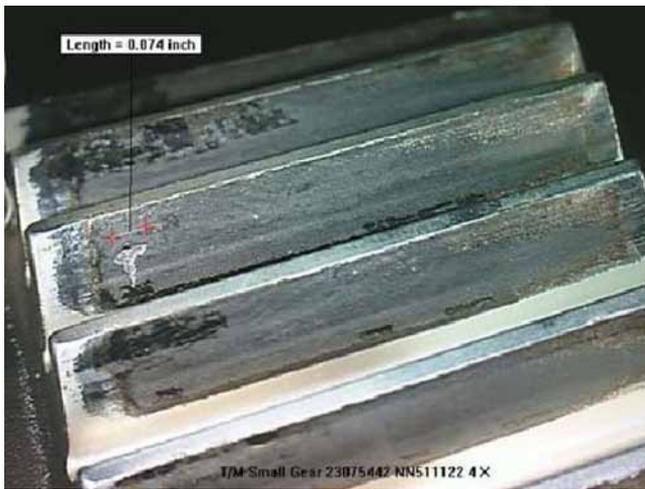
Figure 6—Baseline Gear C, Mesh 2: post-150-hour test.

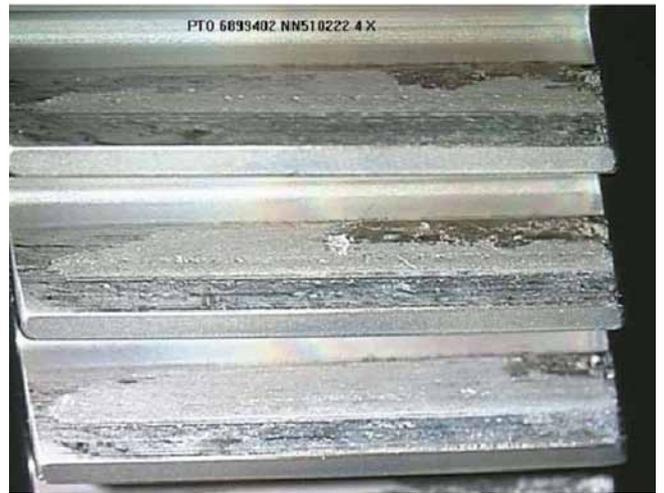
Figure 7—Baseline gear D, Mesh 2: post 150-hour test.

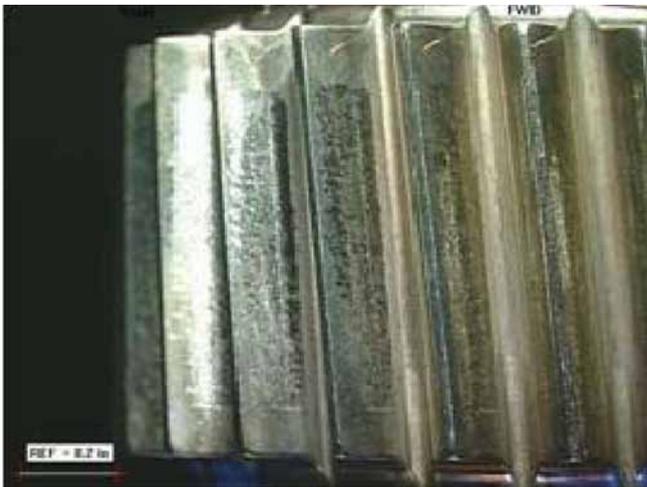
Figure 21—ISF Gear A, Mesh 1: post-2,000-hour test.

2,000 hour ISF test results. The same gears used in the 150-hour test were reassembled. Testing was continued at the same parameters for 2,000 hours. Figs. 21–24 are low-magnification, white-light photos of the ISF gears post-2,000 hours. The gears showed little surface distress.

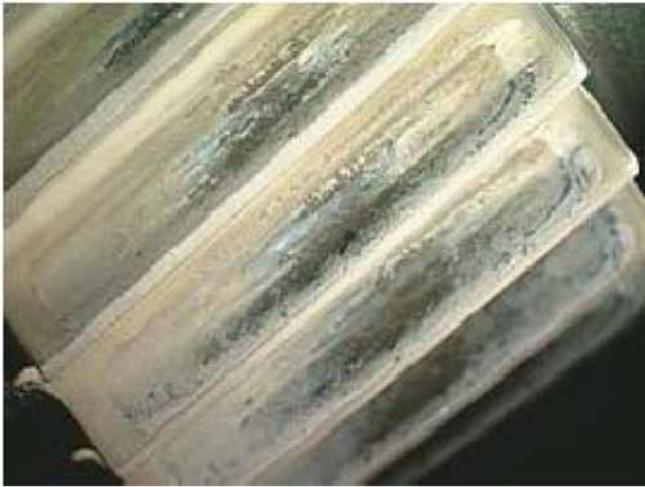
Figure 23—ISF Gear C, Mesh 2: post-2,000-hour test.

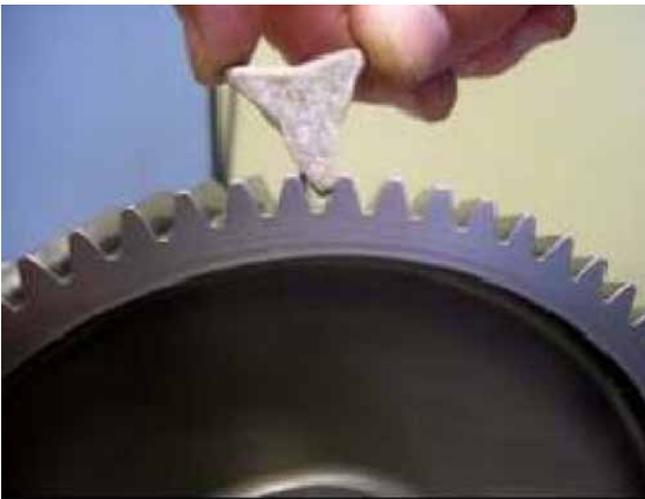
Figure 25—ISF process development shown: Gear B.

Figure 25 shows Gear B and a piece of the initial media used to process the gear. As can be seen, the media is too large to contact the full depth of the tooth.

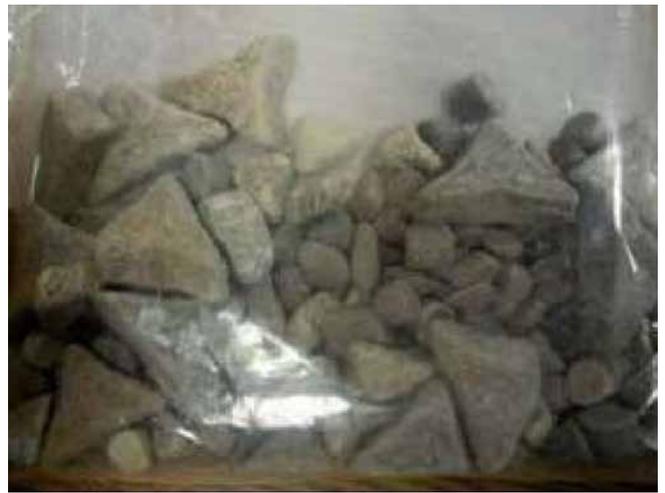
Figure 26—ISF process development: media mix.

The media used is a mixture of several different sizes and shapes (Fig. 26).

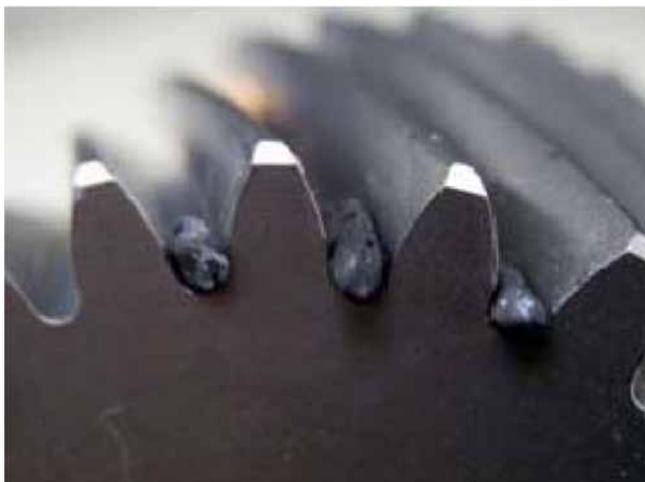
Figure 28—Gear B with smaller ISF media.

ond lot of parts involved a new media that fit the gear tooth pitch. Figure 28 shows Gear B and the smaller media fitting into the tooth space to the root. The final media mixture used is shown (Fig. 29).

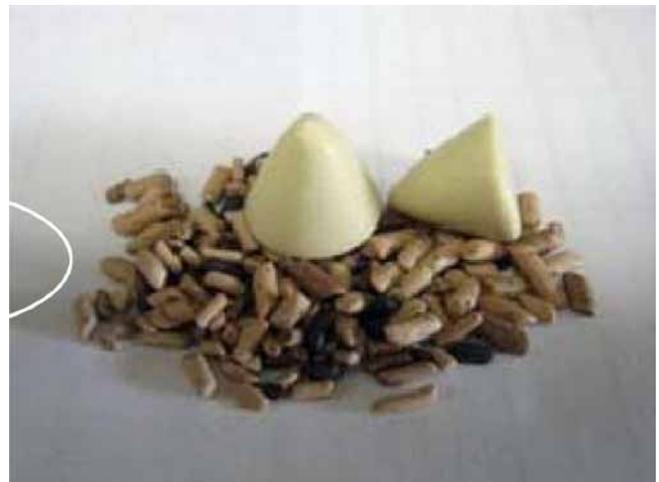
Figure 29—ISF process development: final ISF media mixture used for test gears.
