Repair via Isotropic Superfinishing of Aircraft Transmission Gears

Dr. Suren B. Rao

Management Summary

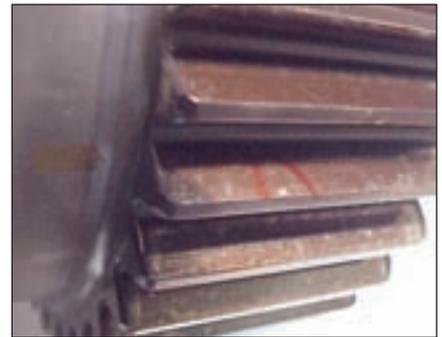
As mentioned, the primary causes of a gear being scrapped are FOD (Fig. 2, circled in red) and gray staining (Fig. 3). The effort to demonstrate the feasibility of gear repair was conducted in two major phases. In the first phase, scrap gears from Cherry Point were analyzed for damage, superfinished by the ISF process and then inspected for dimension, geometry and metallurgy. In the second phase, test hardware for traditional gear tooth strength and durability testing was designed and fabricated for the spur pinion (P/N A02D2065). This included a single-tooth fatigue fixture (Fig. 4).

Figure 2—FOD on spur pinion.

The repaired gears (scrap gears that had been superfinished to remove surface damage) were inspected for dimension, geometry and metallurgical integrity. The tooth thickness was smaller than before by the amount of material removed, but still well within the tolerance. The lead, profile and index error were relatively unchanged after superfinishing, and were found to be within OEM specifications. Some of the gears were sectioned, mounted and examined for hardness, hardness profile, retained austenite and residual stress. The repaired gears met all OEM specifications on these parameters. The microstructure of the repaired gears was also examined, and no deleterious impact on the microstructure due to the ISF process was observed. The surface roughness of the repaired gears was generally in the 4–6 $\mu\text{in. } R_A$, while the ground gears generally had a surface roughness in excess of 16 $\mu\text{in. } R_A$.

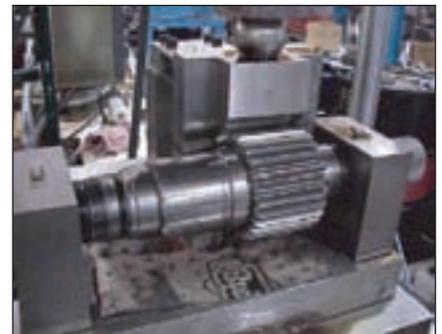
Figure 4—Single-tooth fatigue fixture.
