Test Facility Simulation Results for Aerospace Loss-of-Lubrication of Spur Gears

Robert F. Handschuh and Lucas J. Gargano

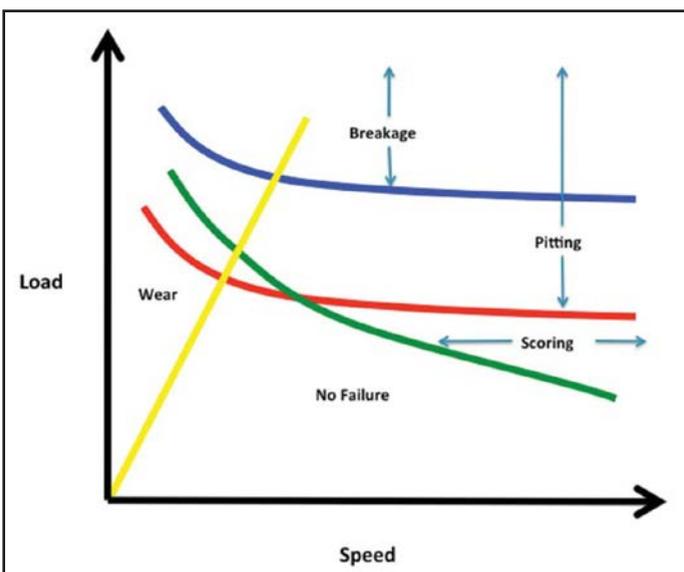
Figure 1 Effects of speed and load on gear wear mechanisms.

Failure mechanisms of gear contacts are summarized in Figure 1 (Ref. 2). Here, two of the mechanisms are of most importance for loss-of-lubrication; the first is the wear region where extreme loading at slower sliding speeds under starved lubrication conditions generates sufficient heat to expedite wear; the other region is the scoring region where high relative sliding of the teeth influences the heat being generated. In either case the friction coefficient increases due to the loss of the full elasto-hydrodynamic fluid film — thus increasing the heat generation rate.

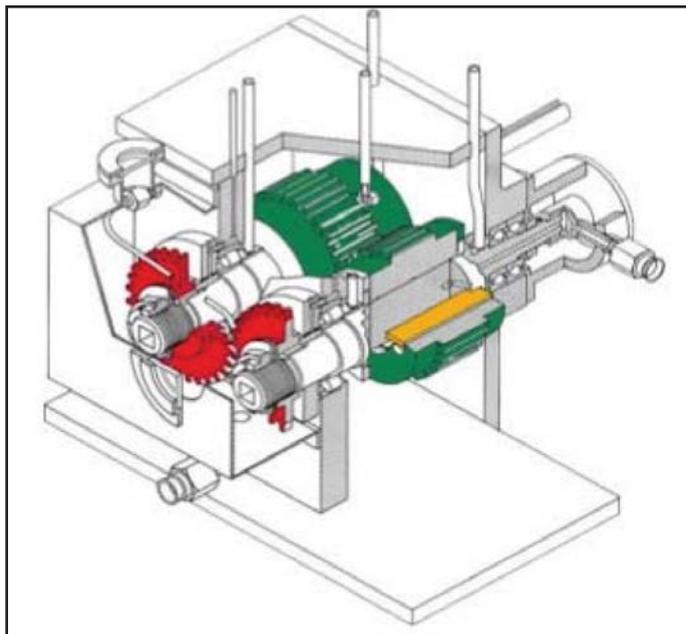
Figure 2 Cross-sectional sketch of the test gearbox used for loss-of-lubrication testing.

The test facility used for conducting all loss-of-lubrication simulation tests is the NASA Glenn contact fatigue test facility (Refs. 6–8) (Fig. 2). The facility is a torque regenerative test rig that locks torque in the loop via rotating torque applicier. The test gears have a 1:1 ratio. Facility speed and torque can be varied as needed during a test. The basic gear design information of the tested gears is listed in Table 1.

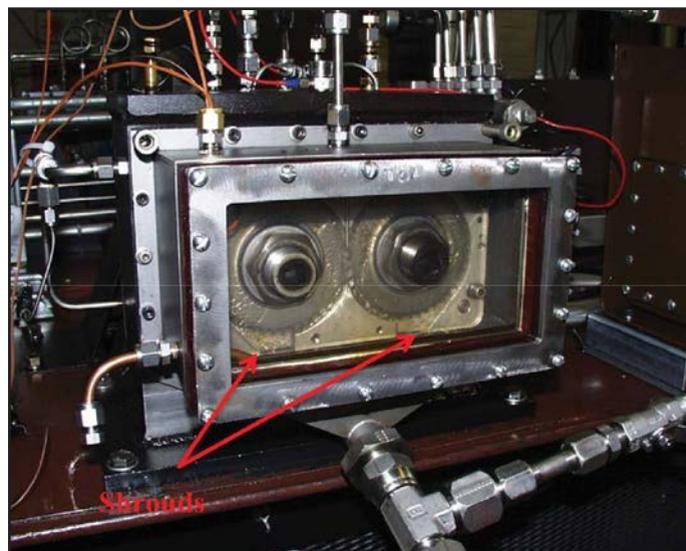
Figure 3 Current test gearbox arrangement utilizing shrouds (bottom exit shown).

As previously mentioned, the facility went through an evolutionary period (Ref. 5) where shrouding, visual access, gearbox lubricant removal, and instrumentation were added to the test section. A photograph of the current test gearbox arrangement is shown in Figure 3.

Static shroud thermocouples were utilized during all tests. High-temperature glass was also utilized as the outside shroud to encase the gears. Ballistic plastic and another layer of high-temperature glass provided visual (and video) access to the gears during operation. Lubricant for normal operation was fed at the into-mesh location through part of the shroud (Fig. 4). The normal operational flow rate was approximately 0.42 l/min (0.11 gpm), at 207 kPa (30 psig) jet pressure, with the lubricant inlet temperature of ~110°C (230°F). Instrumentation and normal lubricant jet locations are shown (Fig. 4). A turbine engine with drive system lubricant MIL-L-85734 was used during the testing at hand.

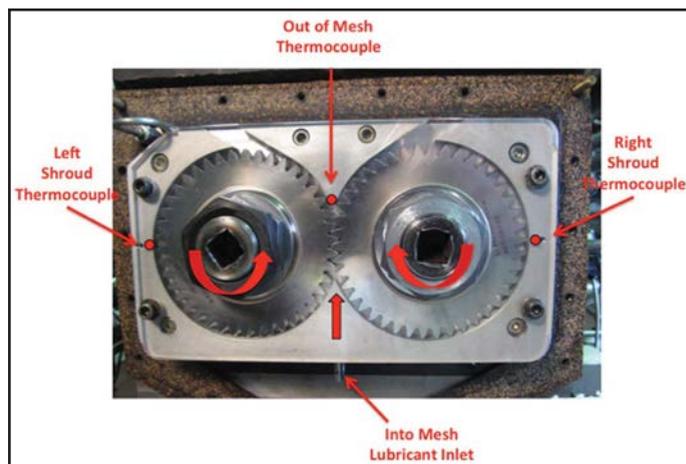
Figure 4 Example of test gear arrangement with outer gearbox cover removed, top exit shrouds shown.

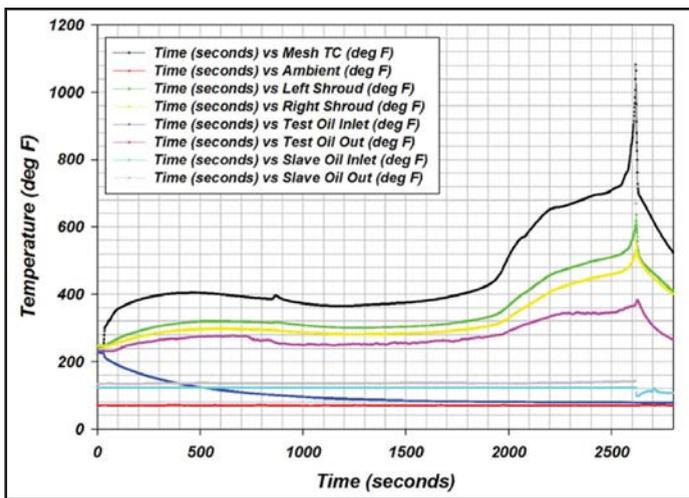
Figure 5 LOL (loss of lubrication) data for 1.72 kPa (250 psi) load pressure ~ 59.3 N*m (540 in*lb) torque tested at 10,000 rpm.

At the lower level of the two loads, two tests were conducted with the loss-of-lubrication time of 40.8 and 43.1 min in length. The data from the static thermocouples imbedded in the shrouds, along with other facility temperatures, is shown in Figure 5.

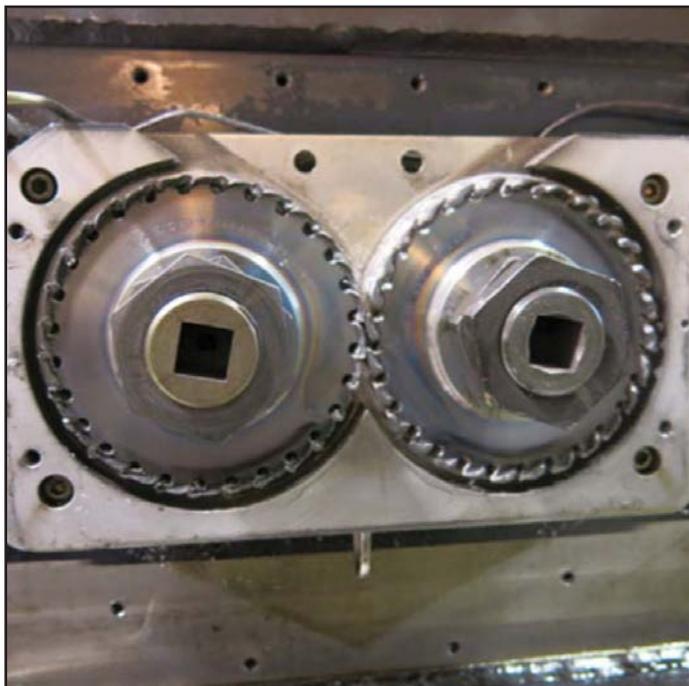
Figure 6 Post-test condition of the gears (gearbox cover and outer high-temperature glass removed).

The gears in the post-test condition are shown in Figure 6. Note that the test was conducted until the gear tooth meshing heat generation and resultant temperature were high enough to plastically deform the gear teeth. This type of post-test condition occurred whenever the test was permitted to continue until total loss-of-torque-delivery was achieved; a typical loss-of-lubrication failure at this condition is shown (Fig. 7).

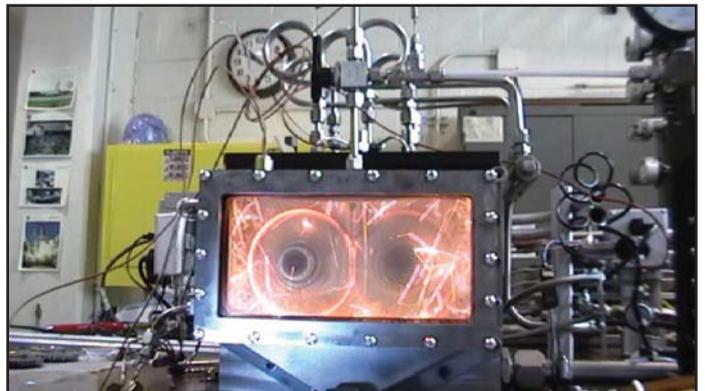
Figure 7 Example of loss-of-lubrication test during final seconds of operation.

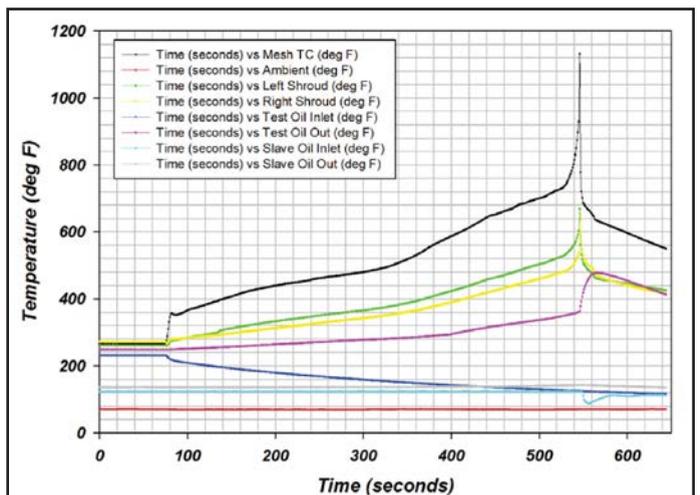
Figure 8 Loss-of-lubrication data from higher load test 83.6 N*m (740 in*lb).

Two other tests were conducted at an elevated level of load, i.e. — ~83.6 N*m (740 in*lb). These tests, in the loss-of-lubrication mode, produced failures in 7.9 and 9.2 minutes. The test temperature data from the 7.9-minute loss-of-lubrication test is shown (Fig. 8). As can be seen from this data, the temperature did not reach an increased steady-state condition prior to increasing to failure, as it did in the test shown in Figure 5. After the primary lubrication system was disconnected, the temperature just continued to rise. The post-test condition of the test gears is shown (Fig. 9) with the gearbox cover removed.

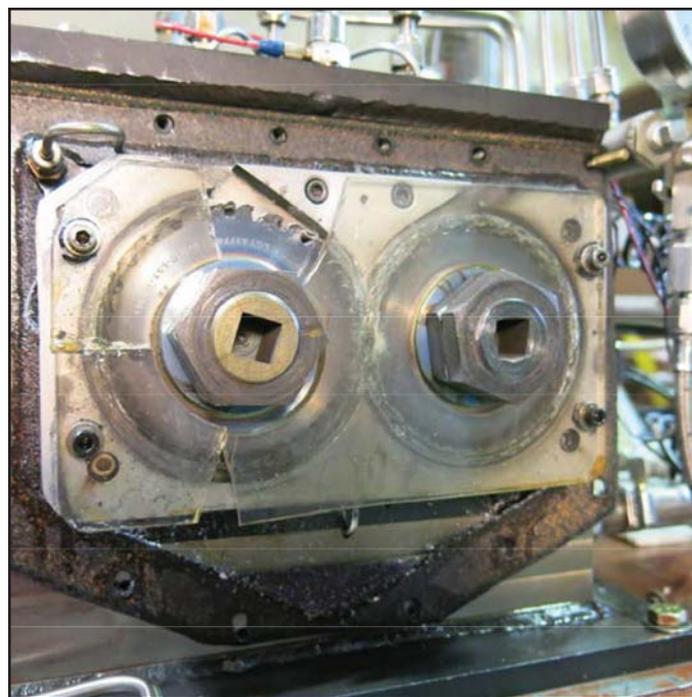
Figure 9 Post-test photograph of increased load test gears with outer shroud high-temperature glass fractured.

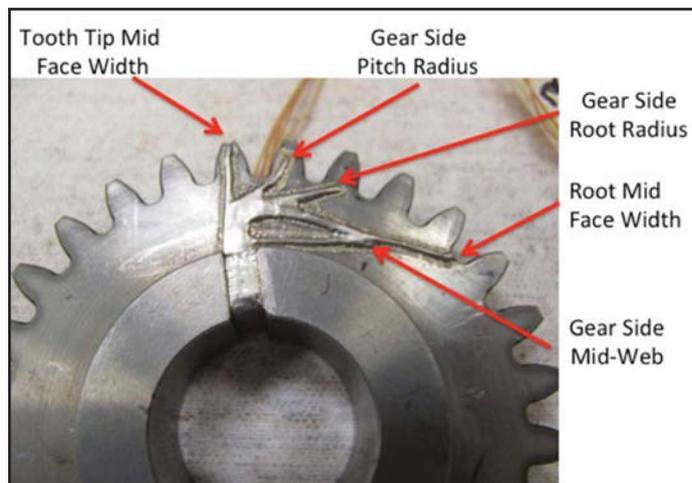
Figure 10 Instrumented LOL test specimen before testing.

The gear used in these tests is shown (Fig. 10); it is the gear that was installed in the left side of the gearbox. The left-side gear acts as the driving gear of the test section of the facility. A total of five thermocouples were attached to the gear at: the tooth tip mid-face width; root mid-face width; on the side of the gear at the pitch radius; root radius; and mid-web locations. As shown (Fig. 10), the thermocouple wires were covered by a thin metal foil that was spot-welded to the side of the gear to protect the instrumentation during operation. The rest of the required

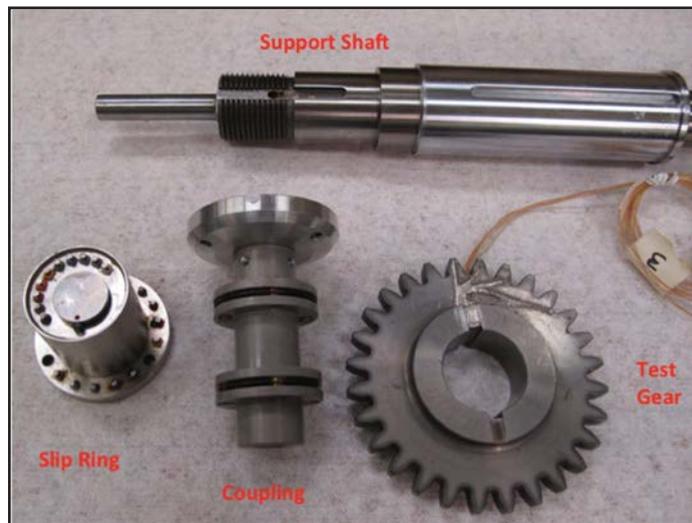
Figure 11 Loss-of-lubrication test specimen and related components.

hardware is shown (Fig. 11) prior to installation in the test rig; the assembly in the test rig is shown (Fig. 12).

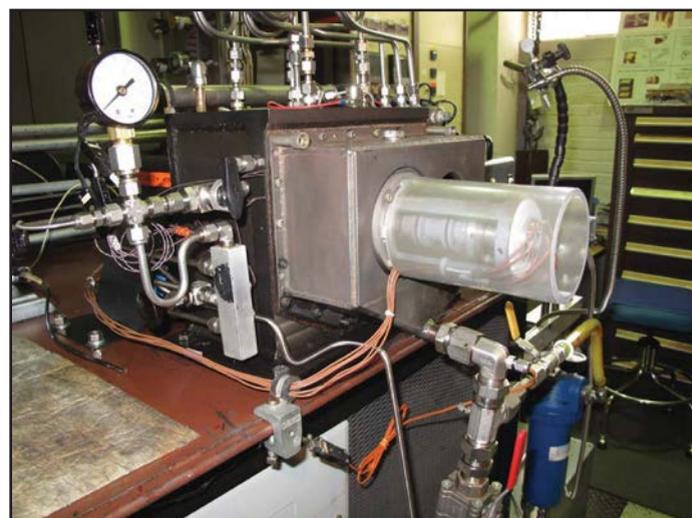
Figure 12 Test set-up for instrumented test gear.

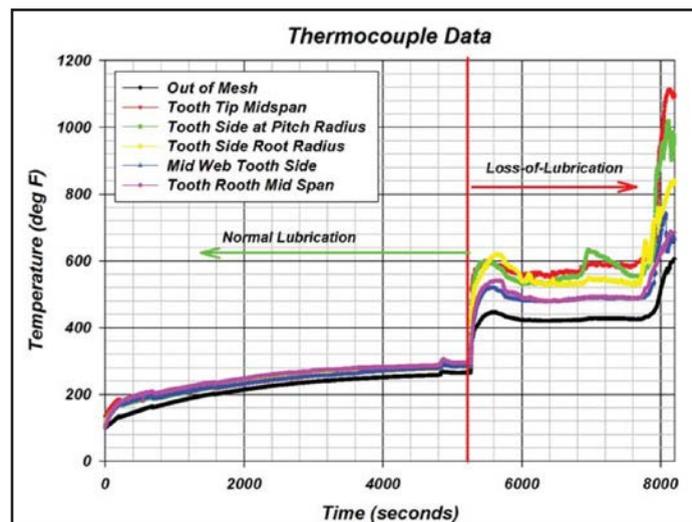
Figure 13 On-gear and out-of-mesh thermocouple data from start-up to instrumentation failure during loss-of-lubrication.

The initial data for warm-up and operation of the facility in the normal-to-loss-of-lubrication mode is shown (Fig. 13).

The data in Figures 13 and 14 indicate that the bulk temperatures of the gear were exceeding the temperature that was found from the static shroud thermocouples. In the normal lubrication condition this value was 20 to 40°F — depending on the location. In loss-of-lubrication mode this amount was as much as 500°F higher on the gear than that of the static shroud thermocouples. In Figure 13 the data beyond 8,200" is believed to be invalid due to post-test inspection of the thermocouple wiring that was melted together at the common locations through the shaft. The thermocouple wiring coating was exposed to bulk temperatures in the gear beyond the melting point of the wire coating.

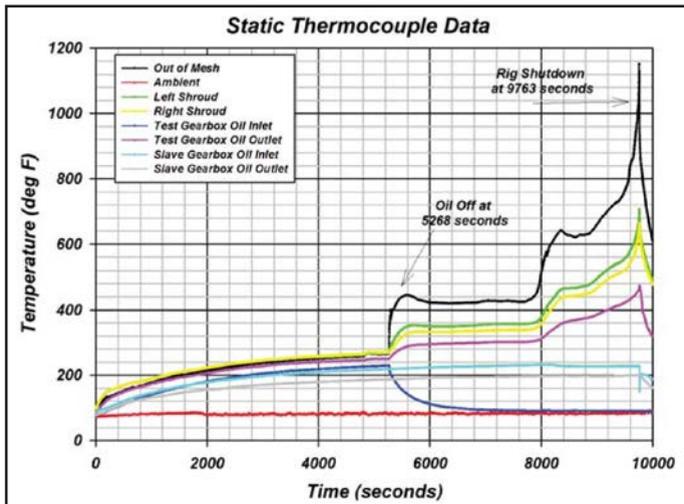
Figure 14 Data from shroud and facility (static) thermocouples.

During this same test the lubricant was shut off and the test run until failure. The data from loss-of-lubrication initiation to failure for the shroud (static) and other facility thermocouples is shown (Fig. 14).

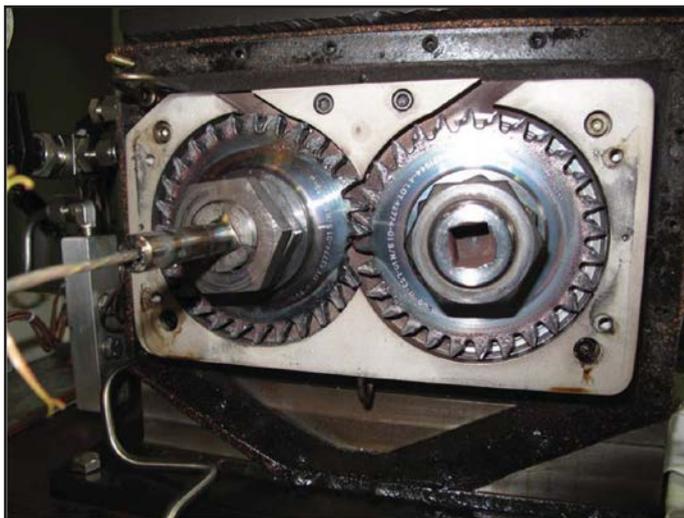
Figure 15 Post-test condition after loss-of-lubrication test was completed. Gearbox housing, slip ring and outer high temperature glass removed.

The post-test condition of the gears used in this test is shown (Fig. 15). What can be noted is that a bending failure occurred before the loss-of-lubrication test — as the failed tooth has no evidence of running in this post-test condition. A hypothesis is that tooth failure was initiated by a spot-weld in the root fillet region from the thin metal protection strap that was used to cover the thermocouple wiring.

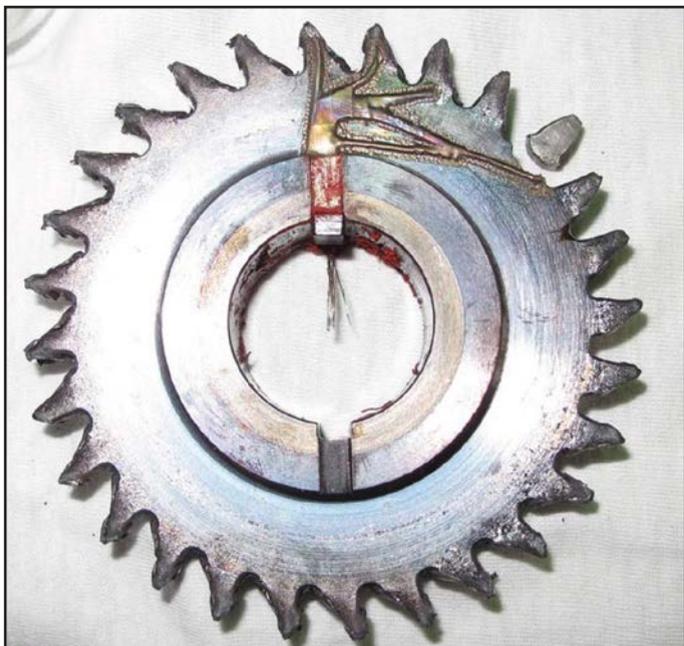
Figure 16 Instrumented spur gear post-loss-of-lubrication test condition.

In Figure 16 the tooth that failed in bending shows no apparent damage from loss-of-lubrication, since it occurred before this lubrication condition was initiated. Upon closer examination, the thin metal strapping used to overcoat the wiring that was spot-welded to the tooth was found to be the initiation site of the bending failure. Future testing of hardware for this purpose will not have this as a hold-down feature for the tooth root-fillet area.
