Repairing a Stone Gear

Joseph L. Hazelton, Contributing Editor

How do you fix a stone gear that has a chipped tooth and has surfaces roughened by acid erosion and covered in black grime?

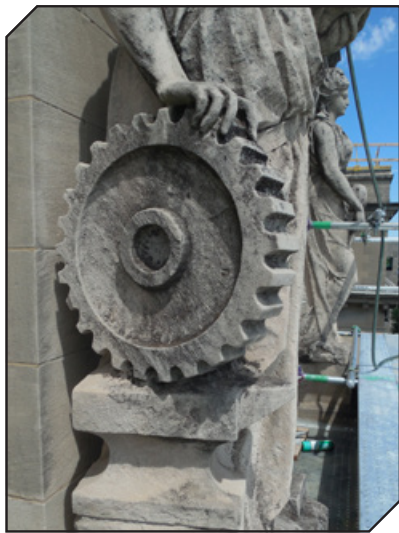
Being outdoors, the statues were exposed to wear and tear from weather. However, the wear and tear included damage that had been done in the past, damage likely done by a local, coal-fired power plant. The damage was acid erosion and black carbon deposits on the statues, including the gear.

Present in the air, the sulfur dioxide mixed with moisture and created a mild sulfuric acid. Then, acid and limestone interacted, starting with the acid dissolving an amount of the limestone and ending with the creation of calcium sulfate: gypsum. However, gypsum deposits are relatively porous, so they can accumulate airborne particles, like pollutants. The result on the statues: "Black scales," Miller says.

Part of a statue, this stone gear was damaged by acid erosion, creating a more porous surface on which black grime accumulated.

To restore the statues, Miller and his team loosened the grime with a mist spray, then removed it with a light power washing. Next, they applied an ammonia solution to kill the organic growths and rinsed it off with water, then applied a special gel to dissolve the gypsum, then another gel to dissolve the organic growths that were deeper in the limestone.

After the gels cured, Miller repaired the statues' cracks and chips, like the chip in the gear tooth. The

cracks were repaired with grout.

The chips were repaired with a material that matched the limestone's color, porosity, and strength. However, the new material's bond with the original limestone is weaker than the limestone's bond with itself. So, if the material fails, it would fall off without taking any original limestone with it. That way, the material won't create new damage in the statues.

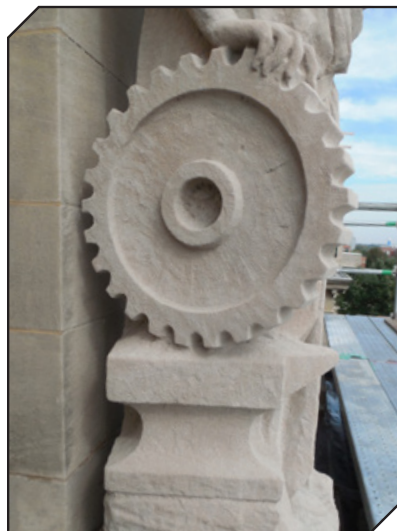
Like the rest of its statue, the gear was restored by art conservator Francis Miller. Free of grime, the gear can be better appreciated as a sculpture. "It's just beautifully carved" Miller says.

With the cleaning done, Miller and his team strengthened the limestone by applying a pre-consolidant and a consolidant. The consolidant seeped into the limestone's pores and created silica gel bonds between its particles.

and they help protect the stone from future erosion and pollutants. Also, the silica gels didn't completely seal the limestone. They allow water and water vapor to migrate and evaporate from the stone. "The last thing we want to do is seal the sculpture and then possibly have freeze-thaw damage from any trapped moisture," Miller says.
