# Gear Failure Analysis Involving Grinding Burn

G. Blake, M. Margetts and W. Silverthorne

## Management Summary

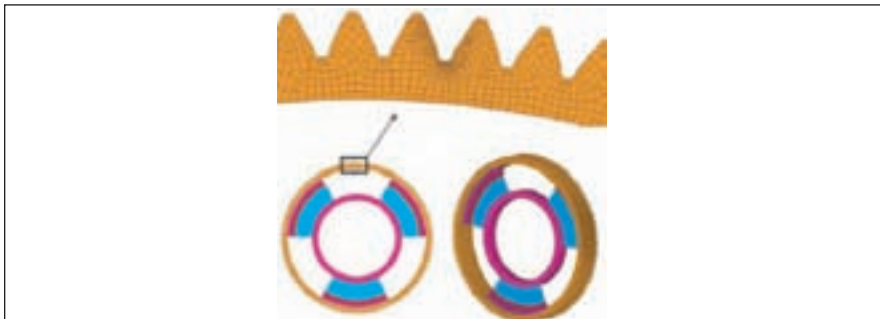
Figure 11—Approximate crack location vs. contact stress distribution.

The flank form inspection of the incident gear located the approximate radial position of the crack. The profile traces were made at the mid face of each tooth. The profile chart shown in Figure 11 shows four adjacent teeth, three of which contain the cracked teeth. The approximate location of the crack is shown as a rapid change (bump) in the lower 25% of the profile chart.

The contact stress distribution of the gear relative to the approximate crack location is shown in Figure 11. The crack location is near the start of single-tooth contact of the gear but not in the area of highest contact stress. However, the crack seems to follow the contour of the surface stress in the axial direction.

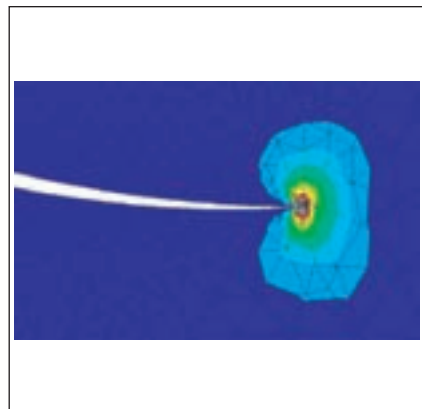
Figure 13—Crack trajectory solution starting from initial crack using maximum continuous torque and speed - first principal stress contours shown.

The crack as measured in Figure 5 was added to the model. Linear elastic fracture mechanics (LEFM) was then used to predict the crack trajectory from this initial point. The solution is shown in Figure 13. The crack tip was modeled as a quarter-point rosette, as shown in Figure 14. The solution shown represents maximum continuous speed and maximum continuous torque applied at the highest point of single tooth contact.

The depth of the initial crack depth is slightly below the case-core transition point. The model assumed no residual stress in this area of the gear.
