# Repair of Large, Surface-Degraded Industrial Gears — a New Approach

Horacio Albertini, Carlo Gorla and Francesco Rosa

This paper presents a new approach to repair industrial gears by showing a case study where pressure angle modification is also considered, differently from the past repairing procedures that dealt only with the modification of the profile shift coefficient.

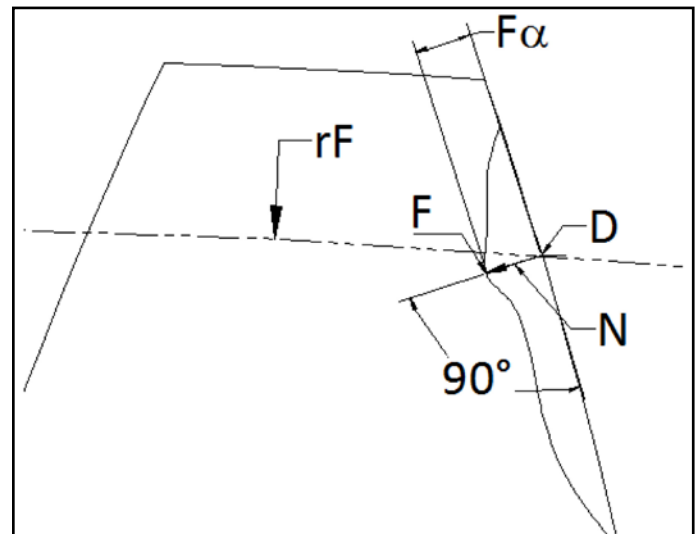
**Figure 2 Normal vector of deepest failure.**

Let us assume that the maximum active tooth profile damage is equal to  $F_\alpha$  and that it is located at radius  $r_F$  (Fig. 2). Point  $D$  is belonging to the original profile of the tooth and point  $F$  is located on the bottom of the damage. The segment  $DF$  is the vector  $N$ , the magnitude of which is  $F_\alpha$  and the direction of which is the unit normal vector  $n$  to the tooth surface at point  $D$ .

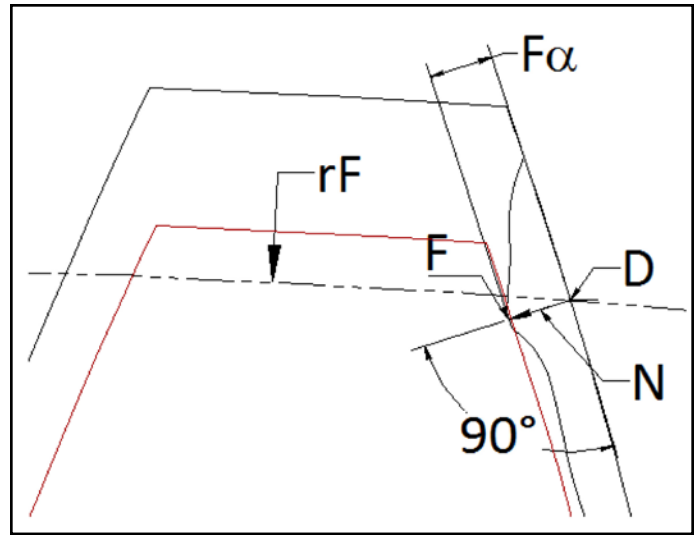
Figure 4 Modified profile, free from defects (red).

The aim of the repair procedure is to define a new gear tooth completely enclosed within the existing gear tooth (since it is only possible to remove material) and such that its external surface (free from defects) passes through point  $F$ . Figure 4 shows an example of the repaired tooth profile (in red).

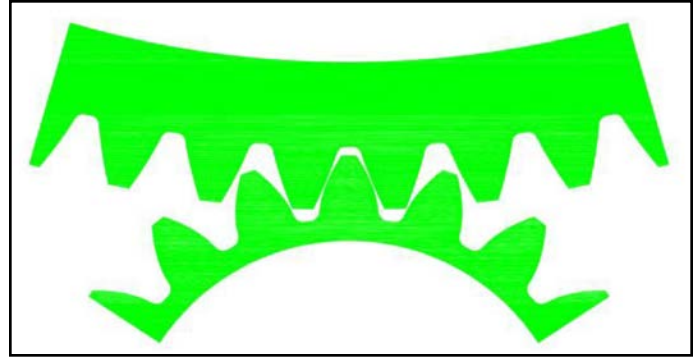
Figure 6 Profile of original pair.

The gear geometry is calculated by gear calculation software (Ref.23), and the profiles of the gear set are depicted in Figure 6. Gear set rating was calculated and the main results are summarized in Table 2. The minimum safety factors for these units are:

It is worth noting that the safety against pitting is below the safety factor, which is supposed to be  $S_{Hmin} \geq 1.0$ . The pinion and the gear have safety factors equal to 0.77 and 0.80, respectively. This is evidence that the teeth may have their flanks damaged by pitting. Indeed, the inspection confirms the presence of pitting (Fig. 7).

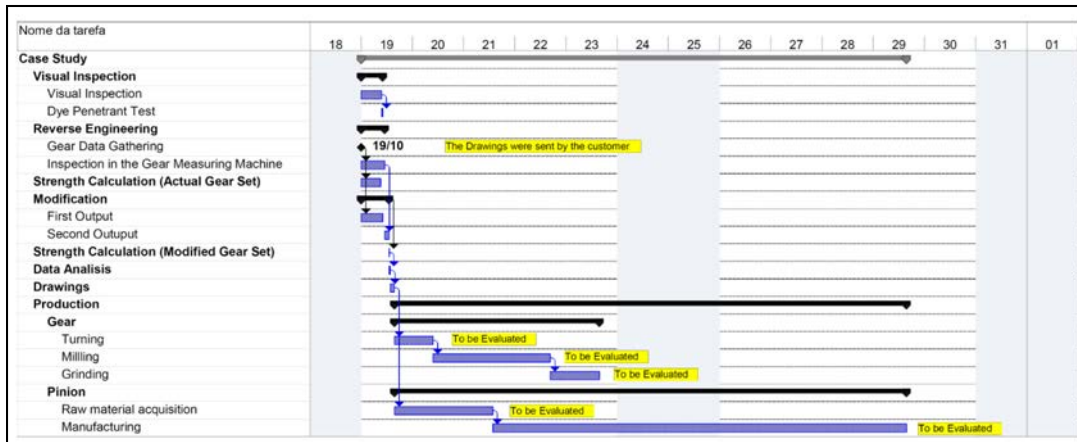
Figure 14 Time spent to complete repair.

Using this procedure, the refurbishment of this case study may take about five days to be executed, considering in addition the machining process (turning, milling, and grinding). The machining and grinding processes were estimated and shall be evaluated since the production stages were not done. Figure 14 displays the Gantt chart from time elapsed up to the drawings' elaboration and the time estimated in the production to conclude process.

The methodology takes about one day to be executed from the visual inspection to the development of the new drawings, regardless of gear set size. Most of the time is spent in the machining shop, turning, milling, and grinding the parts. The time spent in production of the gears shall be more thoroughly studied in future works. ⚙️
