# Space Station's Solar Power Compromised by Balky SARJ Unit

## UNDUE VIBRATIONS, POWER SPIKES AND GRIT GIVE NASA PAUSE

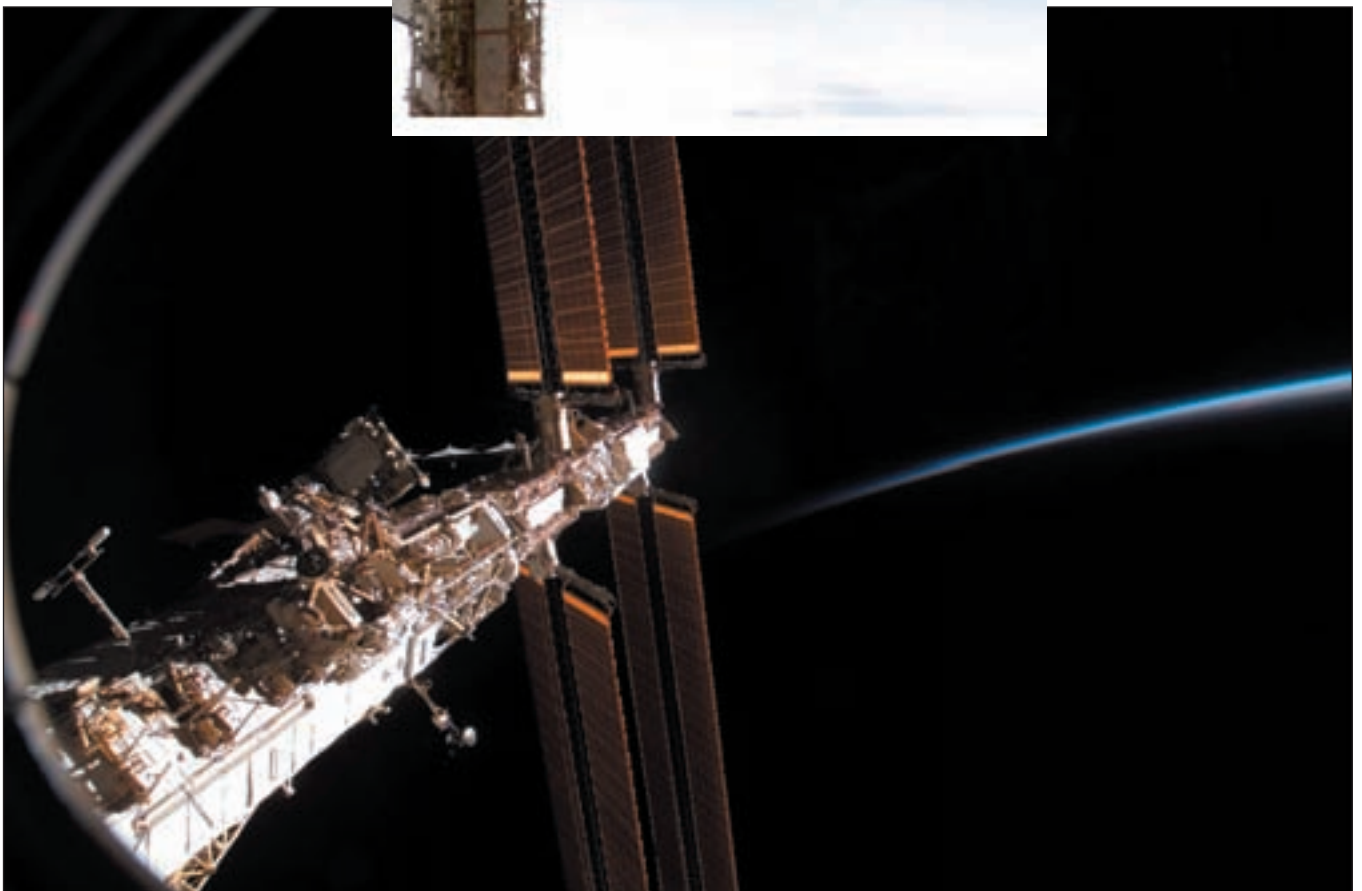
Expedition 16 shuttle Discovery commander Peggy A. Whitson (above) was also involved in the spacewalk investigation of the ISS solar array's (top and next page) faulty SARJ unit. She is seen here examining the damaged starboard component.
