The Anatomy of a Micropitting-Induced Tooth Fracture Failure—Its Causation, Initiation, Progression and Prevention

Raymond J. Drago, Roy J. Cunningham and Steve Cymbala

Management Summary

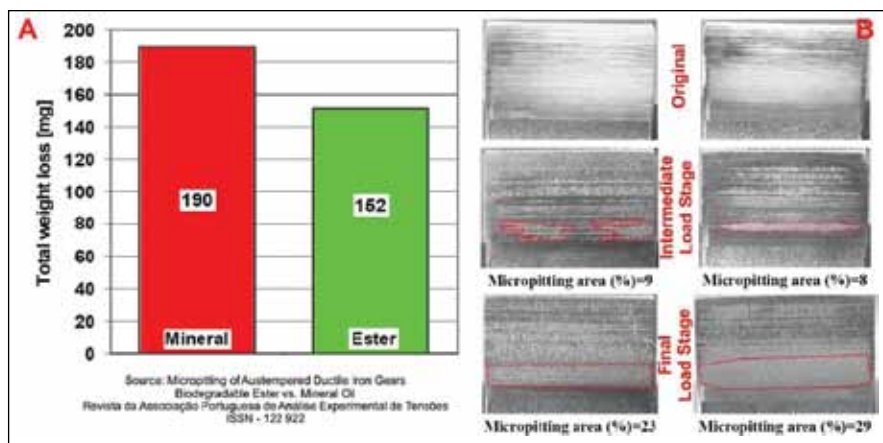
While some testing has been accomplished to investigate the relation between micropitting and specific lubricant additive package combinations, it is still not well understood. Figure 5 shows, for example, the results of one set of FZG tests that compared the efficacy of a biodegradable, straight mineral with an ester-based fluid in the occurrence of micropitting.

Figure 5—Effect of lubricant selection on micropitting performance.
