Repair of High-Value/ High-Demand Spiral Bevel Gears by Superfinishing

Eric C. Ames

Following is a report on the R&D findings regarding remediation of high-value, high-demand spiral bevel gears for the UH-60 helicopter tail rotor drivetrain. As spiral bevel gears for the UH-60 helicopter are in generally High-Demand due to the needs of new aircraft production and the overhaul and repair of aircraft returning from service, acquisition of new spiral bevel gears in support of R&D activities is very challenging. To compensate, an assessment was done of a then-emerging superfinishing method—i.e., the micromachining process (MPP)—as a potential repair technique for spiral bevel gears, as well as a way to enhance their performance and durability. The results are described in this paper.

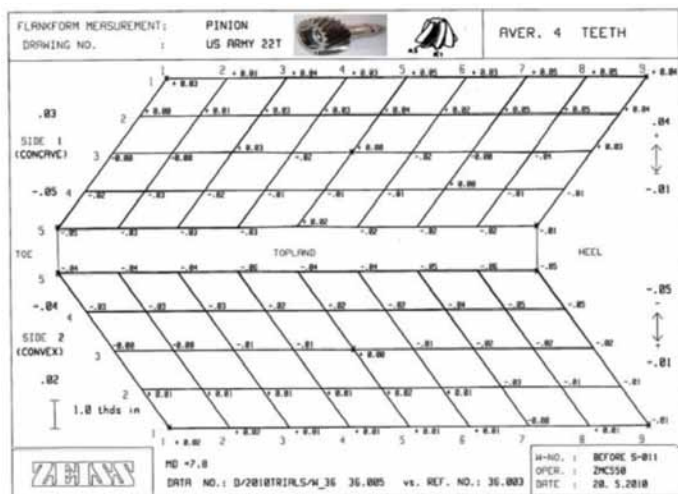
rial removed. Figure 13 shows the results of the topographical inspection performed after the second MMP treatment of A518-00011. The material removal is significantly greater than that achieved in the initial processing. The distribution of material removal was generally uniform from the root up to approximately 75% of the tooth height and also from heel to toe. In the tip region of the tooth, more material was removed with a maximum reduction of 0.00039 inches on the toe end of the concave (driving) side and 0.00019 inches on the tip of the heel. Observation of the convex (coast) side of the tooth showed a very similar pattern, with nearly equal material removal characteristics and the same toe bias. The amount of material removal was consistent with the depth of damage identified during the initial tooth replication and surface analysis (Fig. 6). Based upon the Gleason analysis, the change in tooth thickness was determined to be minimal and on the order of 0.0001 inches.

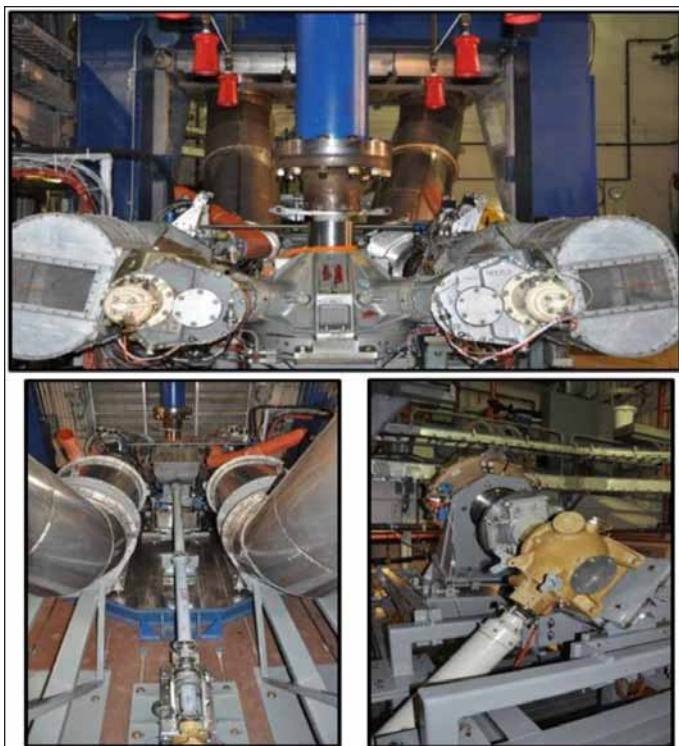
Figure 18 HeDS facility with test gearboxes installed.

The tests were performed at the Naval Aviation Warfare Center-Aircraft Division (NAWC-AD), Helicopter Drive System (HeDS) test facility located in Patuxent River, Maryland. The HeDS consisted of a structural rig capable of physically supporting the MH-60K Main Gearbox MGB, the input modules, the IGB, and the TGB. Two T700-GE-701C (one engine operation was adequate for providing the necessary HP to the tail drive system) engines were used to drive the test gearboxes. The horsepower developed by the single engine was transmitted through the main input module and MGB. The IGB and TGB were driven as they are in the aircraft by the tail rotor take-off flange out of the MGB. The MGB was only lightly loaded for the test. The IGB and TGB were loaded through a single-disk waterbrake dynamometer manufactured by The Kahn Company. The test gearboxes as installed in the HeDS facility are shown in Figure 18. Testing was completed in September 2010. Approximately 32 hours of total operation was accomplished, with 16 hrs accumulated at 800 hp, 1 hr accumulated at powers exceeding 900 hp, and 47 minutes at powers slightly exceeding 1,050 hp. It is worth knowing that the TTO gear mesh is currently qualified for maximum continuous operation at 524 hp. Figure 19 shows the post-test condition of the TTO pinion and mating bevel gear.

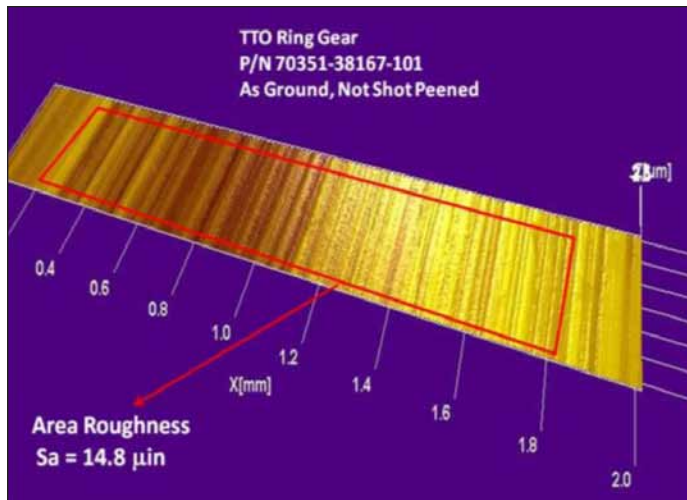
A detailed 3-D analysis of these replicas was performed by Coubrough Consulting, LLC Independence, Ohio. The replica surfaces were measured using a NanoFocus μsurf topometer employing confocal technology. Localized regions of the tooth tip, mid, and root areas were evaluated similar to the pre-test evaluation; the pinion surfaces are shown (Figs. 22–24). The roughening of the tip region, slight polishing of the mid tooth region, and formation of a line of micropits in the root area can clearly be seen. The surfaces of the TTO gear that mated with the pinion are shown (Figs. 25 and 27–28). The TTO gear replica taken after two hours of testing was of poor quality and prevented detailed analysis. Figure 25 shows the surface roughness and topography of the TTO bevel gear prior to testing. The surface finish was measured as 15 micro inches (Sa). It should be noted that the TTO gear was not shot peened. Measurements of a production intermediate gearbox spiral bevel pinion, which was ground and shotpeened (Fig. 26) show a surface roughness of 12 micro inches (Sa). While the measured Sa values were similar, the texture of the two surfaces was clearly different, with the shot peened surface having less directionality as the peaks of the grinding features were reduced. As the endurance testing progressed, a dark line developed on the root area of the TTO bevel gear (Fig. 19). The replica analysis failed to show indications of any change in topography associated with this feature, which may be an oil stain. The effect of additional running at 800 hp and the higher transient loads appeared to have little further influence upon the TTO gear surface finish and topography, with only slight changes in surface finish (Figs. 27–28).

Figure 25 Surface roughness and topography of TTO gear prior to testing.

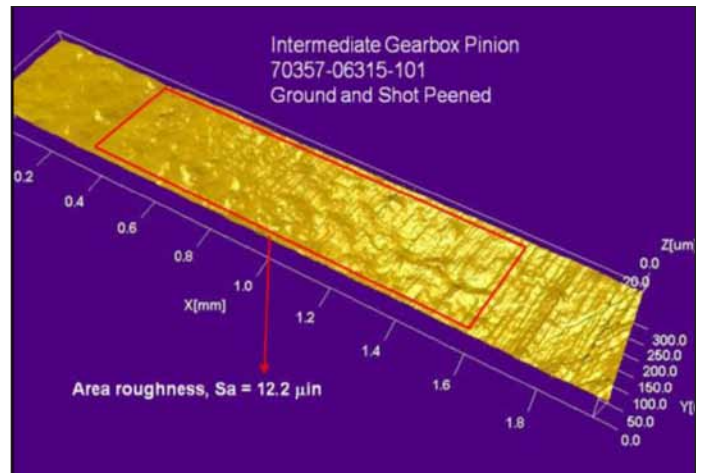
Figure 26 Surface roughness and topography of new-production IGB pinion.
