# The Effect of Material Defects on Gear Performance—A Case Study

Raymond J. Drago, P.E. and Alejandro Font Filax, Ph.D.

## Abstract

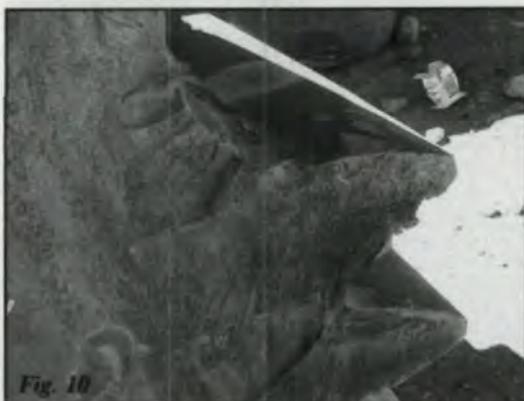
Fig. 10—Cracks progressed from the tooth roots.

Based on the view of the fracture face shown in Figure 10, it appears that the original failure had multiple origins and that it spread from the tooth root area down into the shaft section.
