Longitudinal Tooth Contact Pattern Shift

J.B. Amendola, J.B. Amendola III and D. Yatzook

Management Summary

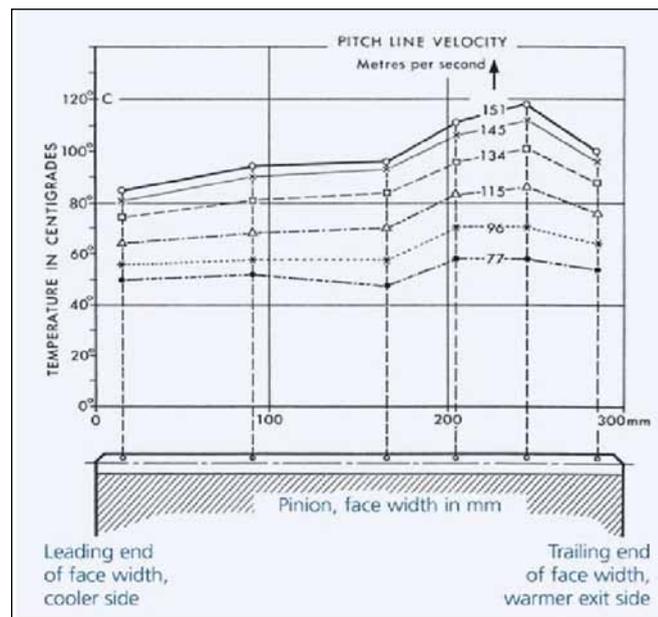
Figure 4—Effect of pitch-line velocity on tooth flank temperature and establishment of an asymmetrical speed/temperature gradient.

Investigations by Martinaglia (Ref. 9) were performed to accurately determine temperature conditions in a high-speed pinion (Fig. 4).
