# The Effect of Start-Up Load Conditions on Gearbox Performance and Life Failure Analysis, with Supporting Case Study

R. J. Drago

## Management Summary

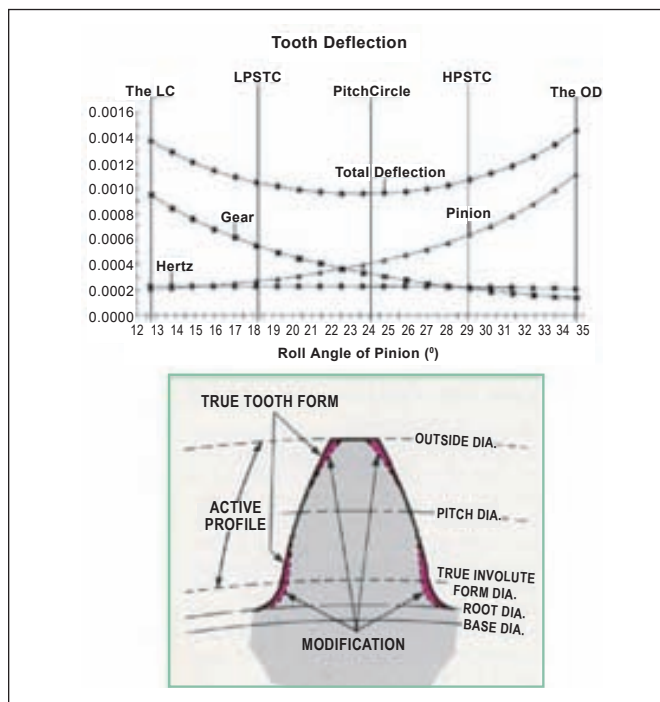
Figure 9—Schematic showing the application of profile modifications to a gear tooth to avoid deflection-induced, high local loading.

The application of profile modifications does not improve the basic load rating of a gear tooth; however, they do make the tooth much less sensitive to spalling failures, thus allowing the gear set to achieve its inherent life. While the theory is far beyond the scope of our discussion here, spalling failures are not adequately addressed by the durability ratings calculated through the use of the AGMA rating standard. The durability ratings calculated by the standard refer to the pitting failure mode, an example of which is shown in Figure 10, for reference—not the spalling failure mode.

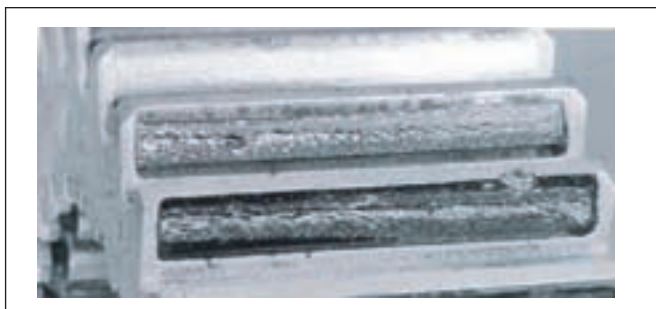
Figure 10—Typical gear tooth pitting failure.

Careful evaluation of the failed pinion (Fig. 7) shows that it did not suffer a pitting failure at all, but rather a spalling failure induced by very high loads at the lowest contact point on the pinion. Note that the damage on the tooth shown in Figure 10 occurs mainly away from the lowest point of contact, and generally in the midsection of the tooth height. This is the typical appearance of classical gear tooth pitting. Conversely, the spalling damage shown on the pinion in Figure 7 starts at the very bottom of the contact zone—in the region of the hard line at the bottom of the tooth—and progresses upward along the tooth profile. This difference is especially significant regarding the remedial actions that are practical for this gear system, as will be explained further below.
