Machine Marks on Gear Flanks: Their Cause and Prevention

What causes shaving cutter marks on gear flanks and can they be prevented?

Expert answer provided by Jim Caldwell, Star SU LLC

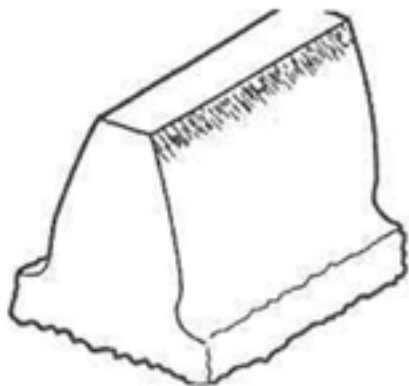
A very rough tearing or gouging occurs across the entire face width, but only in the upper portion of the tooth (Fig. 1). The dedendum of the tooth will have a completely normal, shaved appearance. This condition tends to occur in conventionally shaved pump gears or in other applications having a low number of teeth, high pressure angle, or larger

Figure 1 Example of tip gouging.

modules. It occurs when the involute sliding velocity is too high relative to the helical sliding with the cutter. The following actions have proven effective to ameliorate this condition:

- Slow down the rotation speed of the cutter to a minimum.
- Make sure the coolant is not degraded; change as needed.
- Certain cutter profile modifications have proven helpful; check with your vendor.
- Consider having the cutter redesigned. It may be possible to change the helix angle and serration dimensions of the cutter design to rid yourself of this condition.
