# Misalignment No Beauty in Gearsets

Don McVittie

**When we have problems with gearset failure, a common diagnosis is misalignment." What exactly is that and how do we prevent it?**

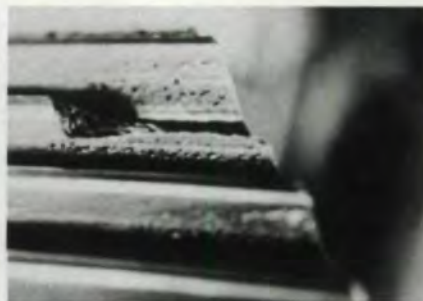
*Fig. 5 - Bending failure caused by a misaligned gear set.*

In any case, the misalignment must be fixed. If it is allowed to persist, the teeth will fail. Fig. 5 shows a typical bending failure which resulted from failure to correct a misaligned gear set.

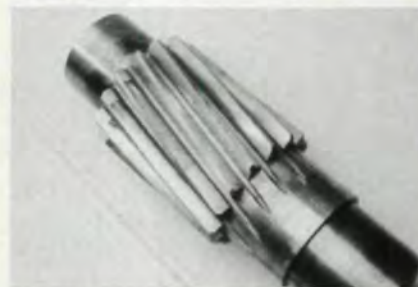
*Fig. 6 - This new gear box failed because of misalignment even though it was supported between bearings.*

We should be aware that even parts supported between bearings can be misaligned under load. Fig. 6 shows a classic case. This new gear box developed problems during an overload test before going into service, but it could have happened at any time.

Unfortunately, a careless assembler didn't get the cone of one bearing seated all the way against its shoulder. A simple check with a feeder gauge between the back of the cone and the shoulder would have shown a gap, but the check was overlooked. The press fit held the cone in place for a while, but an overload moved it to the shoulder, creating a gap between cup and cone. A loose adjustment would have had the same effect.

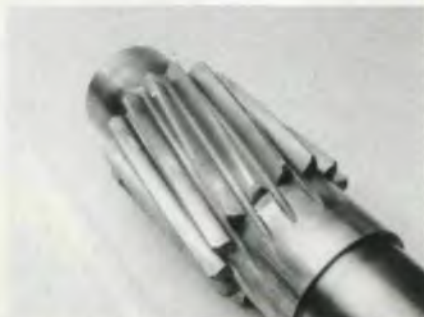
Fig. 8 - The pitting pattern on this helical pinion is the result of a heavy load at one end caused by misalignment.

Sometimes there simply is no easy fix for a misalignment problem. Maybe the box is bored out of line, the gears weren't matched originally, or the parts are so slender that they bend under load. In any case, the load is so heavy at one end of the teeth that wear is unacceptable. Fig. 8 shows this kind of pitting pattern on a helical pinion.
