Influence of Grinding Burn on Pitting Capacity

Christof Gorgels, Fritz Klocke and Tobias Schröder

Management Summary

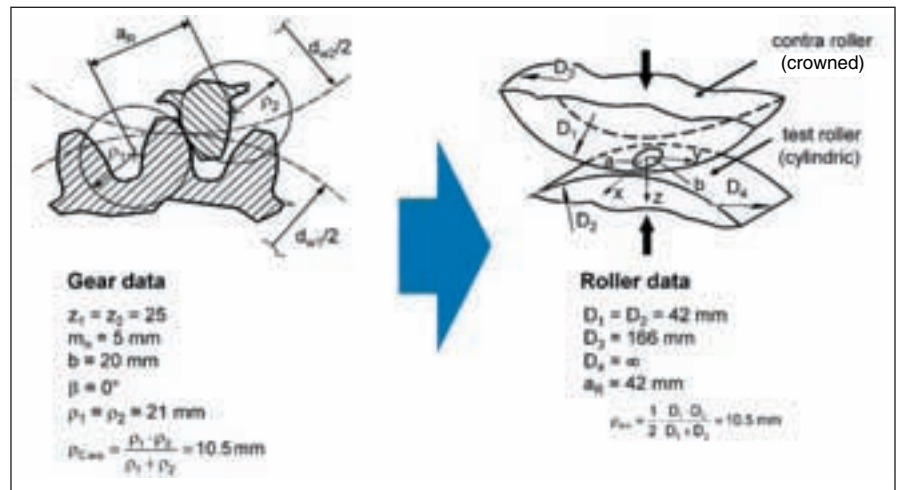
Figure 1—Geometry of gear flank and test roller.

Roller test rig and geometry. The roller geometry is derived from the contact conditions between two gear flanks. The roller radius is taken from the curve radius of the gear flank involute profile in the contact. In this example, the pitch circle was chosen as the basis for the determination of the roller radius. The outer diameter for both rollers is $D_1 = D_2 = 42$ mm. The thermally-damaged test roller has a cylindrical shape. The contra roller is crowned in order to prevent wear in the area of the roller edges. In order to prevent edge pitting on the contra roller, a diameter in the axial direction of $D_3 = 166$ mm is applied for crowning. Further data can be found in Figure 1.

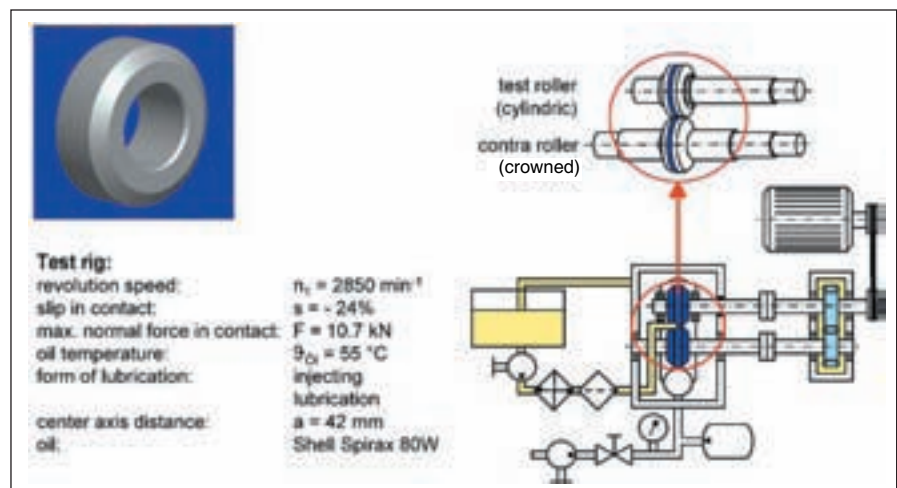
Figure 2—Twin-roller test rig.

Figure 2 shows the test rig and the technical data. The motor drives a transmission; the drive gear of the transmission is coupled with the test roller and the driven gear is connected to the contra roller. Gohritz determined that for this gear set, pitting would be most likely to occur in the area of a negative slippage of $s = -24\%$ (Ref. 8). Therefore a slippage between the two rollers of $s = -24\%$ is realized through a gearing between the two mating rollers. The revolution speed on the drive side is $n_1 = 2,850 \text{ min}^{-1}$.

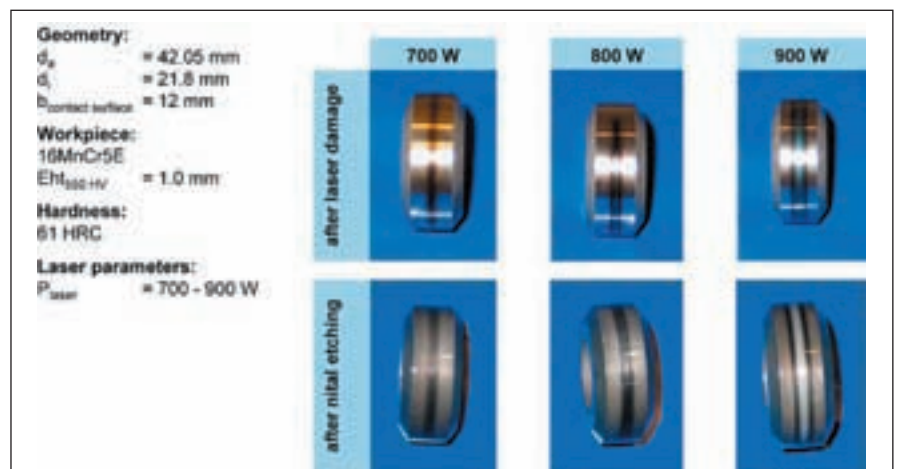
Figure 3—Test rollers.

using a laser. In order to eliminate the influence of the oxide layer after laser damaging, a very small amount of stock has been removed from the roller surface by grinding. The surface of the thermally damaged samples, after the laser process, grinding and nital etching, can be seen in Figure 3.

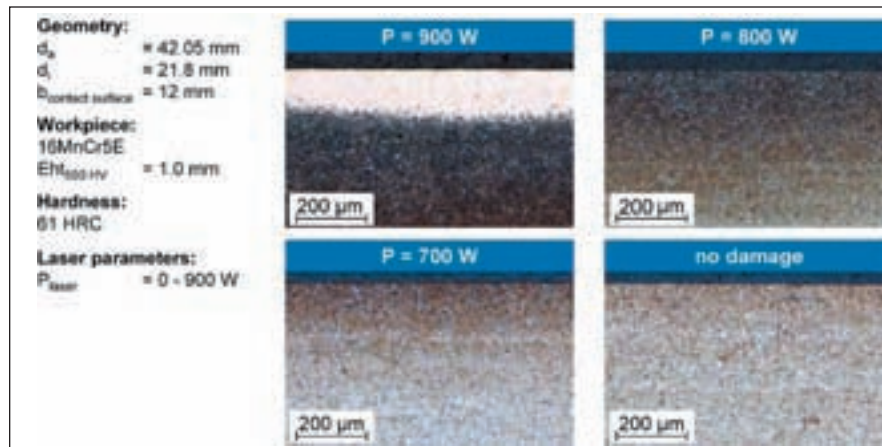
Figure 4—Material structure of damaged test rollers.

of the laser-damaged rollers is to make sure that the induced damage is comparable to typical grinding burn seen in the gear profile grinding process. In order to analyze the characteristics of the damage, the material structure (Fig. 4), the hardness profile (Fig. 5) and the residual stress profile (Fig. 6) have been analyzed.

The analysis shows that the occurrence of the thermal damage reveals a good correlation to what would typically be observed on a damaged gear flank; the structural damage goes well below the surface. The tempered samples have a decrease in hardness close to the surface as well as residual tensile stresses. The rehardened sample shows a very high hardness close to the surface with the hardness decreasing inside the tempered zone below the rehardened area. Very high-compressive stresses are also in evidence near the surface, changing into very high tensile stresses at a distance from the surface of $z = 200 \mu\text{m}$.

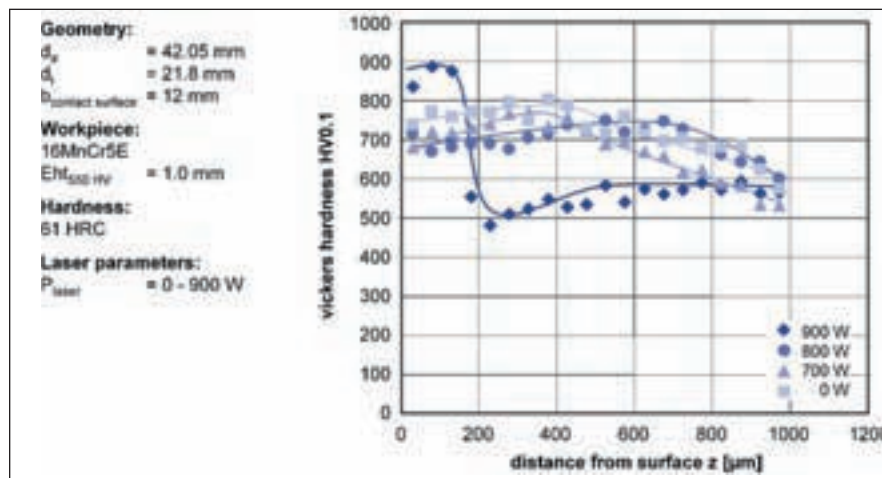
Figure 5—Microhardness profile of selected test rollers.

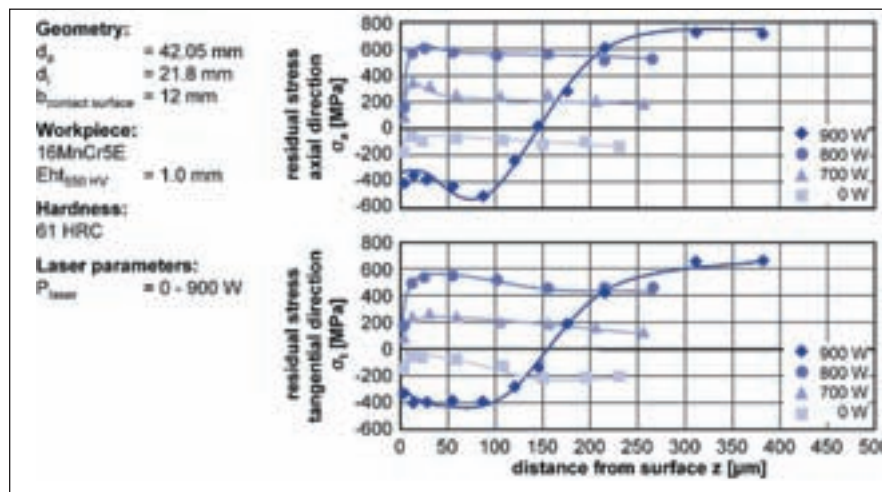
Figure 6—Residual stress profile of selected rollers.

below, due to the high tensile stresses in this area (Fig. 6).

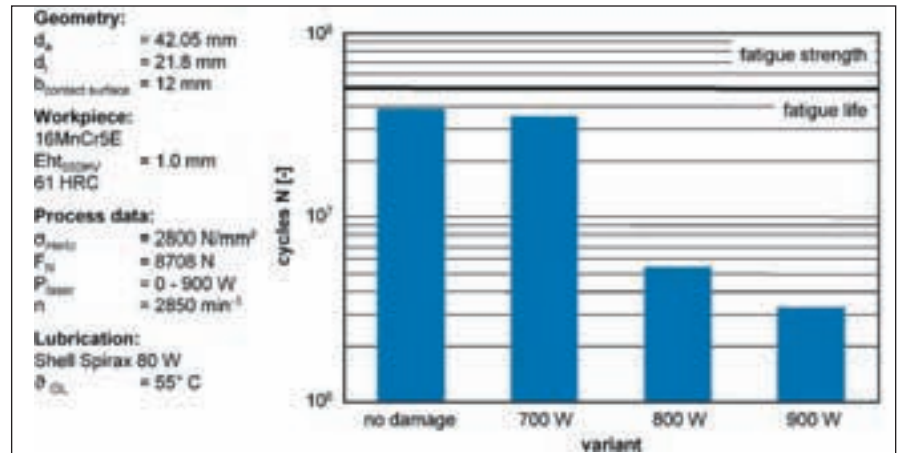
Figure 7—Fatigue life impacted by thermal damage.

different rollers, the maximum load cycles—depending on the degree of thermal damage—are shown in Figure 7. After reaching $N = 50,000,000$ load cycles, the limit for the fatigue strength would be reached. Testing was carried out in the area of fatigue life; in this way a comparison of the differing, thermally damaged rollers could be accomplished.

The undamaged reference had an average sustainable number of load cycles, until pitting occurs, of $N = 38.8 \cdot 10^6$, and was therefore near the limit for fatigue strength. The failure mechanism was a pitting on the sliding surface. The rollers with a slight tempering ($P_{\text{Laser}} = 700 \text{ W}$) failed after an average of $N = 35.1 \cdot 10^6$ load cycles. These results demonstrate that a slight tempering results in only a small reduction of sustainable load cycles.

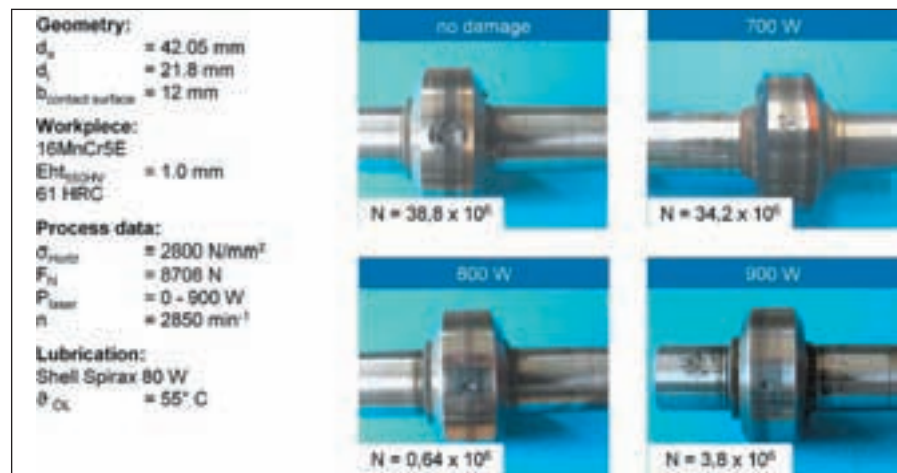
Figure 8—Comparison of pitting depending on degree of thermal damage.

The wear phenomenon to be found on the test rollers after damage occurs is displayed in Figure 8. The non-damaged roller and the two rollers with tempering ($P_{\text{Laser}} = 700 \text{ W}$ and 800 W) show pitting in the middle of the contact area, while the rehardened roller shows pitting on the edge of the contact area.

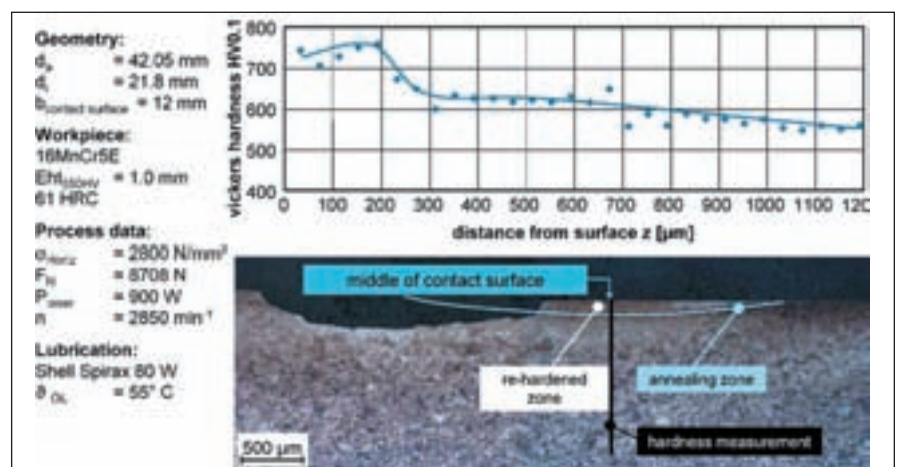
Figure 9—Analysis of pitting on roller with rehardened zone.

An explanation for the migration of the pitting out of the middle is supplied when Figure 9 is taken into account. The material structure in the area of the pitting is shown. The middle of the contact surface is marked where the hardness profile was measured. The hardness profile shows a high hardness near the surface and a low hardness (tempered

The line showing the start of the annealing zone below the rehardening zone shows that the middle of the pitting is in the area of the changeover from the rehardening to the tempered zone on the surface. This shows that the rehardened area breaks off the tempered zone

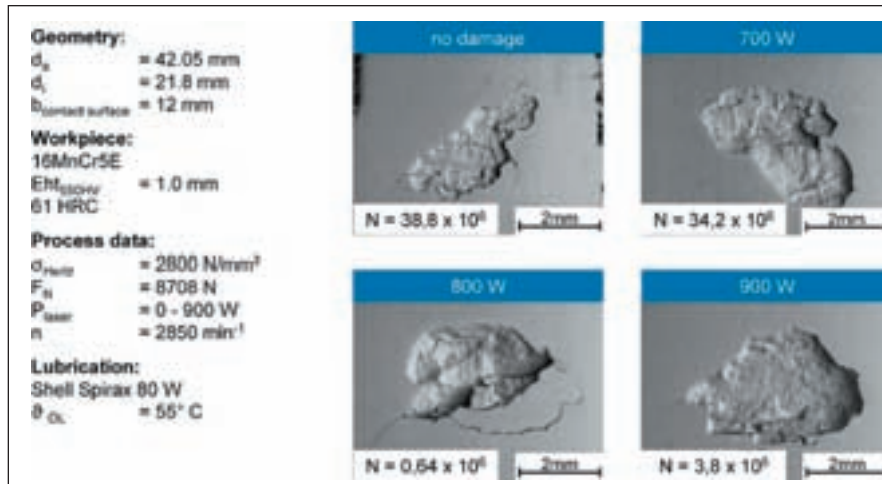
Figure 10—Comparison of pitting using scanning electron microscope.

In Figure 10, pictures of the pitting using scanning electron microscope. The undamaged and the slightly damaged variants show pitting with no surrounding cracks. The strongly tempered roller ($P_{\text{Laser}} = 800 \text{ W}$)

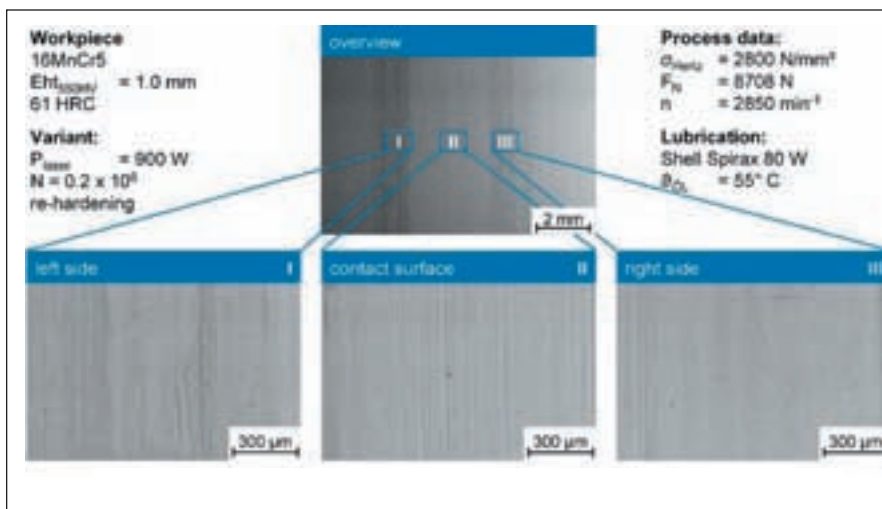
Figure 11—Surface structure of roller with rehardened zone after 200,000 load cycles.

To gain a more detailed analysis of the surface wear mechanisms occurring on a rehardened roller, the surface has been examined with a scanning electron microscope after a very short time frame of $N = 200,000$ load cycles; the photos are shown in Figure 11. The upper photograph shows an overview of the sliding surface, and the three lower photographs display a more-detailed image of the middle, left and right areas. In the middle, the ground surface structure remains visible. This is the rehardened area that shows a high resistance to abrasive wear. On the sides, where the tempered material can be found, this structure is no longer visible. The typical grinding structure has been leveled, showing that in this area—even though the Hertzian stress is lower—higher wear occurs.

on the degree of damage, but mainly on the number of load cycles. Only the rehardened roller shows a change on the side of the sliding surface similar to the results shown in Figure 11. Also it must be stated that the crowned shape of the contra roller and the geometrical change of the test roller lead to an increasing contact width, resulting in a reduced Hertzian stress with an increasing number of load cycles.

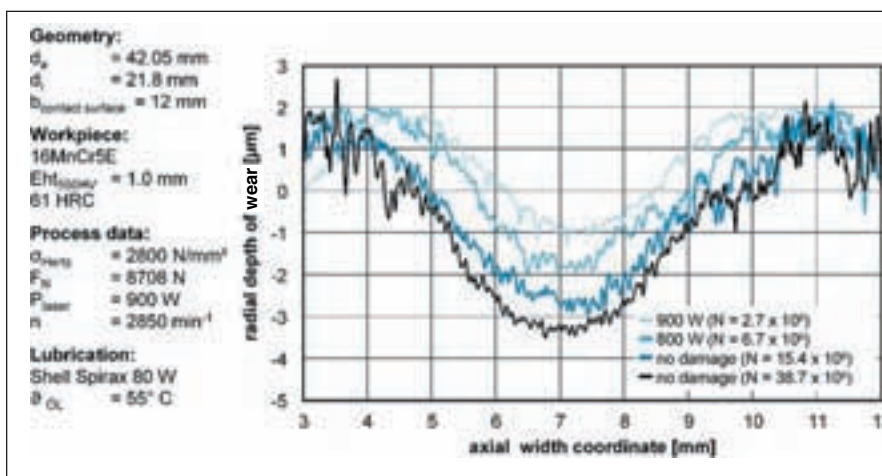
Figure 12—Topography of the test roller contact surface.

In order to determine the degree of influence of the damage and attendant wear on the sliding surface, the topography of the test roller sliding surface in the axial direction has been analyzed. The undamaged rollers have been analyzed after reaching half the sustainable load cycles ($N = 15.4 \times 10^6$) and at the full sustainable load cycles ($N = 38.7 \times 10^6$). The rehardened roller ($P_{\text{Laser}} = 900 \text{ W}$) and the strong-tempered roller ($P_{\text{Laser}} = 800 \text{ W}$) were analyzed after the full sustainable load cycles. The profiles are shown in Figure 12.

Results show that in the middle of the sliding surface there is a change in geometry of up to $5 \mu\text{m}$. It can also be demonstrated in Figure 12 that the geometrical change does not depend
