Tooth Flank Fracture – Basic Principles and Calculation Model for a Sub-Surface-Initiated Fatigue Failure Mode of Case-Hardened Gears

Dipl.-Ing. I. Boiadjiev, Dr.-Ing. J. Witzig, Dr.-Ing. T. Tobie and Prof. Dr.-Ing. K. Stahl

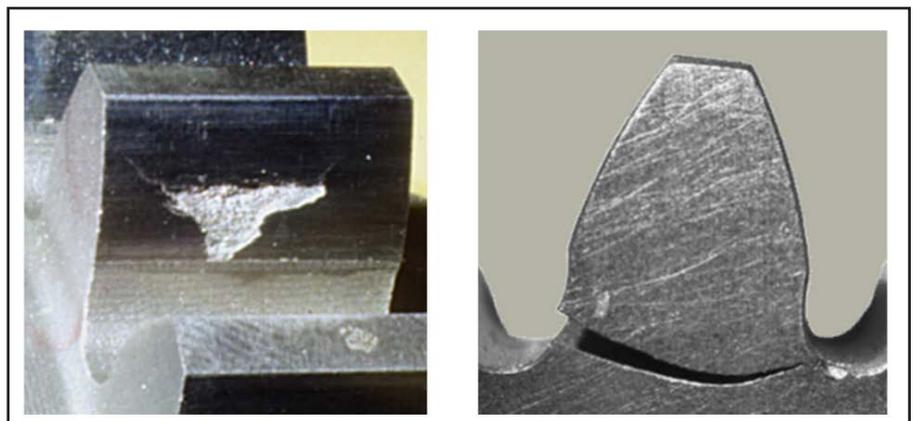
Figure 1 Typical surface gear failure examples – pitting (left) and tooth root breakage (right)

Gears with tooth flank fracture show characteristic features that differentiate them from gears that failed due to pitting, micropitting or tooth root breakage. For example, Figure 1 shows two gears that failed due to pitting and tooth root breakage, which have in common the fact that the crack was initiated at or close to the surface. Figure 2 shows two example gears—a test and a turbine gear—with tooth flank fracture. These are only two examples, among many others, showing that sub-surface fatigue failures, such as tooth flank fracture, can occur in almost every field application. Failures due to tooth flank fracture are reported in wind and steam turbines, truck gearboxes, bevel gears for heavy machinery, and test gearboxes. Typical failure mode for tooth flank fracture is that the crack initiation is normally located below the flank surface in an approximate depth of the case-core transition (Fig. 3a and b) in the active flank area. The primary crack is often initiated at non-metallic inclusions that have significantly different Young’s modulus compared to the normal material structure. Such imperfections below the surface act as stress risers during the roll off of the flank because of the notch effect. If the material strength is locally exceeded, a crack with growth potential could be initiated in the material that can lead to tooth flank fracture later.

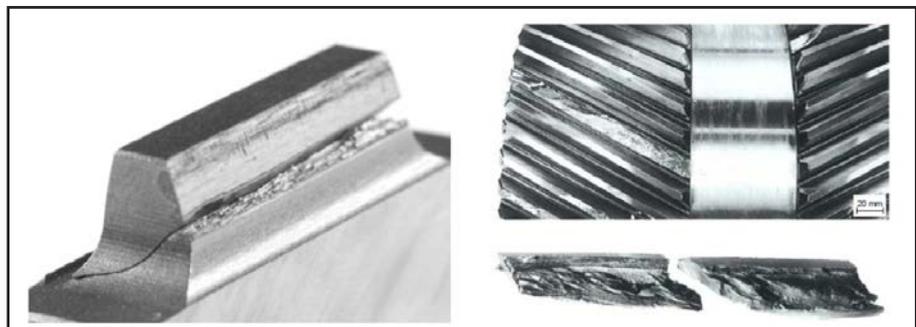
Figure 2 Examples of tooth flank fracture – test gear from (19) (left), turbine gear from (2) (right)

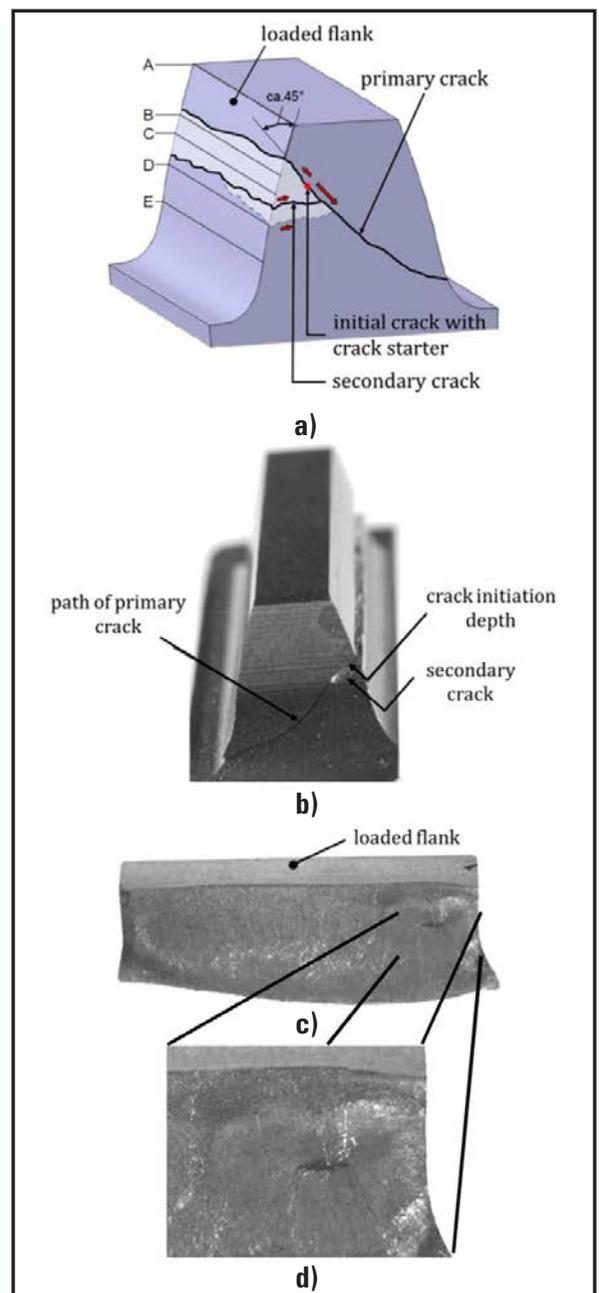
Figure 3 Characteristic features of tooth flank fracture (19)

After a crack has been initiated below the surface, it slowly propagates during operation in an angle of 40° to 50° relative to the flank surface—but without direct connection to the surface. During the crack propagation a so called “fish eye” can occur due to relative microscopic movement of the cracked surfaces. The primary crack propagates from the crack starter towards the surface of the loaded flank, and into the tooth core towards the opposite tooth root section. The crack propagation rate towards the loaded flank is smaller in comparison to the core, due to the higher hardness. After the primary crack has grown enough so the tooth stiffness is reduced, secondary cracks may occur under load. A distinctive feature of these cracks is that they normally start at the flank surface and propagate parallel to the tooth tip into the material. As shown in Figure 3a) and b), after the secondary crack meets the primary one, particles from the active flank might break out. As the main crack reaches the

loaded flank surface the remaining cross section of the tooth that carries the load is rapidly decreased. When a critical cross-section is reached, the upper tooth piece is separated from the gear. The final breakage of the tooth is due to overload breakage (Fig. 3c). On the fracture area, a typically shiny crack lens around the crack starter and a zone of rough overload breakage can be observed (Fig. 3c and 3d). Due to the given characteristics, the failure type of tooth flank fracture can be differentiated from other failure types such as tooth root breakage and tooth interior fatigue fracture (TIFF) that show a crack progression over the tooth cross-section as well. The failure type of tooth root breakage is characterized by a crack in the 30°-tangent area on the tooth root fillet. According to (Ref. 3) the load on the tooth leads to a complex, multi-axial stress condition. The bending stress in the tooth root changes over time when the load on the flank moves towards the tooth tip or the tooth root, respectively. Due to the bending moment, stresses in the tooth root cross-section are induced, which are tensile on the loaded and compressive on the unloaded flank side. These stresses have their maximum at the surface, so the risk of a crack initiation is greatest there. The two main differences between the failure modes of tooth flank and tooth root breakage are location of the failure in tooth height direction and location of the initial crack. The typical endangered area for tooth flank fracture can be found at half tooth height of the active flank, whereas tooth root breakage normally occurs below the active flank in the 30°-tan-

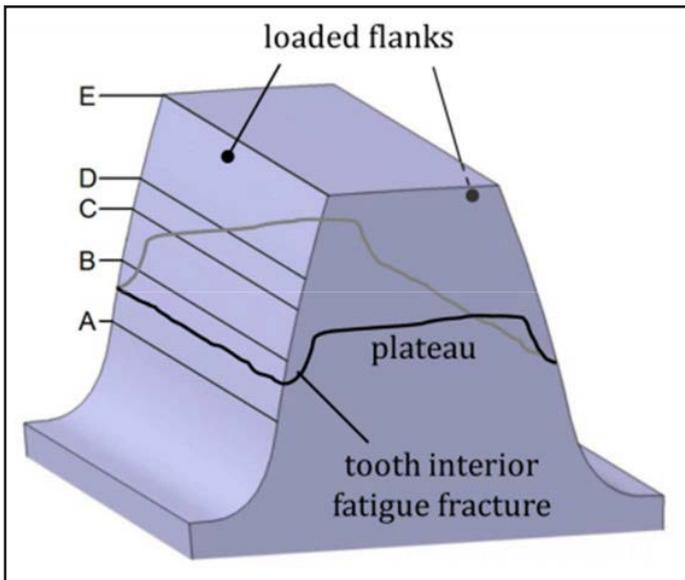
Figure 4 Schematic visualization of tooth interior fatigue fracture (TIFF).

gent area on the tooth fillet. Furthermore, the crack initiation of the tooth root breakage happens mostly at, or just below the surface, and not in greater material depth like the initial crack of the tooth flank fracture. The failure type of tooth interior fatigue fracture is most common on gears with alternating loads, where both tooth flanks are used to transmit torque. A characteristic feature of TIFF (Fig. 4) is that the crack propagation path runs nearly parallel to the tooth tip surface with small drops near the surface. The causes for TIFF are not only the alternating loads on both sides on the tooth, but also the tensile residual stresses in the tooth core resulting from the heat treatment. Also typical for TIFF is that the upper tooth segment is normally separated along a plateau at half tooth height.

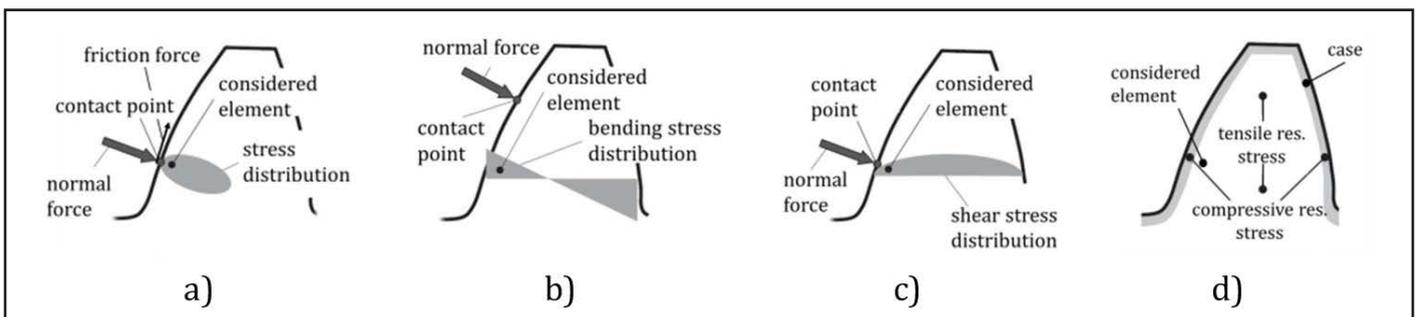
Figure 5 Stress conditions inside the tooth (19).

General stress conditions in the tooth. The induced stresses inside the loaded tooth are shown in Figure 5. Considering an ideal, smooth flank surface, the general stress condition inside the tooth is composed of following components:

Figure 5 shows the stress components acting in a considered element below the surface. In Figure 5a) the stress distribution due to the normal force is shown, where the contact stress can be described according to the Hertzian theory. The effects of the relative sliding between the two gear flanks are considered with the friction force. Figure 5b illustrates the bending stress distribution over the tooth cross-section. Due to the normal force, tensile stress is induced on the side of the loaded flank and compressive stress on the back flank. In comparison to the bending stress, which is nearly linear over the tooth cross-section, the stresses due to shear load can be approximated by a parabolic distribution with a maximum at the middle of the tooth. In Figure 5d the residual stresses are shown. As a result of the heat treatment, compressive stresses normally occur in the case area, and are compensated by tensile stresses in the tooth core. Unlike the stresses in 5a, b and c, the residual stresses are load-independent and constant over time if the load is not too high. The residual stresses and the load induced stresses can be superimposed if the different time dependence of the stress components is considered.

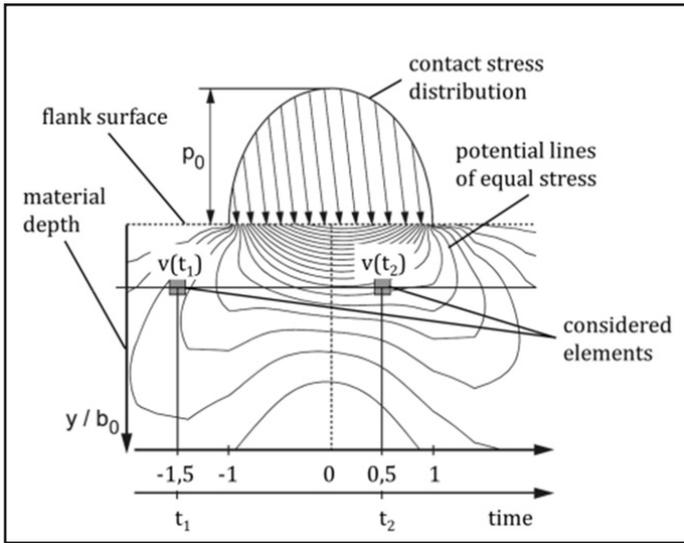
Figure 6 Time-dependent stress in the rolling contact (7).

Stress conditions in the rolling contact. On a loaded tooth flank the rolling direction x can also be seen as the time axis. For each considered element in the material the stress conditions change due to the relative motion of the mating tooth flanks. Figure 6 illustrates schematically the rolling contact with the induced stress (one component of the 3-axis stress condition) below the surface. Under the assumption of constant equivalent radius of curvature and normal force, all volume elements in the same material depth are exposed to equal stresses, but at different times during the roll-over process. Furthermore, a single volume element is subjected to different stresses at different times, so when the material exposure is calculated in a considered element below the surface, the stresses have to be considered over the whole time axis (x -axis). However, the difficulty in this observation is the turning of the principal coordinate system during the rolling contact, resulting in a variation of the absolute stress values as well as the direction of the principal stresses for each volume element. The stress distribution over the material depth is mainly influenced by the maximum Hertzian pressure p_0 resulting from the Hertzian contact load and the local equivalent radius of curvature ρ_c . As shown in Figure 7, the shear stress τ_H below the surface increases with an increasing equivalent radius of curvature ρ_c —even if the maximum contact pressure p_0 and maximum shear stress τ_H remain the same. Because the relative radius of curvature increases not only with increasing center distance, but also with increasing pressure angle or increasing addendum modification factor, an increased shear stress τ_H below the surface can be expected in these gear configurations. Furthermore, based on the fact that the local strength profile derived from the hardness profile remains constant, the remaining strength reserve erodes and the risk of a crack initiation below the surface increases.

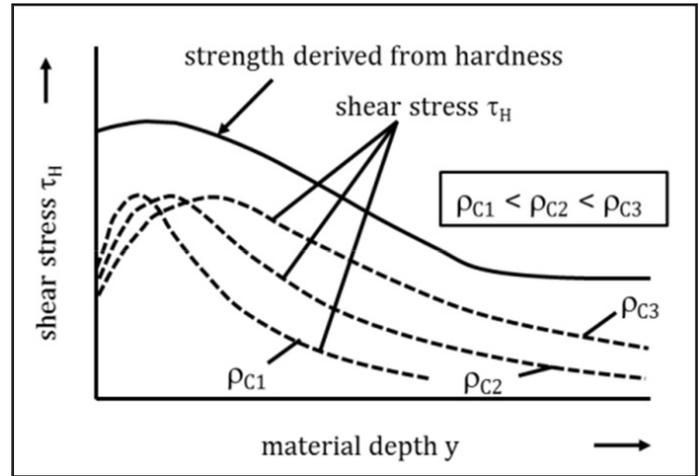
Figure 7 Influence of the equivalent radius of curvature on the shear stress below the surface (19).

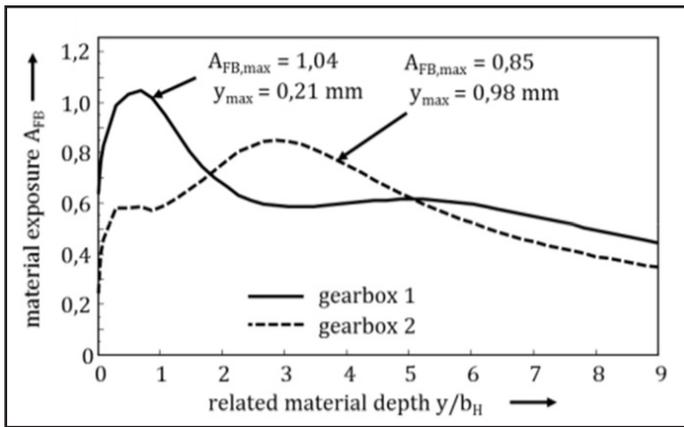
Figure 8 Comparison of the calculated material exposure curves for two example gearboxes (19).

Figure 8 shows the comparison of two calculated material exposure curves for two example gearboxes. The material exposure maximum $A_{FB, max}$ for gearbox 1 is reached near the surface, whereas the maximum exposure $A_{FB, max}$ for gearbox 2 can be observed in greater material depth. The location of the peak is mainly influenced by the equivalent radius of curvature, by the occurring contact loads and by the heat treatment parameters. Depending on the location of the maximum material exposure, the failure type can be predicted. High material exposure values at the surface indicate pitting whereas material exposure peaks in greater depth can be interpreted as at high risk of tooth flank fracture. Figure 9 shows a variation calculation of the material exposure for one contact point with and without consideration of the compressive residual stresses near the surface. By neglecting the compressive residual stresses in the case their positive effect on the material exposure is lost, which always leads to a maximal exposure close to the surface. By using the reduced calculation model without consideration of the residual stresses the tooth flank fracture failure, which has its initial crack in greater material depth, cannot be reproduced. This indicates a decisive influence of the residual stresses on the calculation results. Thus fatigue failures due to tooth flank fracture can only be evaluated correctly if the residual stresses are considered during the calculation. As shown in Figure 10 the reduction of the case-hardening depth (curve 1) leads to an increase of the maximum material exposure in greater material depth, whereas the local maximum near the surface remains almost unchanged. Furthermore

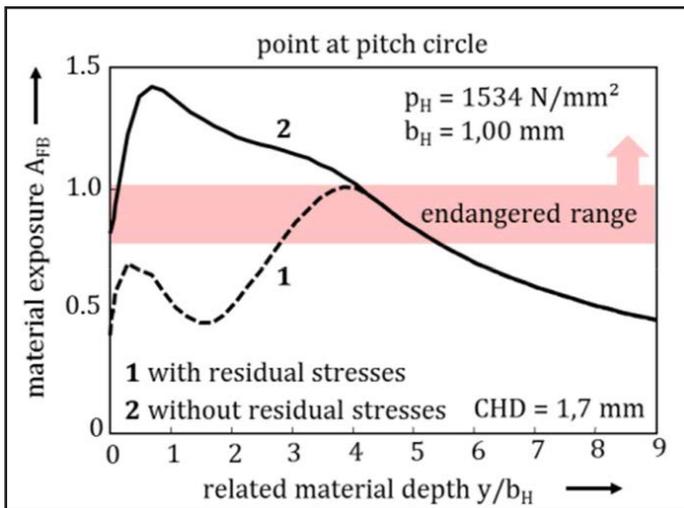
Figure 9 Material exposure curve for one contact point calculated with and without residual stresses (19).

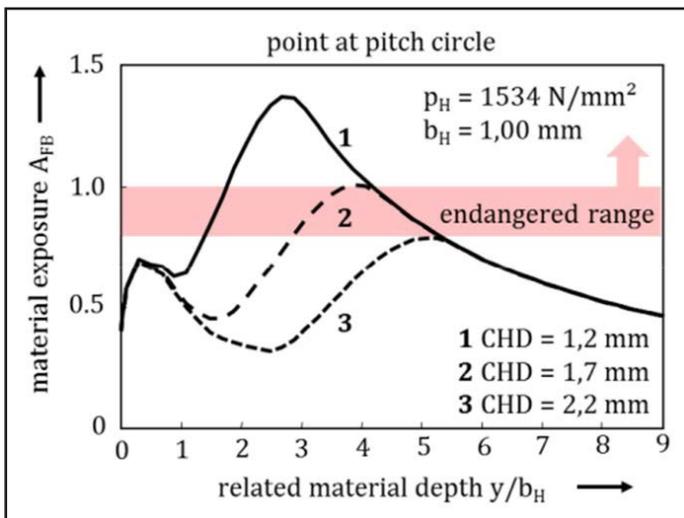
Figure 10 Influence of the CHD on the calculated material exposure (19).

the maximum of the material exposure shifts towards the surface. Because of the reduced CHD, the core hardness is already achieved in smaller material depth while the hardness near the surface remains the same. An increase of the CHD has the effect that the maximum value of the material exposure is decreased and shifted towards greater depth. All three curves indicate a strong influence of the case hardening depth on the maximum material exposure and its location below the surface. The local peak near the surface is not significantly changed by the CHD variation.

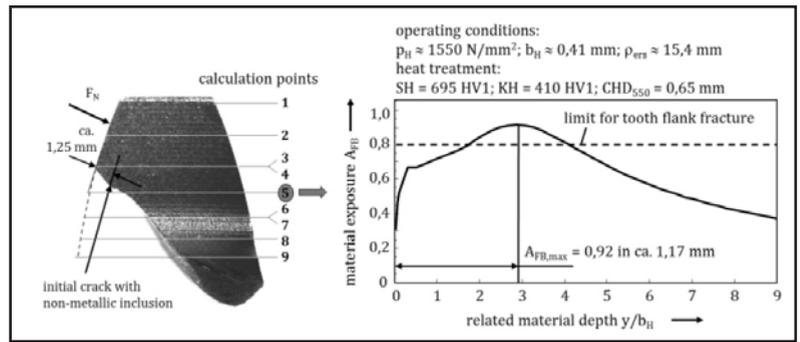
Figure 11 Comparison of test result and calculated material exposure (example for tooth flank fracture).

Figure 11 shows example comparison between test result from the gear running tests and the corresponding calculated material exposure. Because of characteristic features, the failure could be identified as tooth flank fracture (Fig. 11, left). The initial crack occurred at flank mid-height in a depth of ca. 1.25 mm below the loaded flank surface, which equals nearly twice the case hardening depth. In Figure 11, right, the calculated material exposure curve for mesh position 5 is plotted over the material depth. The maximum value of $A_{FB, max} = 0.92$ occurring in a depth of 1.17 mm exceeds the limit of 0.8 and therefore indicates a significant risk of tooth flank fracture. The critical material depth derived from the gear test was very well represented by the calculation as well.

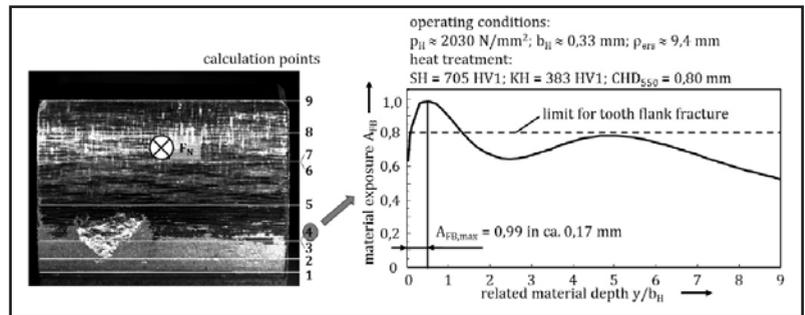
Figure 12 Comparison of test result and calculated material exposure (example for pitting).

($m_n = 5$ mm, $a = 91.5$ mm, $z_{1,2} = 17/18$) is shown in Figure 12. The pitting failure, as illustrated on the left, occurred during the test run near the tooth root at mesh position 4. The maximum material exposure of $A_{FB, max} = 0.99$ in this position is found just below the loaded flank surface, while the material exposure in greater material depth is slightly below the limit for tooth flank fracture of 0.8 and therefore still non-critical regarding tooth flank fracture. Consequently a good correlation between the test and the calculation results is present.

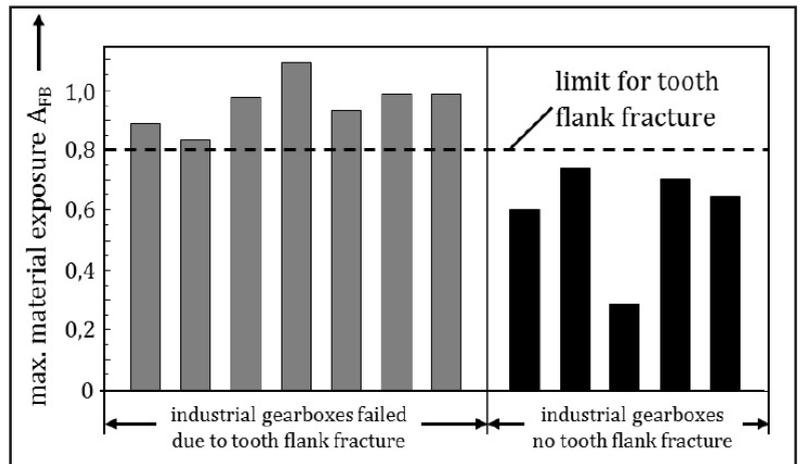
Figure 13 Calculated maximum material exposure for different industrial applications (19).

Figure 13 summarizes the results from calculation studies regarding tooth flank fracture, including gearboxes from different applications such as wind turbines, water turbines, high-speed gearboxes and roller mills. For all examined gearboxes the calculated global maximal material exposure is given. The gearboxes on the left failed due to tooth flank fracture and for all gearboxes on the right no damage or failures due to

flank breakage were reported. A good correlation can be found between the calculated maximum material exposures and the observations of the different industrial gearboxes. The comparison confirms tooth flank fracture failures when the critical value of 0.8 of the material exposure is exceeded. All other gearboxes, where no flank breakage occurred, lie beneath 0.8. In general a good applicability of the calculation method could be observed.
