Classification of Types of Gear Tooth Wear - Part I.

Louis Faure
CMD Transmissions,
Cambrai, France

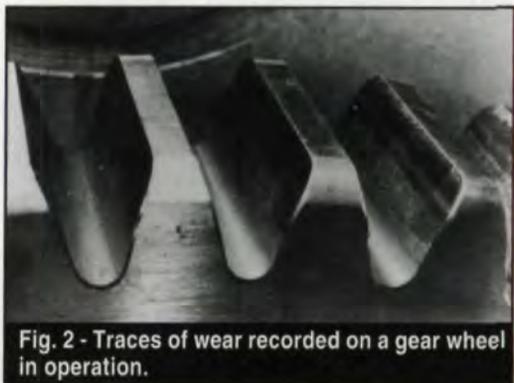
Fig. 2 - Traces of wear recorded on a gear wheel in operation.

The wear zone is generally gray colored and slightly dull, with sometimes lustrous areas and the presence of scoring. (See Fig. 2). Note the presence of a dull zone below the pitch, where the wear is greater, and of a lustrous area on each side of the pitch and slightly higher. Also note the transverse scoring slightly marked near the tooth tip and the machine streaks still visible near the pitch.

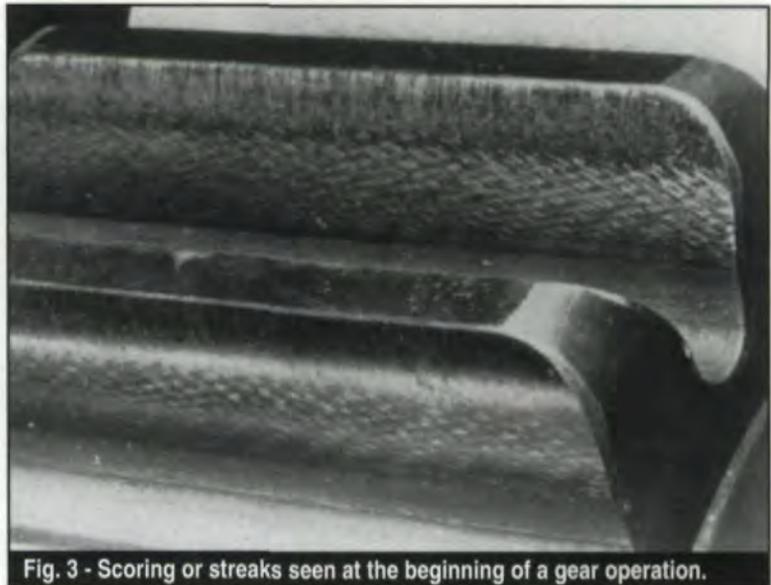
Fig. 3 - Scoring or streaks seen at the beginning of a gear operation.

This type of wear appears in the form of fine grooves or lines in the sliding direction. These streaks or scores are formed progressively in the zone characterized by a high sliding speed, at the tooth tip and near the root of the gear teeth. (Fig. 3)

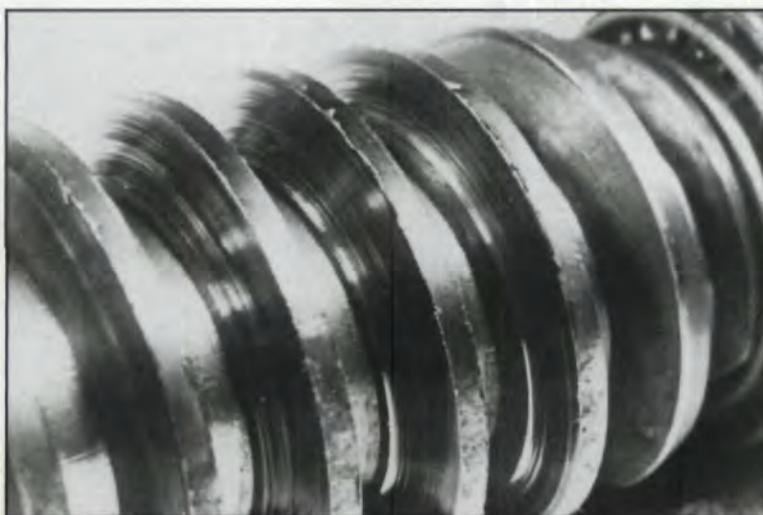
Fig. 4 - Scoring by circular streaks seen on a worm gear.

The formation of scoring can be considered as a preliminary stage preceding scuffing. These streaks generally lead to more severe local wear of gear teeth in the zones where there is a higher pressure. Frequently we note in time a stabilization of these streaks when the wear level of the scored surfaces has been sufficient to generate a better distribution of the load, which as a consequence diminishes the maximum pressure on the gear teeth. In this case only the black color base of streaks or scoring will remain. This stabilization phenomenon can be accelerated by increasing the oil viscosity and by improving filtration. This type of wear is often encountered in worm gears. (Fig. 4)

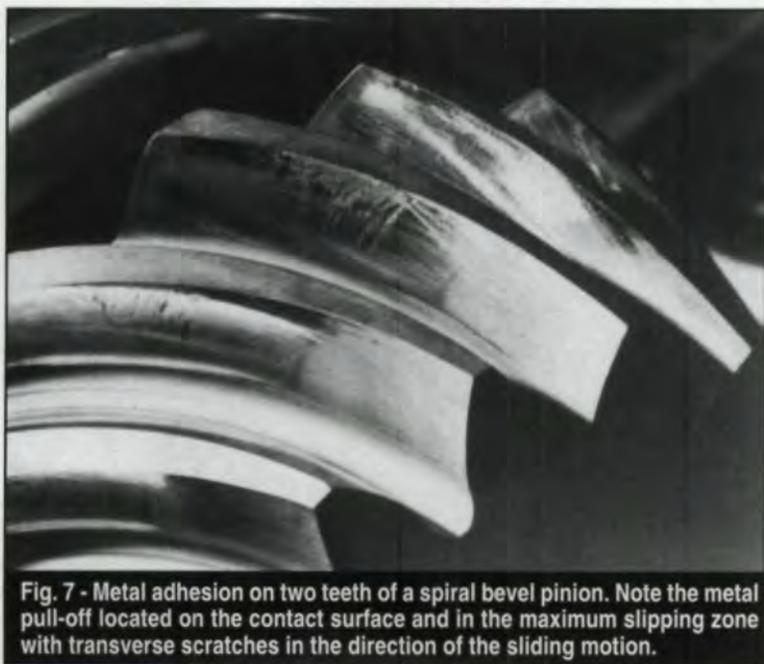
Fig. 7 - Metal adhesion on two teeth of a spiral bevel pinion. Note the metal pull-off located on the contact surface and in the maximum slipping zone with transverse scratches in the direction of the sliding motion.

For added safety the lubricant viscosity can be increased (if necessary). Fig. 7 gives an example of metal adhesions encountered on several teeth of a spiral bevel pinion.

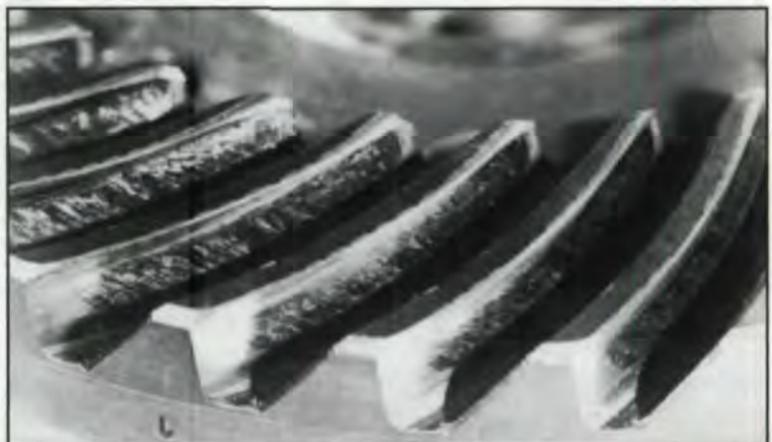
Fig. 9 - Destructive scuffing on the teeth of a spiral bevel wheel. Note the presence of deep streaks and important deformations of the profile in the contact zones. This gear wheel can be considered as destroyed.
