# Hob Basics

## Part II

**T**his is Part II of a two-part series on the basics of gear hobbing. Part I discussed selection of the correct type of hobbing operation, the design features of hobs and hob accuracy. This part will cover sharpening errors and finish hob design considerations.

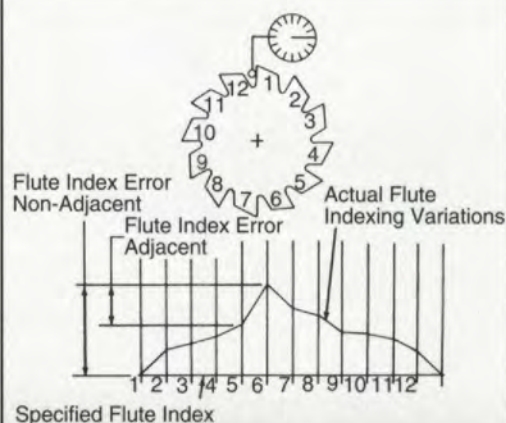
Fig. 5 — Method of measuring hob flute errors by use of an index mechanism.

**Index Error.** Hob flute indexing error is the deviations of the actual radial positions of the hob flutes from the theoretical positions (See Fig. 5). Index error occurs when stock is sharpened off the hob flutes unequally.

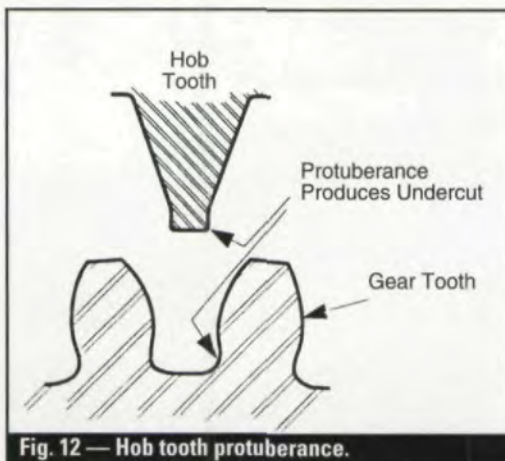
Fig. 12 — Hob tooth protuberance.

**Protuberance.** Protuberance is a modification of the hob tooth form at the top corner to produce undercut on the gear teeth (See Fig. 12). This undercut provides clearance for the shaving cutter or grinding wheel, and also prevents the formation of an abrupt change in profile with its resulting stress concentration. With small numbers of teeth, the tooth form cut with a hob without protuberance is often undercut enough, but a protuberance is required for larger numbers of teeth to eliminate contact between the tip of the shaving cutter or grinding wheel and the fillet of the gear tooth.

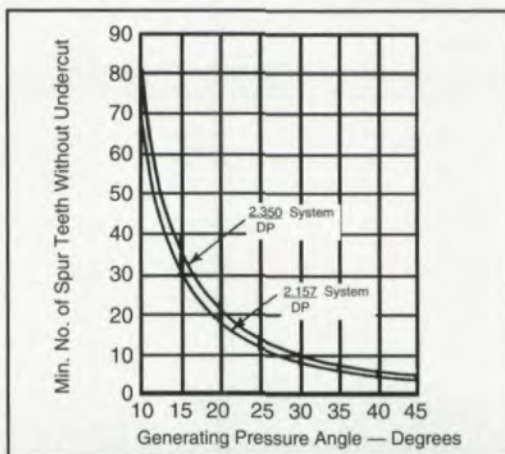
Fig. 14 — Hobbing without undercut.

The first method is to increase the pressure angle. An increase in the pressure angle of the gear will allow a decrease in the number of teeth without undercutting the tooth profile. See Fig. 14 for the relationship between the number of teeth which can be hobbled without undercut for the 2.157/DP and 2.350/DP systems.

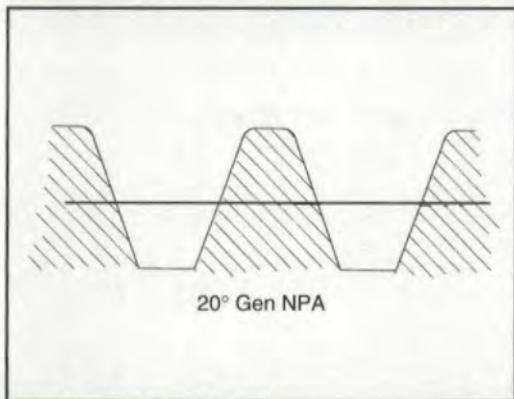
Fig. 19 — Hob rack form.

Fig. 17 shows a gear tooth generated by a 20° normal pressure angle pre-shave hob with a .040 tip radius and .0025 protuberance. This hob design is unacceptable since it produces a condition where there is no stock at the T.I.F. diameter. By reducing the radius to .030 and reducing the protuberance to .002, an acceptable gear tooth can be generated (See Fig. 18). This design leaves a full amount of shave stock at the T.I.F. while still allowing ample undercut. Fig. 19 shows the final hob tooth configuration in this case.
