Our Experts Discuss Hobbing Ridges, Crooked Gear Teeth, and Crown Shaving

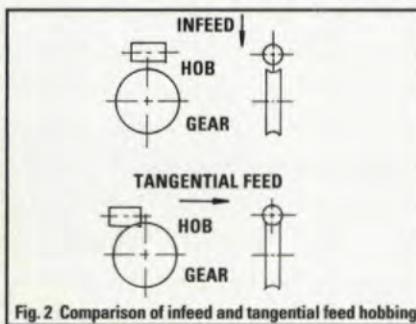
Bill Janninck replies: We examined the sample worm gear you submitted as an example of the ridging problem. To illustrate it we show a scale graphical diagram of the gear tooth flank in Fig. 1. The lines on the flank show the ridges or high points on the profile surface representing a surplus of mate-

rial. In the gear cutting trade the flats causing this are called generating flats and are similar to facets. These flats are a function of the number of flutes in the worm gear hob used in cutting the gear by the infeed process. In this process changes in feed or speed have no effect on the flats, as the hob and gear are locked together by the machine gearing. Unless the flutes in the hob are changed, these flats are unavoidable.

So let us ask another question. Could we improve the ridging using the infeed process? Yes! In your case the gear has 23 teeth and the hob has 4 starts. There are no common divisors in 4 and 23 so we have what is called a prime or hunting ratio. (If the numbers were 4 and 24, the ratio would be even or non-prime.)
